# Central Middle School

## Week of September 6, 2019

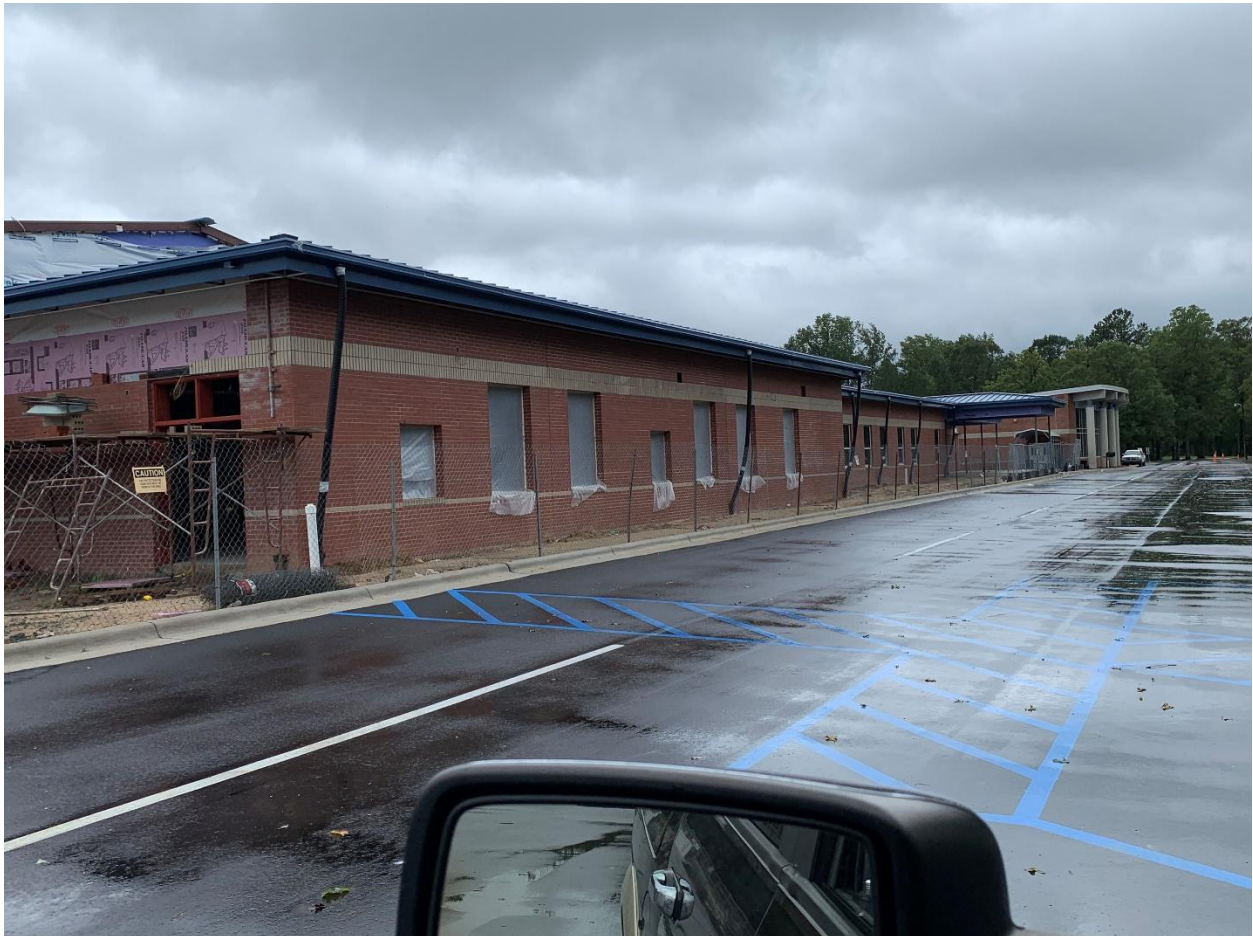
Progress is evident as I walk through the construction with quite a few windows installed. The goal was to have all windows installed before the hurricane. Thursday afternoon it appeared the windows on the north side of the building including the band room and the art room are not installed.

The above picture taken Friday afternoon confirms those windows are not installed.

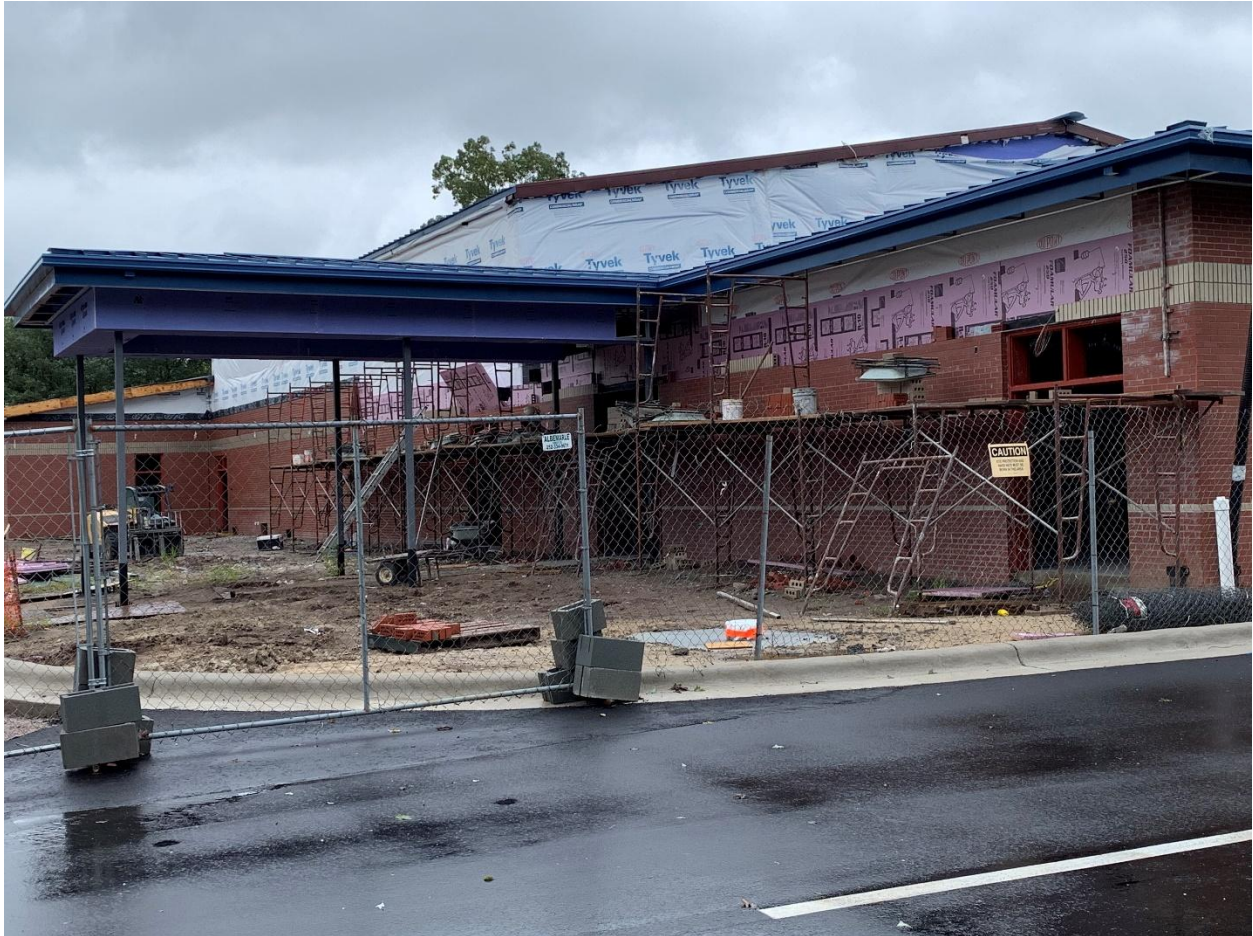
The brickwork on the outside of the gym is almost complete and looks very good. The bricks across the east side of the gym have to go up about two more feet to the eave of the weight room roof. The east wall of the gym above that level will be beige stucco finish metal panels.

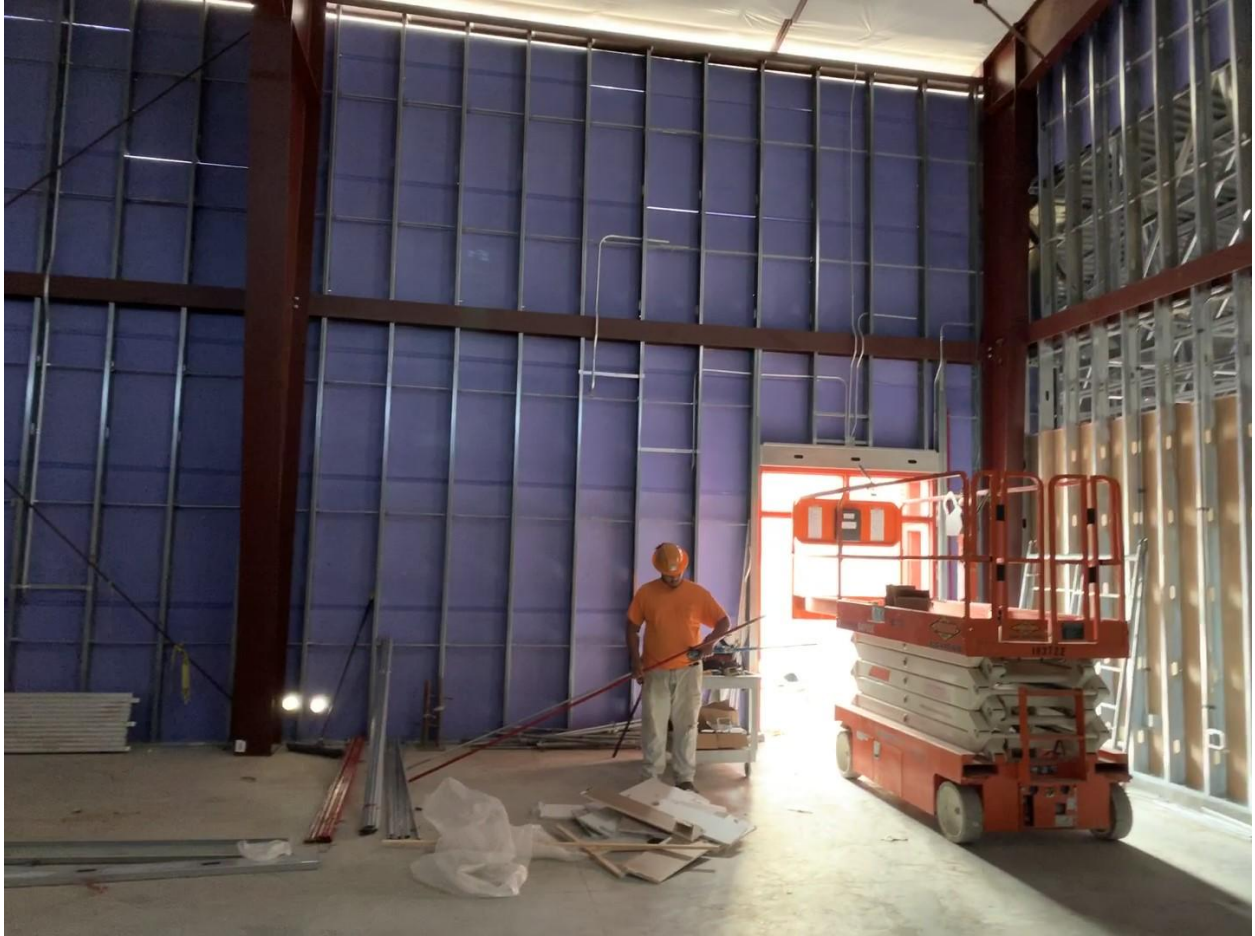
Entering the gym through the weight room I find an electrician installing conduit on the east wall.

All that work and installation of insulation has to be completed before sheetrock can be installed.

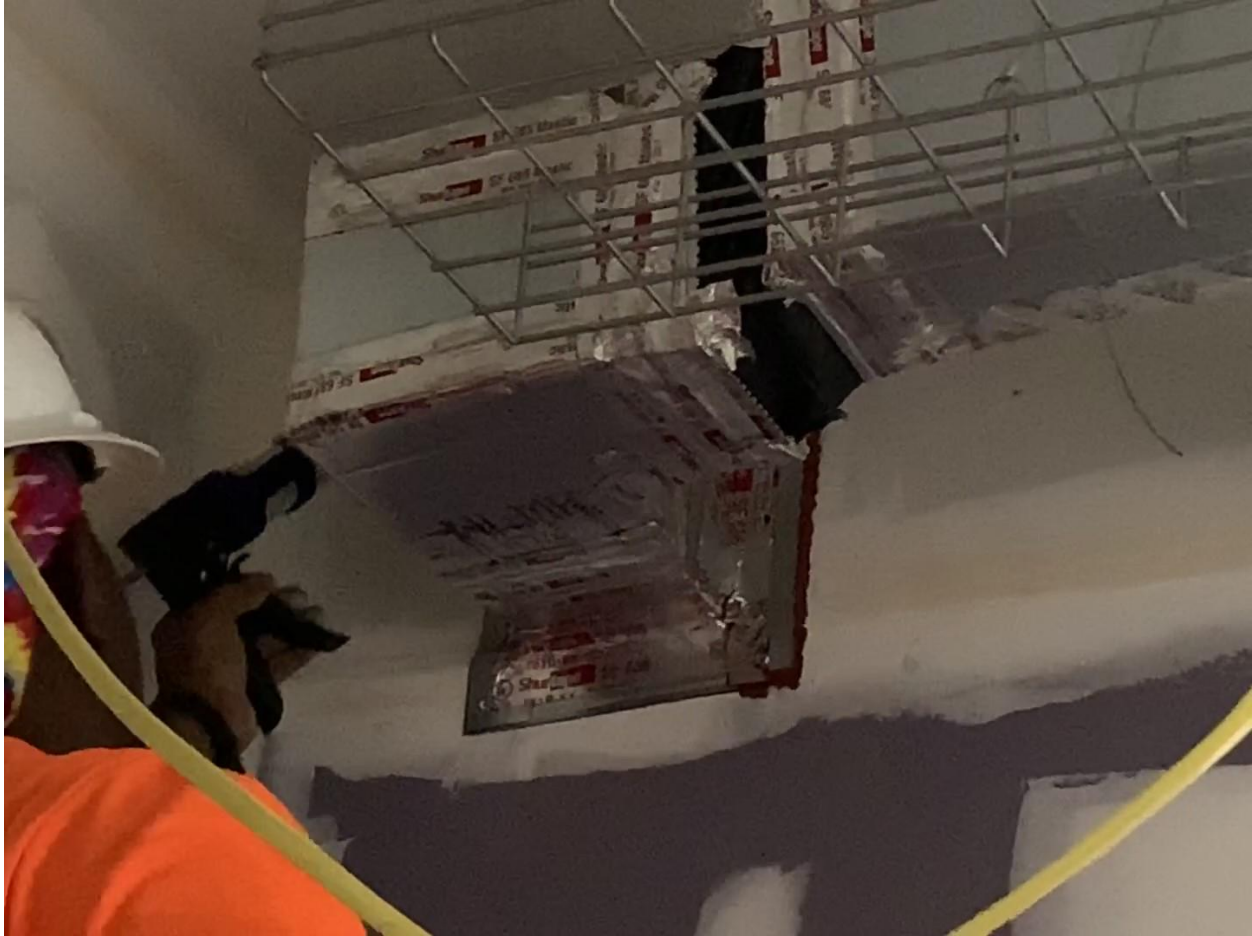
Moving down the front hallway I find a workman caulking seams around ductwork. I notice a boot installed on the connection between a straight run and a through the wall fitting.

This is a normal way to correct misalignment. The boot is a rubberized fabric made for the purpose and holds up well. None of this will be visible when the ceilings are installed.

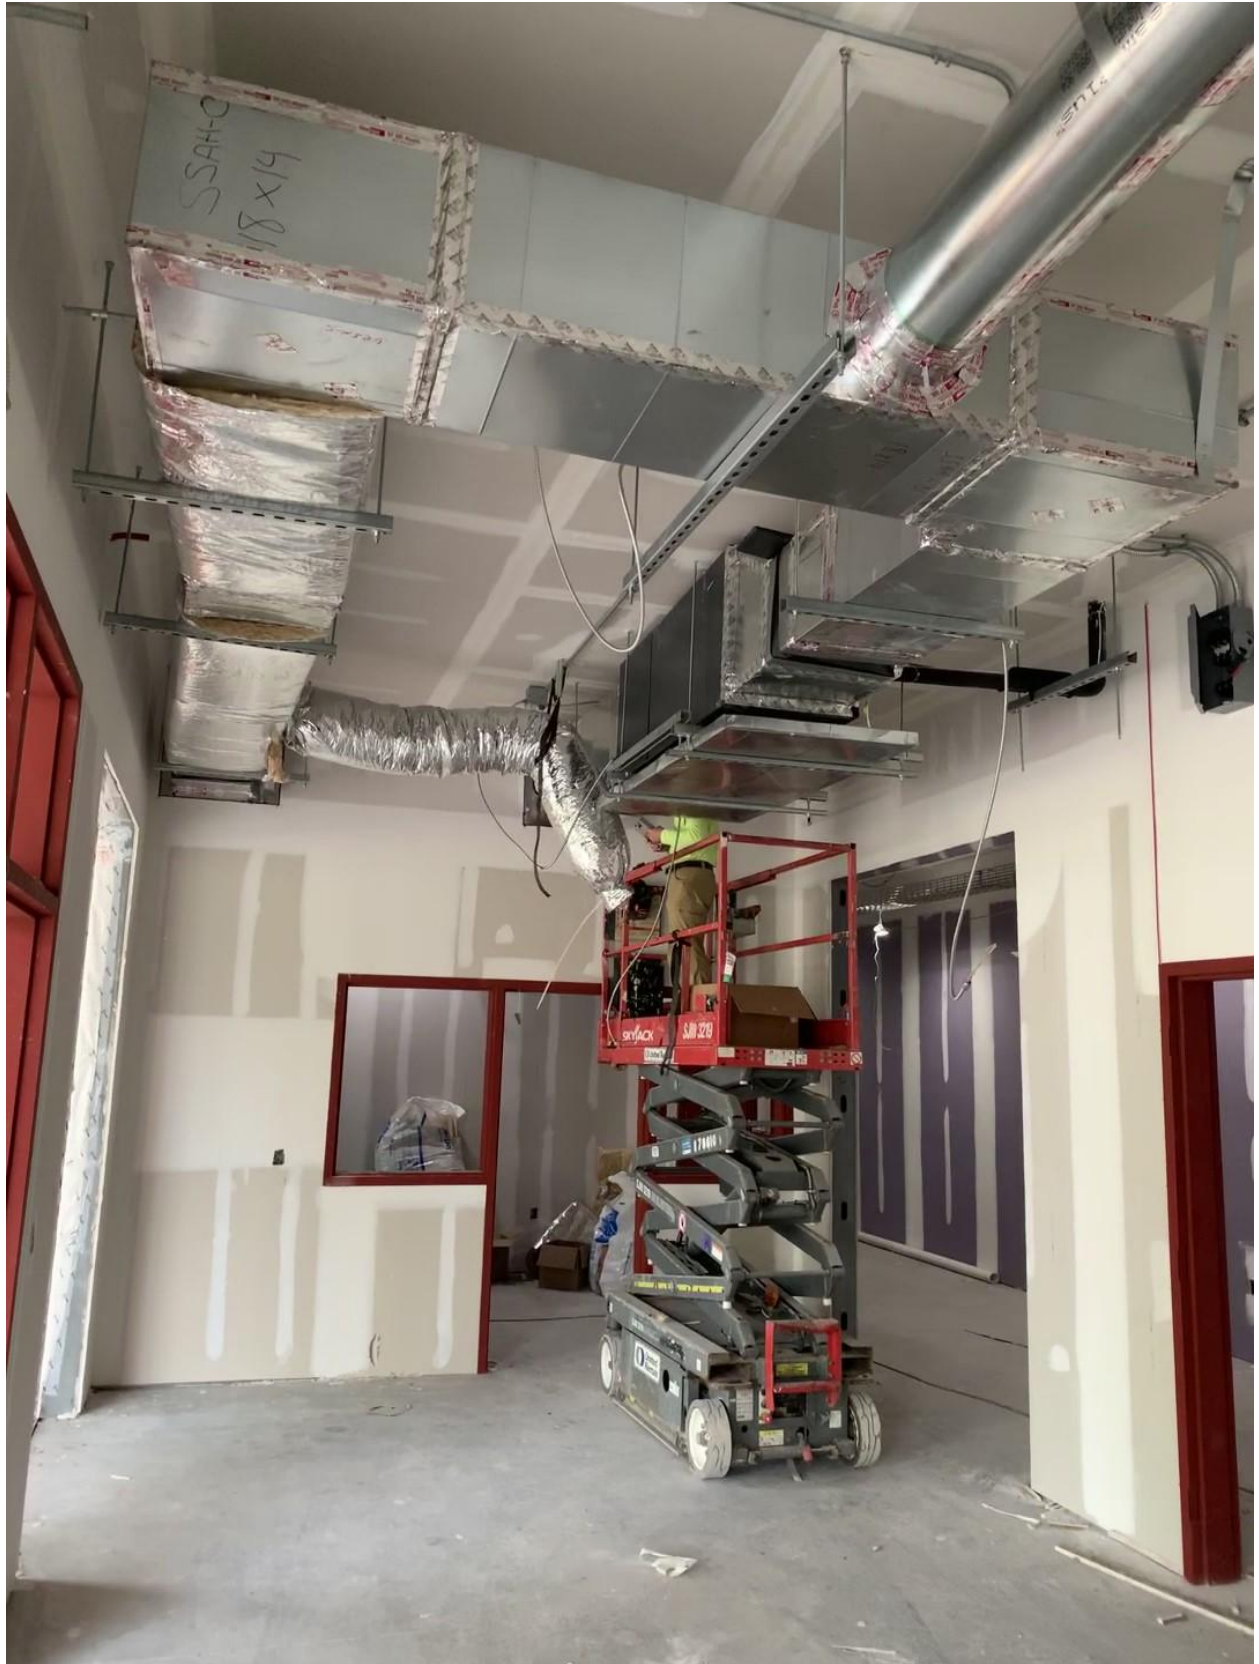
Quite a bit of HVAC work has taken place in the front entrance with air handlers and ductwork filling the space above the ceiling.

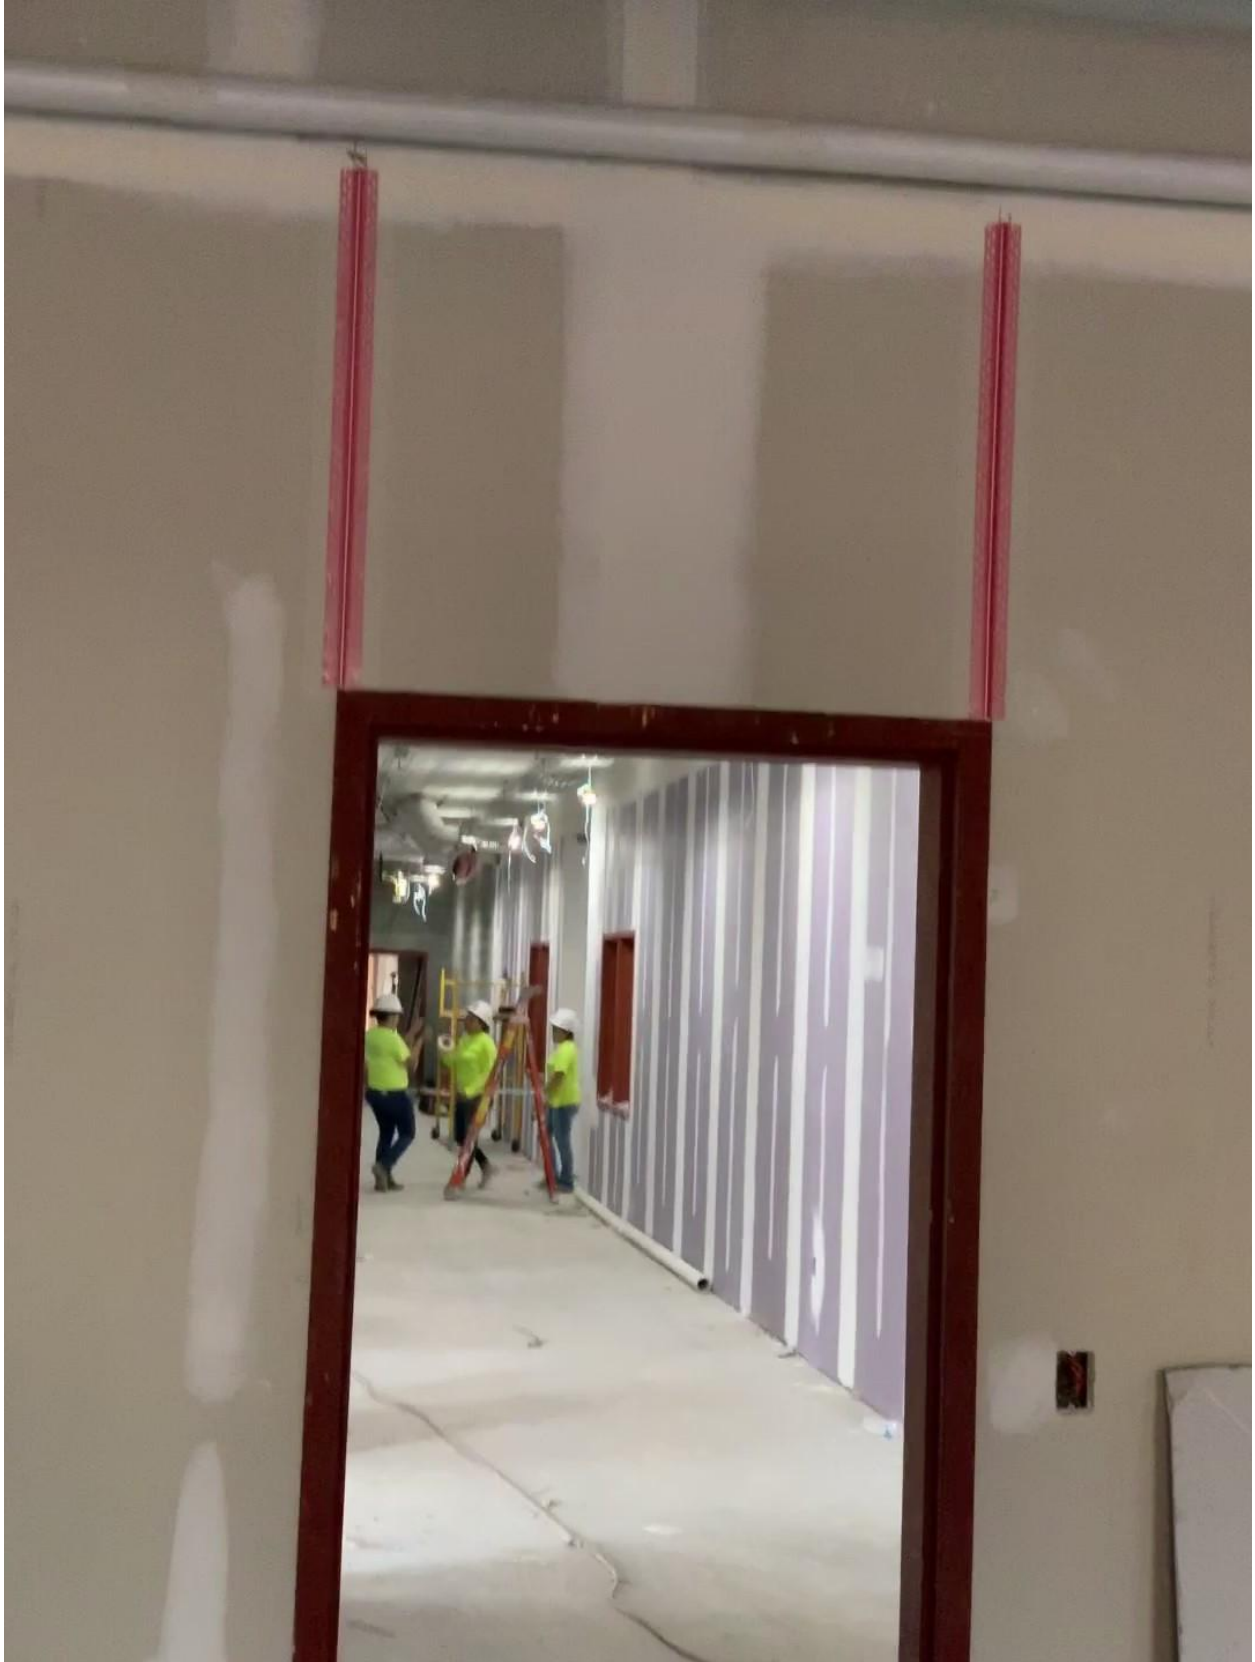
In the computer lab I found grooves cut in the sheetrock with red tape covering the area.

This is where the drawings call for the sheetrock to be grooved to keep cracks

from appearing due to doors slamming shut. The groove is simply a relief very similar to the grooves cut into concrete slabs. It is going to crack so the idea is to make it crack where you want it. Red caulking was being applied to the bottom of

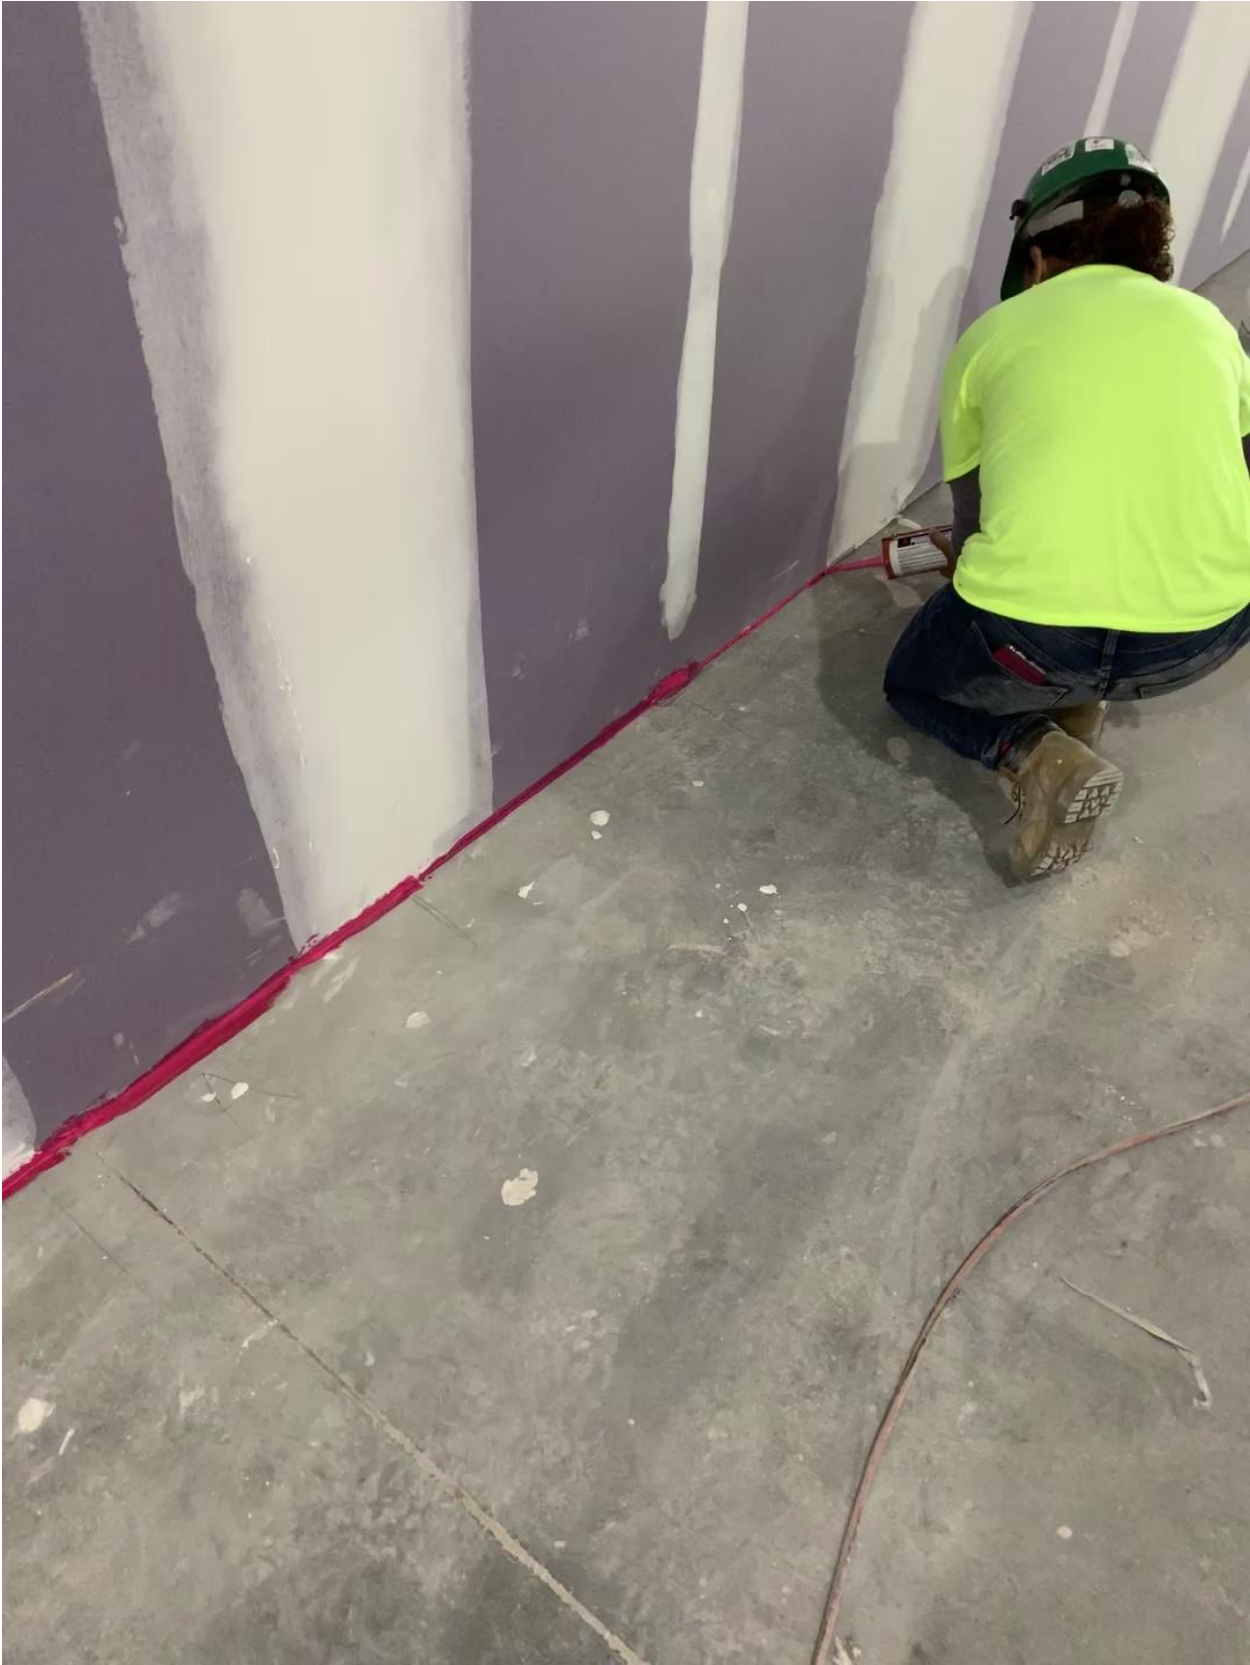
the firewalls to make sure they are properly sealed.

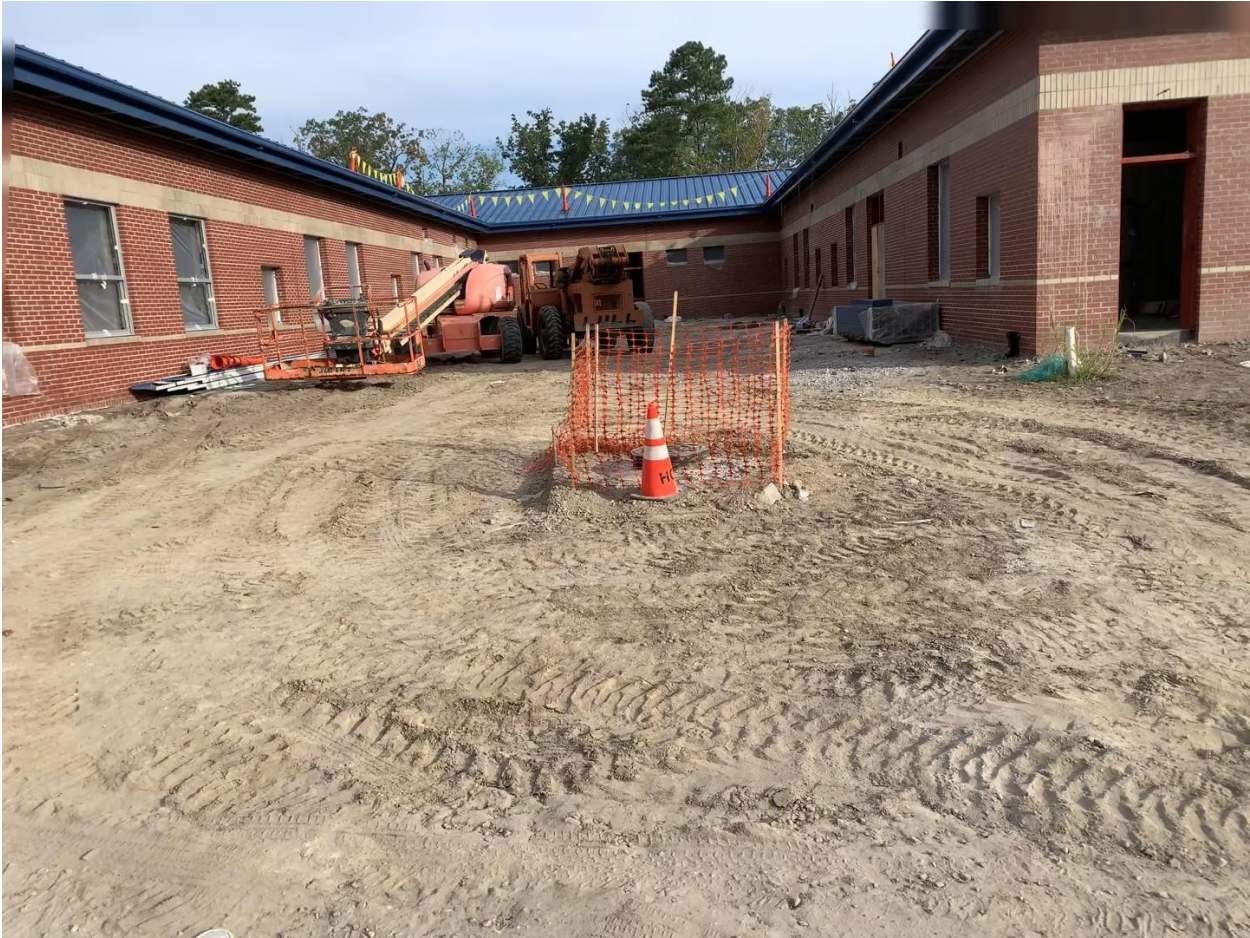
The outside at the back is looking much more like a finished product.

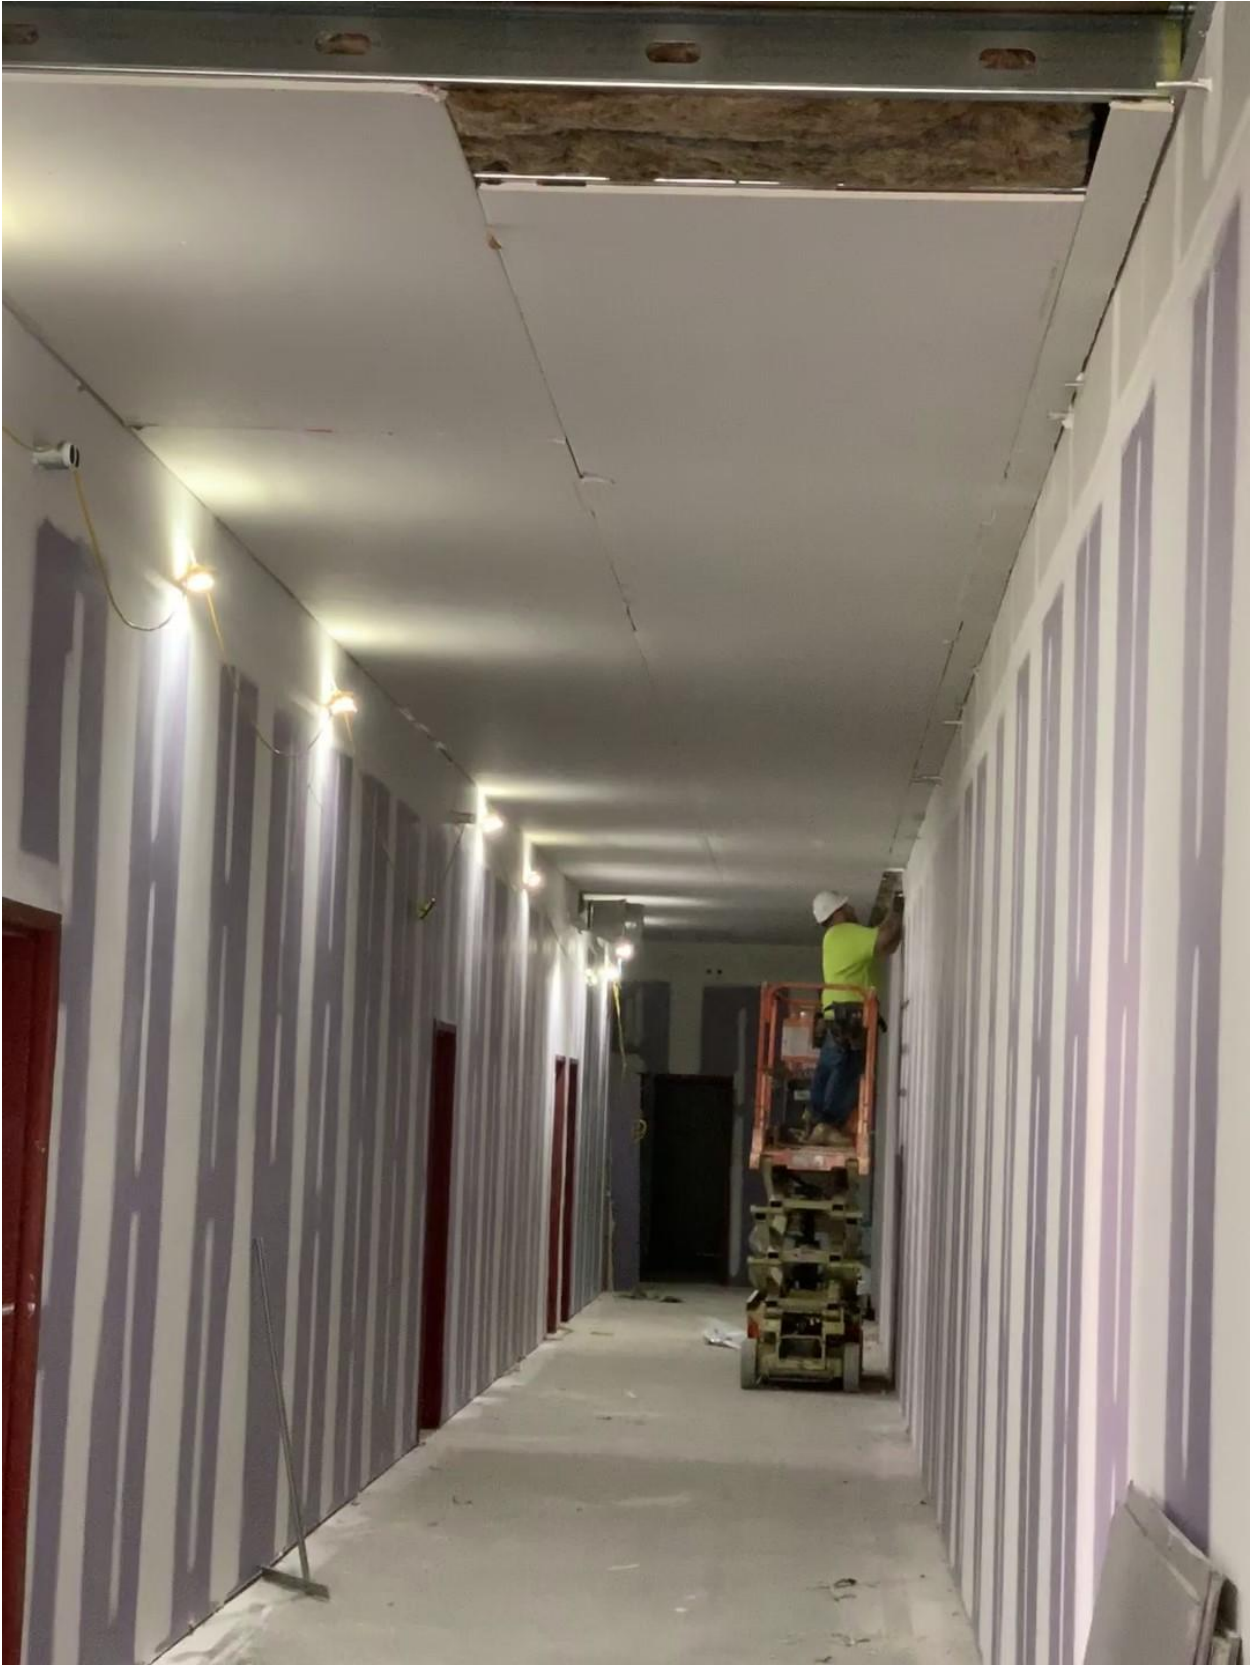
Housekeeping inside and out continues to be very well done. Drywall finishers

continue to work in the hallway next to the gym showing considerable progress.
