Central Middle School

Week of October 4, 2019

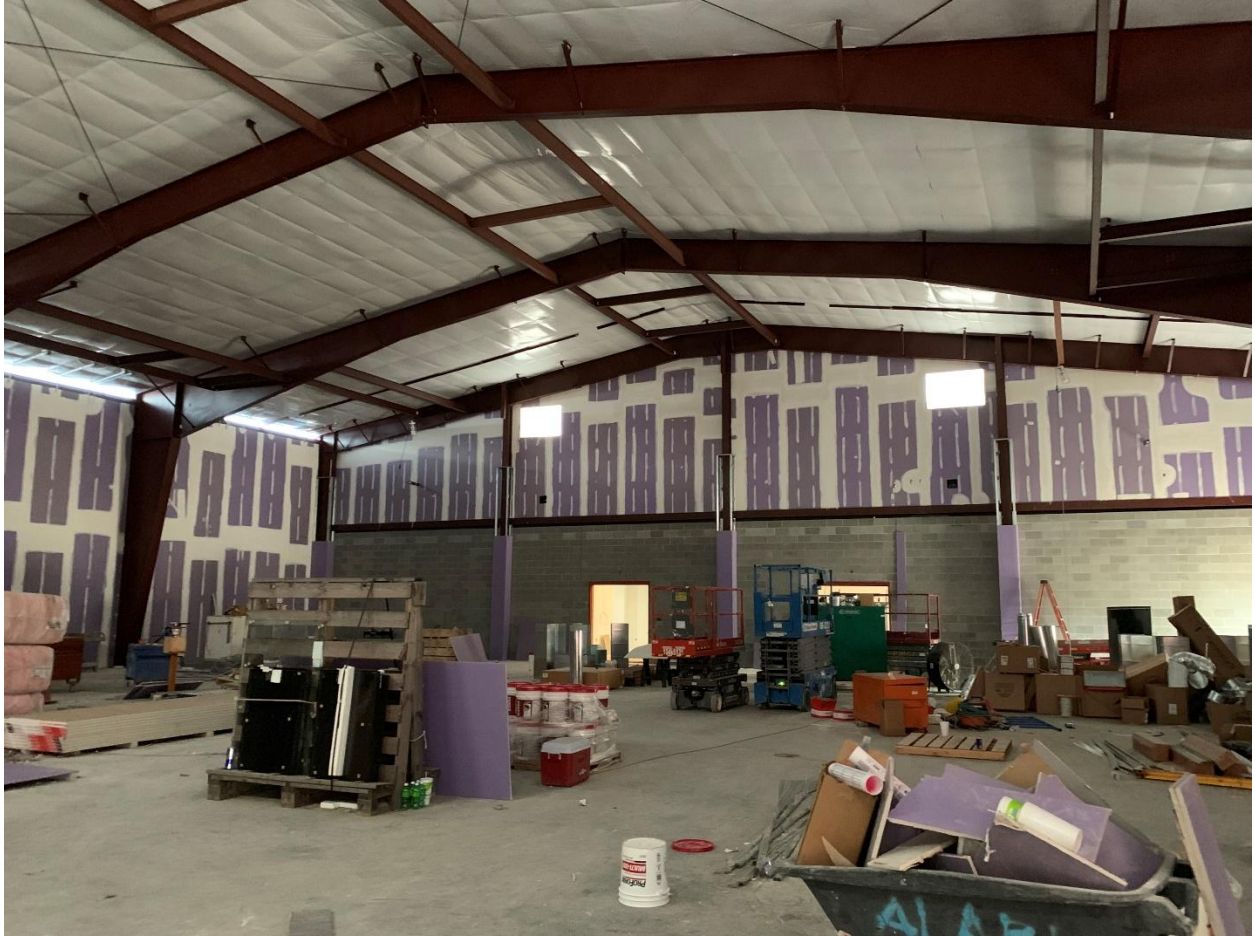
All the major sheetrock is up in the gym. The box around the columns will probably continue up the wall to the bottom of the main girder. The spanner beam running horizontally across the wall will be covered with sheetrock as well as the columns up to the intersection with the girder. The holes in the end wall are openings for makeup air for the HVAC units to be located in front of those openings.

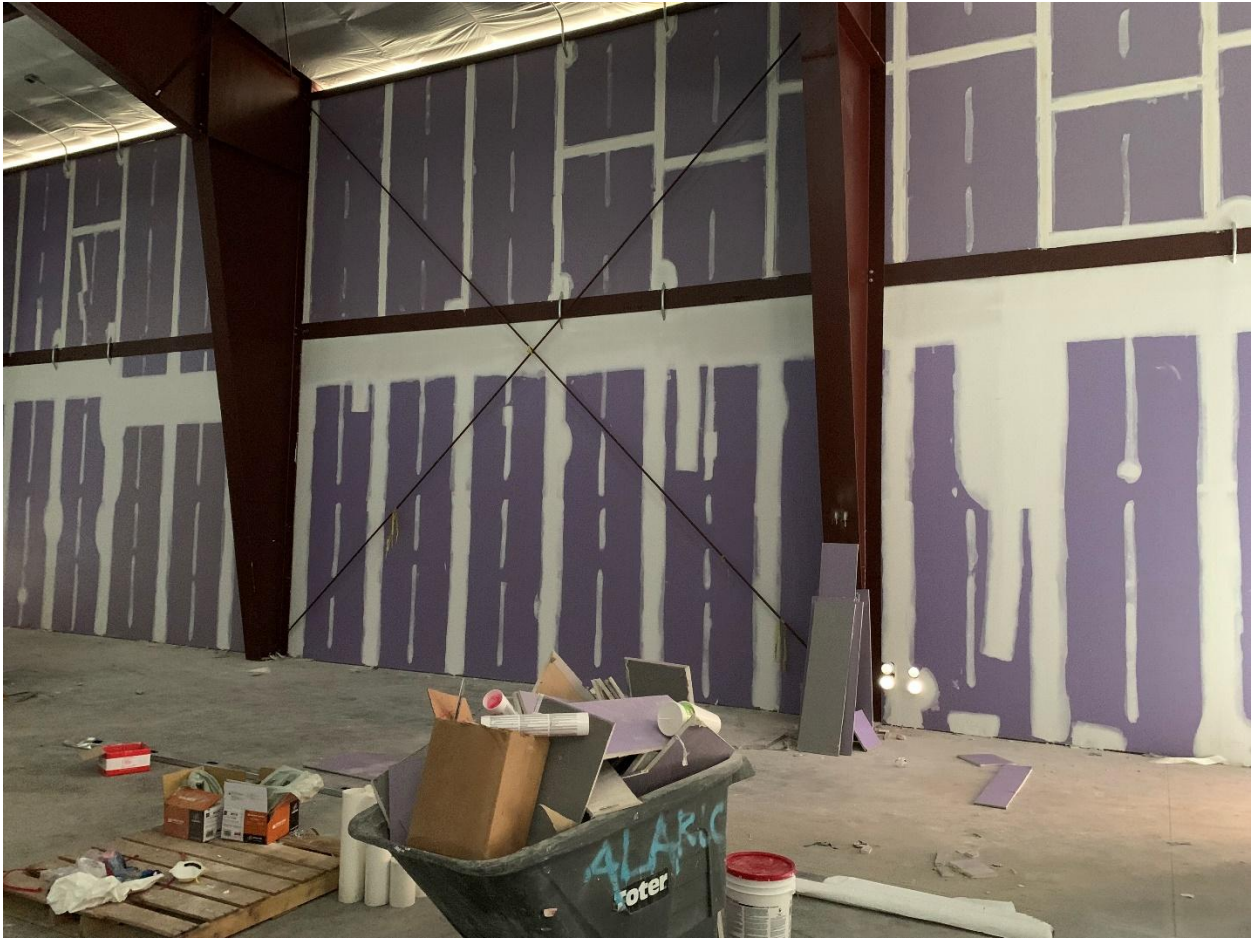
The east wall has a spanner beam similar to the north and south walls. Conduit is routed around the gym side of the beam. Randy Baker has suggested that contractors box the beam and conduit with sheetrock and we figure a way to keep the bracing from becoming a climbing attraction.

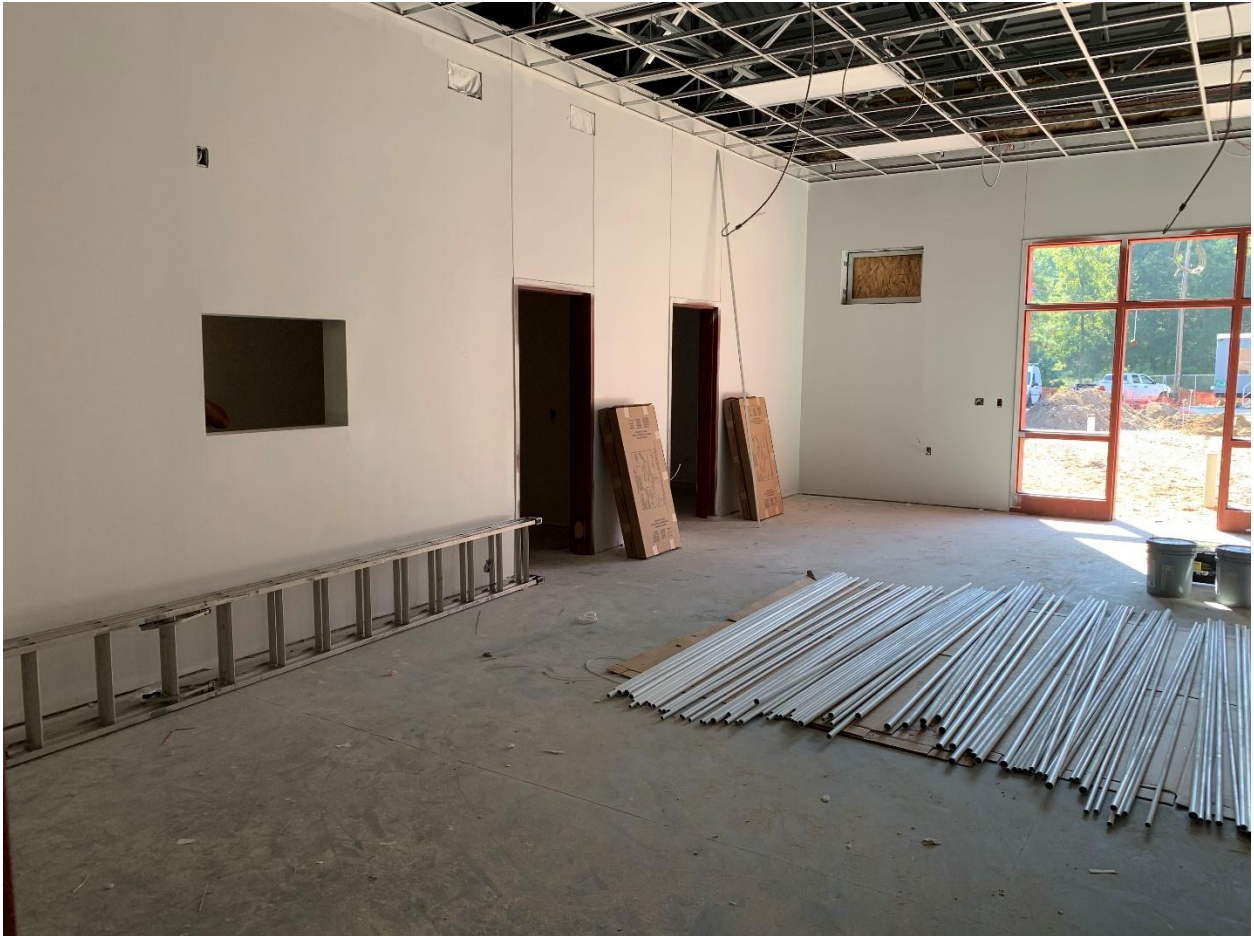
The media center continues to take shape with the ceiling grid we saw being installed last week now complete and lights and duct vents in place. The opening on the left is a window for the media coordinator's office. It is located higher than we might normally expect because there is a cross brace in the wall that determined the location and height of the bottom of the window.
