Central Middle School Week of November 1, 2019

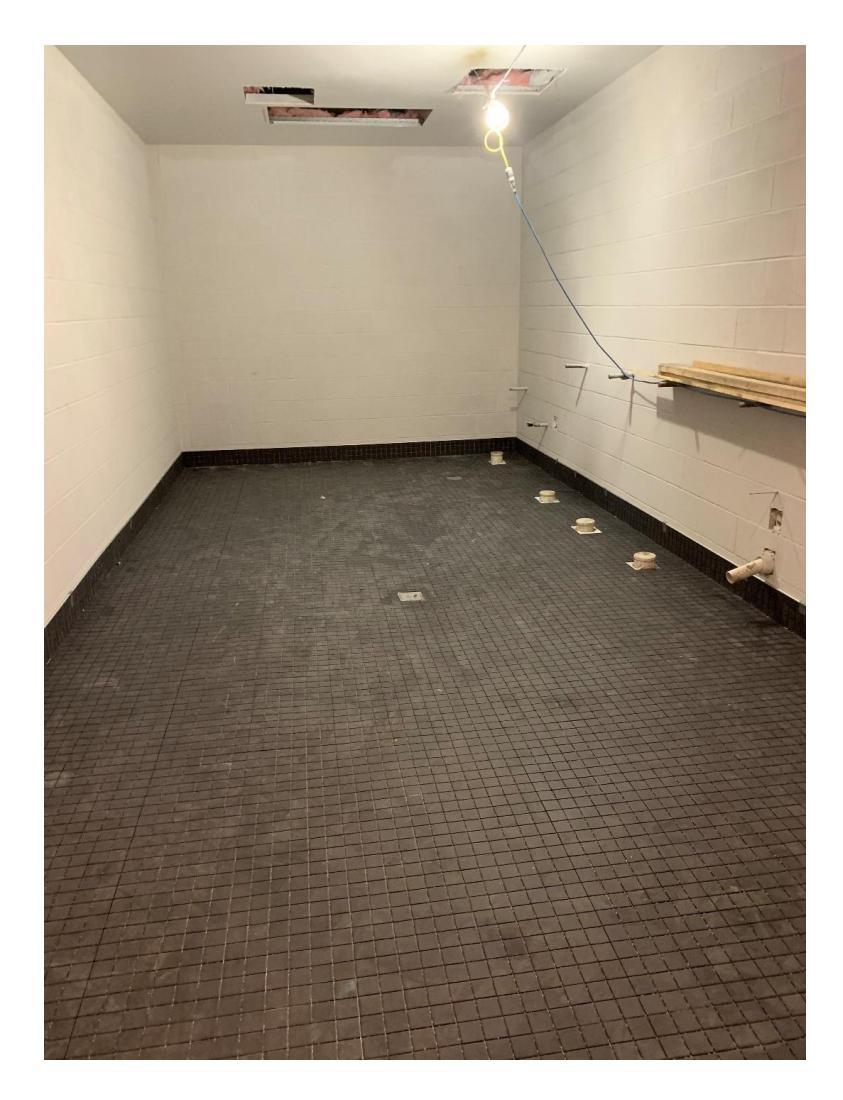
The floor in the men's bathroom is complete and not covered. It is a very nice looking job.

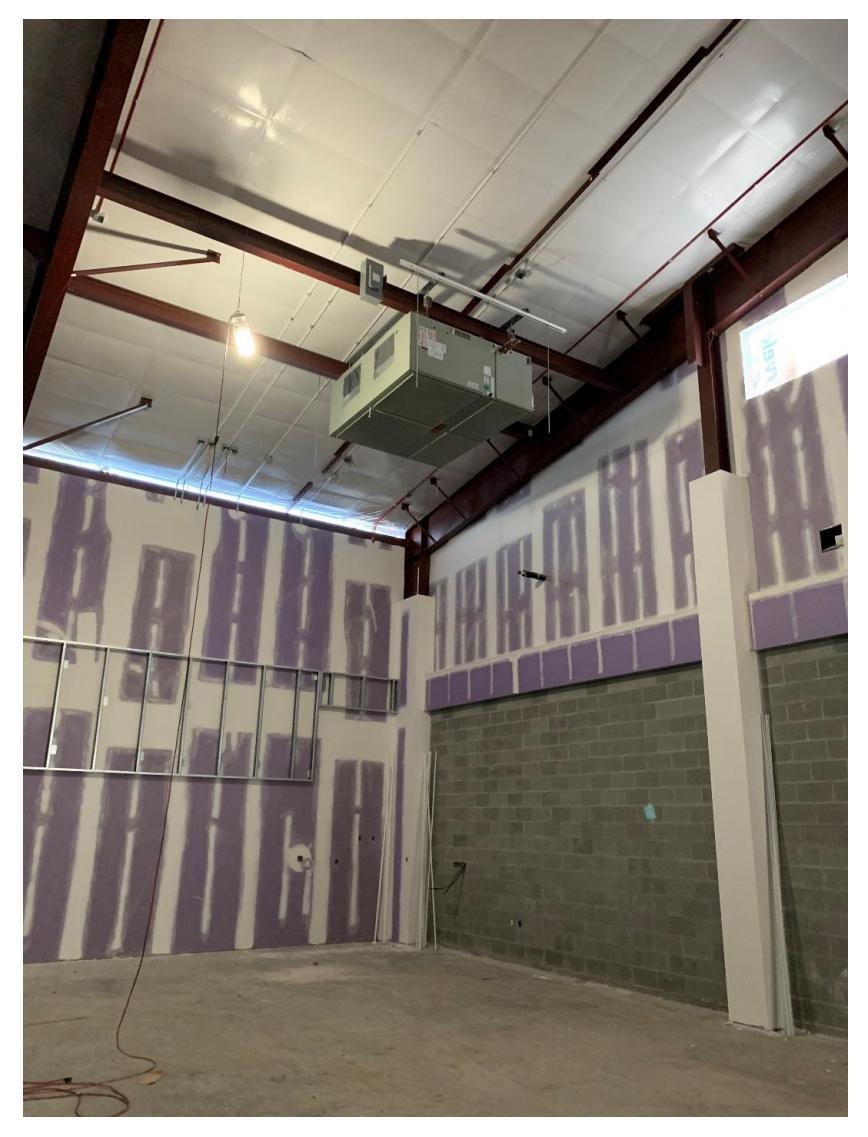
Moving into the gym, the four HVAC units are mounted. This unit is located in the northwest corner of the gym. The metal frame located below and left of the unit is the frame for sheetrock to keep children from trying to climb the cross bracing behind the top of the bleachers in the center section of the gym. A similar frame is under the brighter purple sheetrock below and to the right of the unit. That is covering a beam at the top of the block wall.

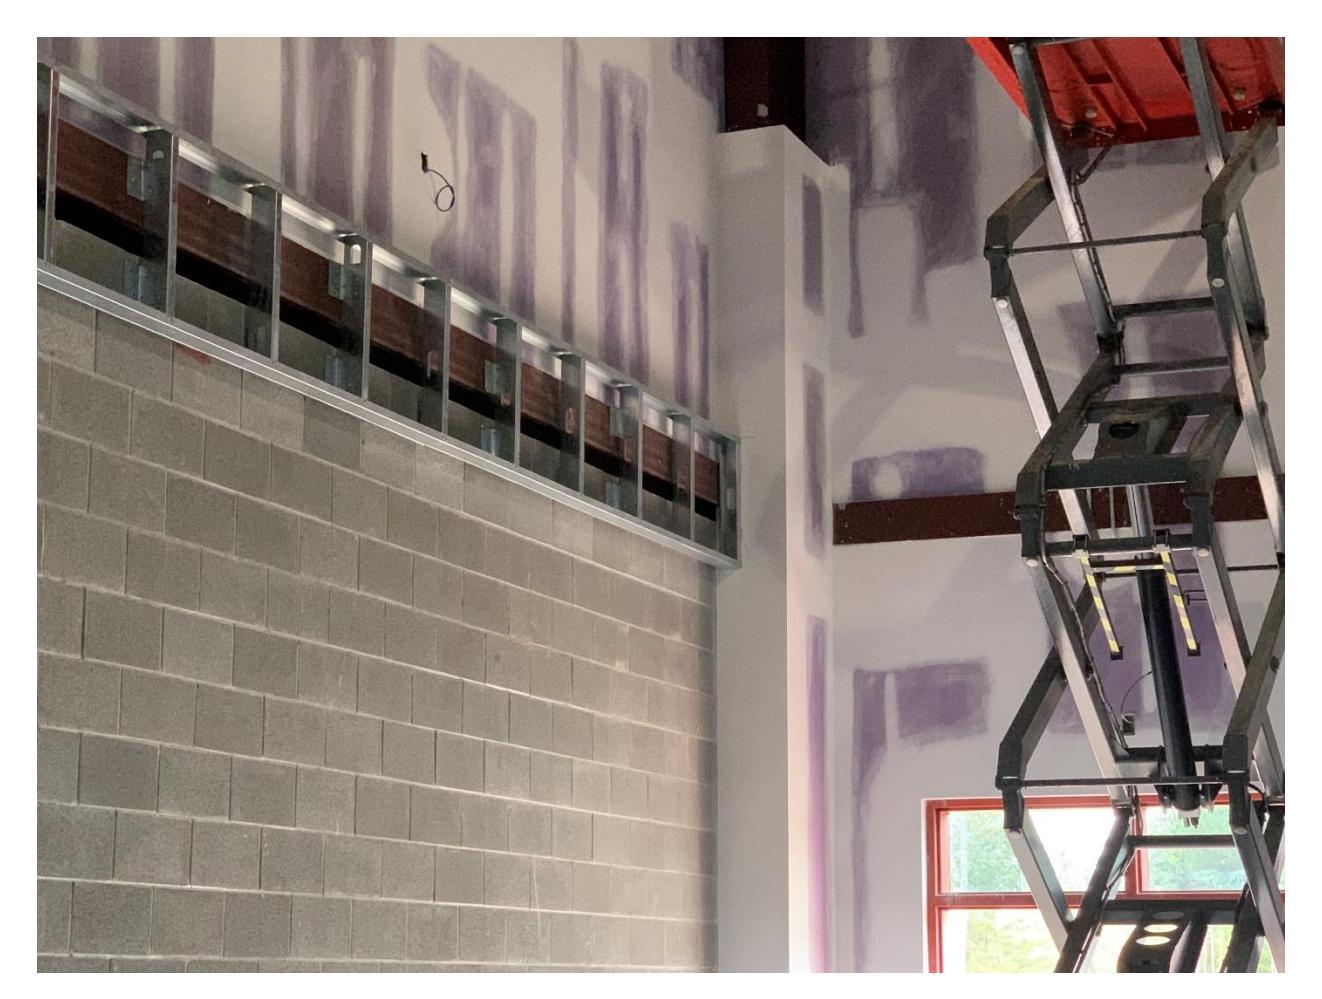
The beam seen behind the frame in the next picture is the one mentioned earlier. The sheetrock simply cleans things up and makes the gym more attractive.

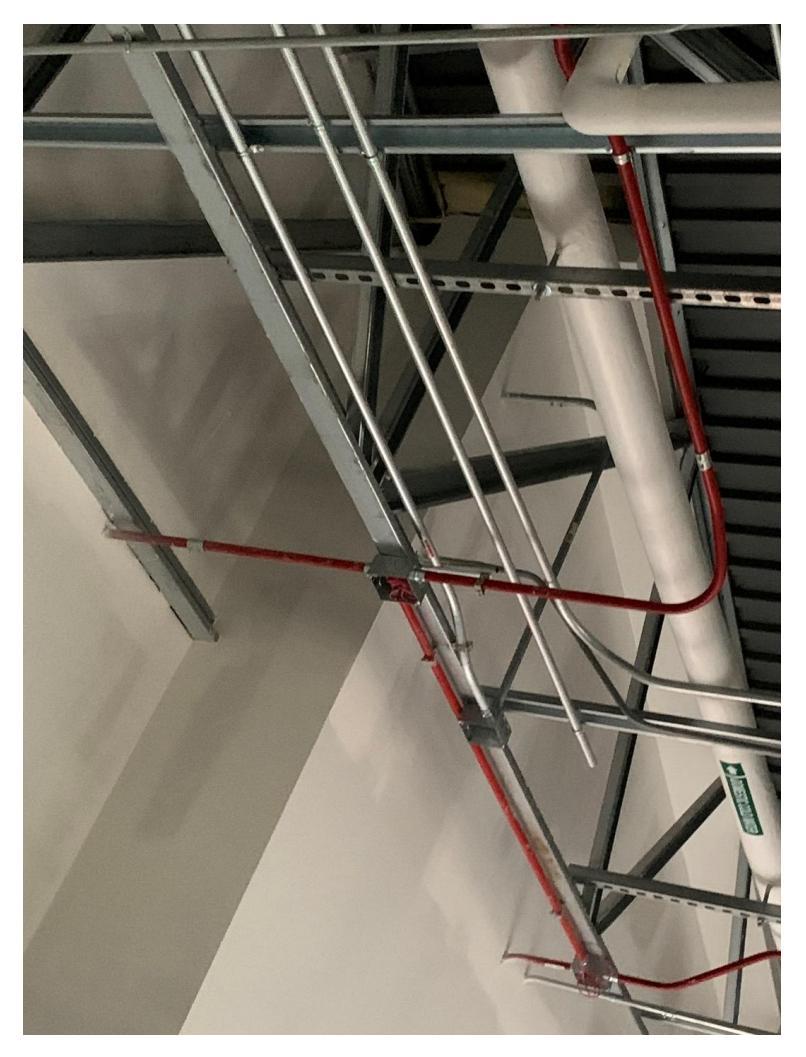
The weight room does not have a finished ceiling. The red conduit is for the fire alarm system and is located in the weight room.

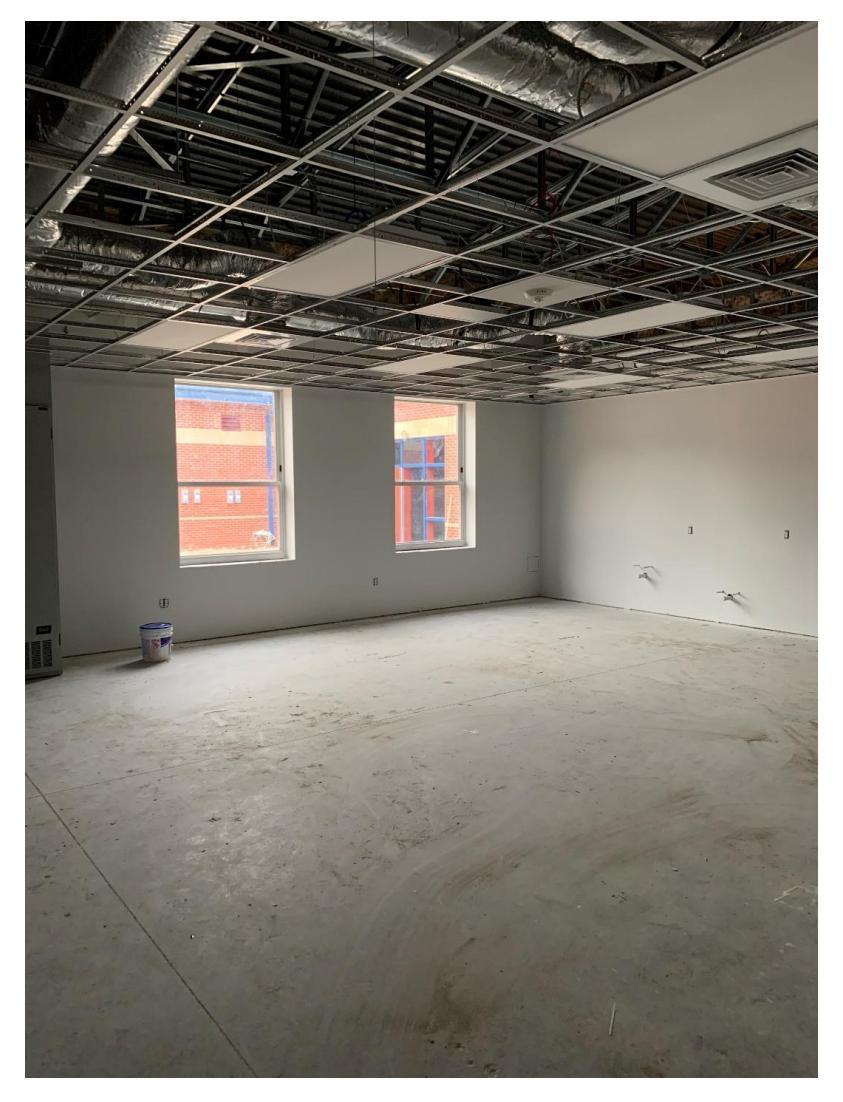
Walking the east hallway we find most classrooms with the ceiling grid in place, light fixtures mounted and in the center of the room the round thing is the smoke detector. This week is the first time we have noticed the smoke alarm sensor.

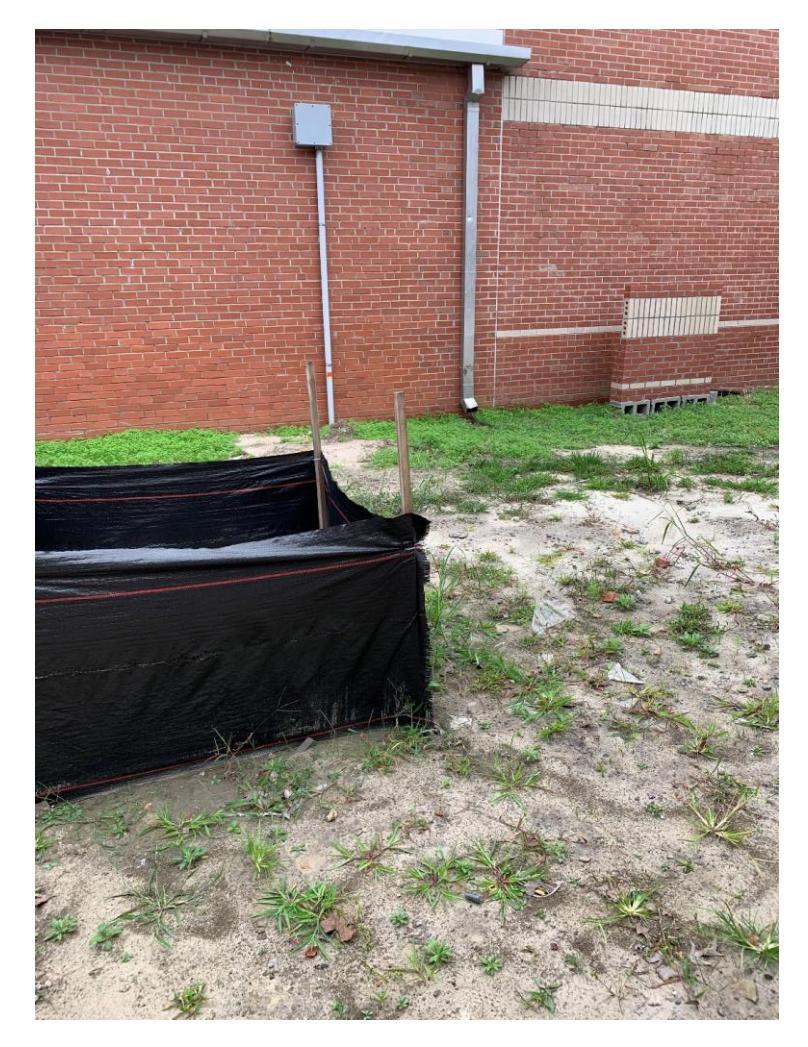
Our walkthrough is for multiple purposes. The first is to see what is taking place, make sure it looks as we expect things to look, learn how and why things are done and look for possible areas for improvement. The next photo is of the area at the front of the school between the new front entrance and the old building. The black plastic frame is a containment around a drain to collect the rainwater in this area. We noticed the gutter on the old building and asked Brian Plyler to look into piping that gutter to the pipe attached to the drain inside the plastic. This will help keep water from collecting on the concrete in this area creating a hazard in freezing weather.

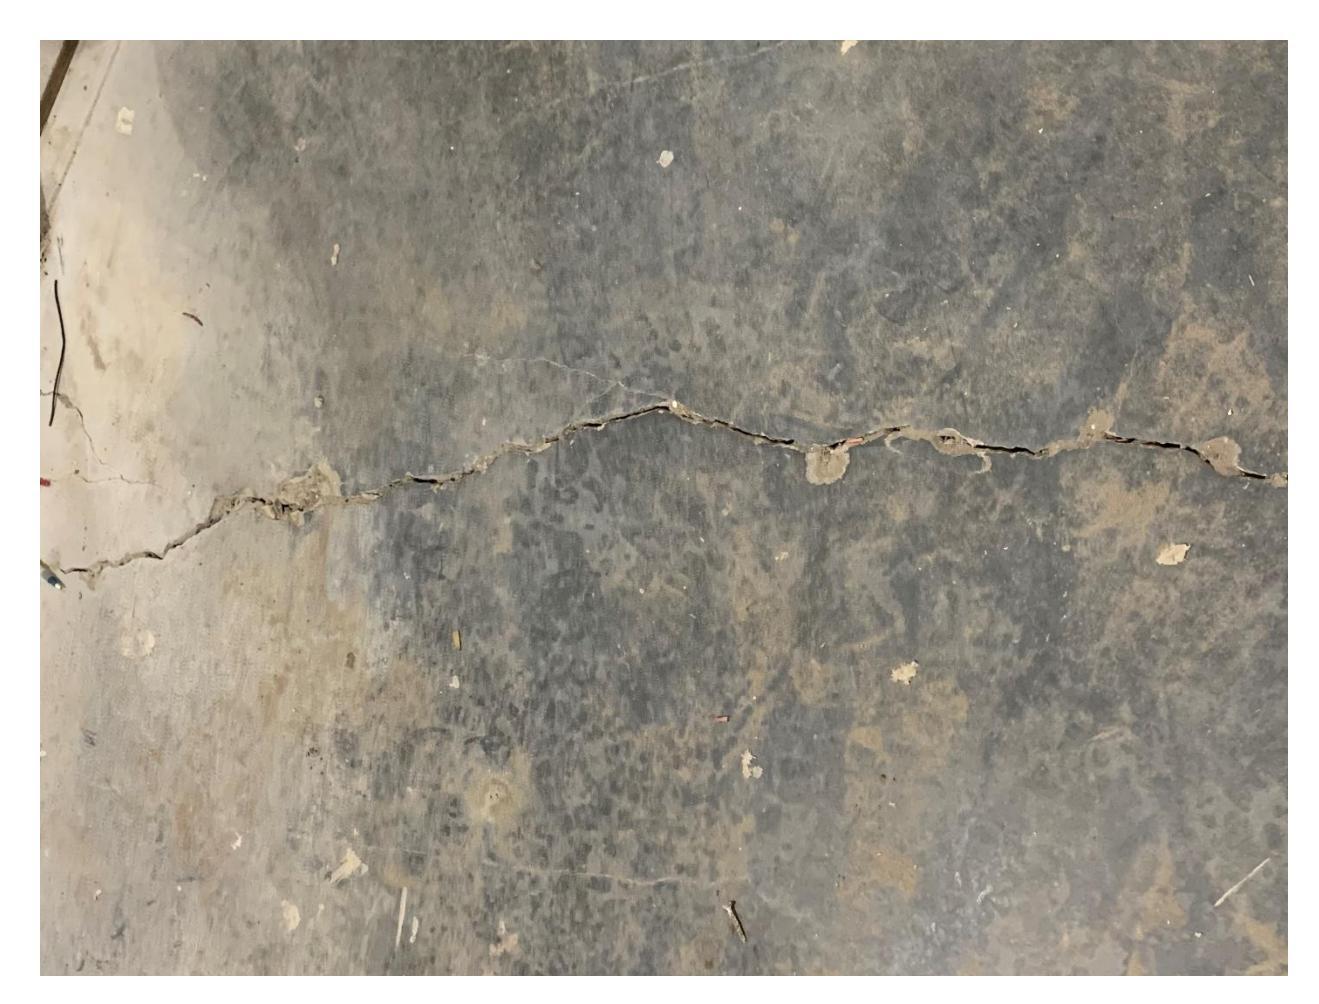
When we got to the end of the east hallway where it meets the main hallway we found a sizeable crack. Expecting the floor tile process to begin shortly, I was concerned this crack will telegraph through the tile making an unsightly mess. I discussed the issue with Daniel Plyler. Mr. Plyler says the crack will be veed out with a grinder; an epoxy applied in the V followed by floor leveler and we should have no problem with the crack in the future.
