CENTRAL MIDDLE SCHOOL

PROGRESS WEEK OF APRIL 5, 2019

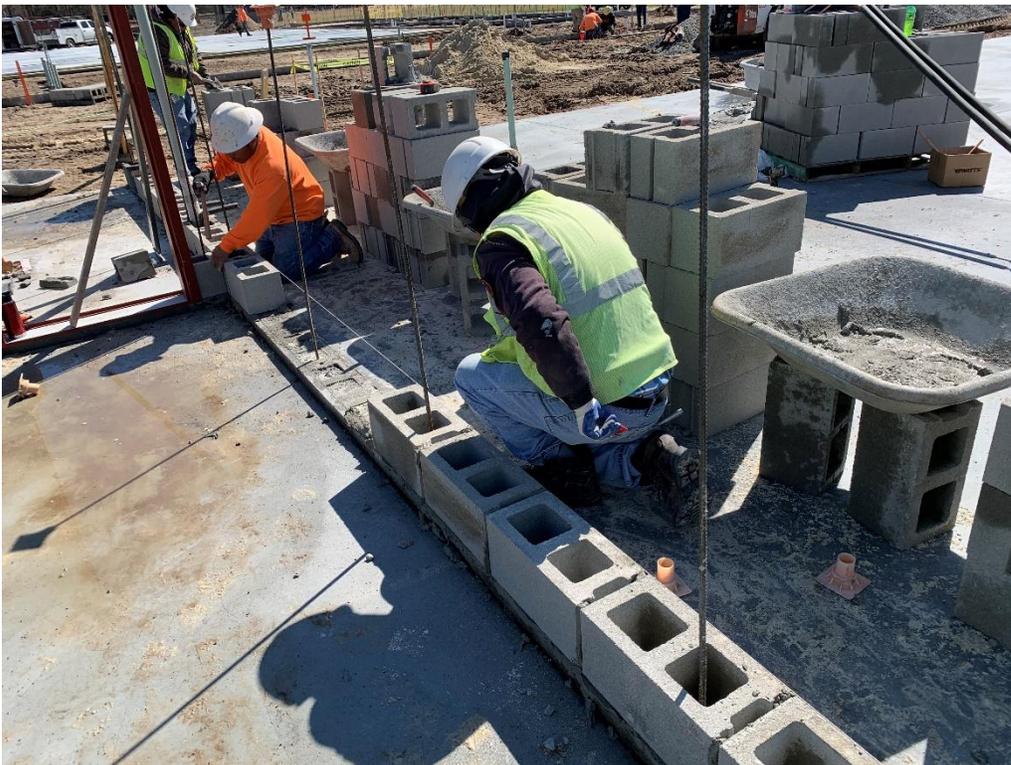
Workmen starting the south wall of the group bathroom in the eighth grade wing. This picture was taken Wednesday.

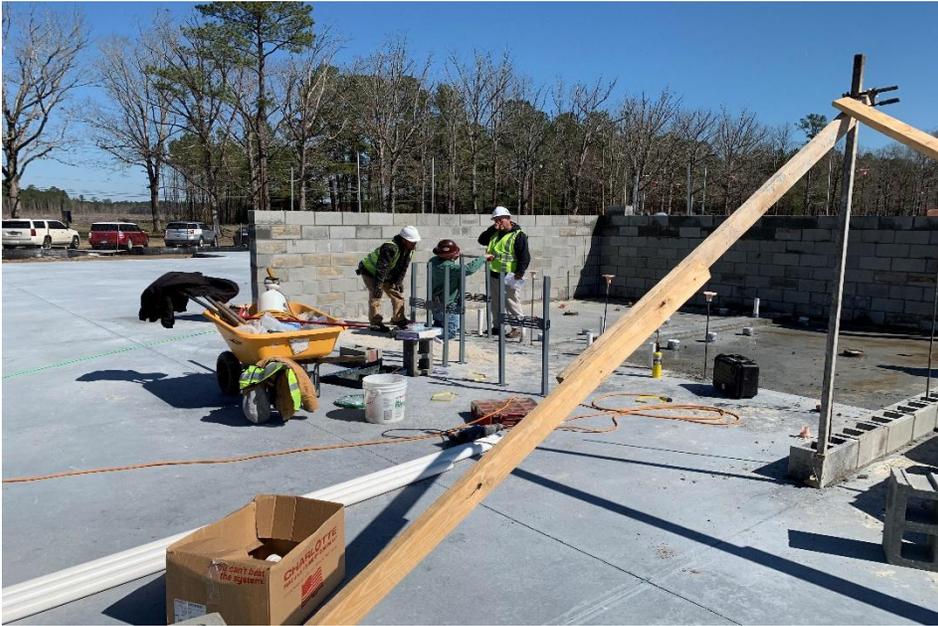
Plumbers starting pipe bank for lavatories west wall of eighth grade group bathroom. This picture was taken Wednesday.

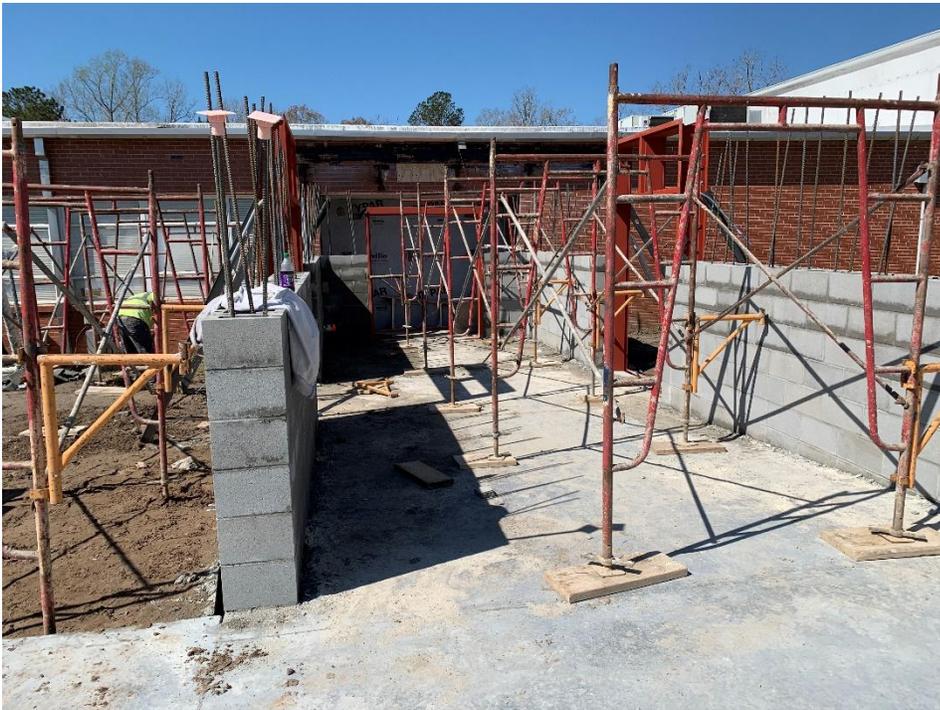
Walkway between seventh and eighth grade wings.

Brick masons can lay up to seven courses of block per day. The above picture was taken on Wednesday.

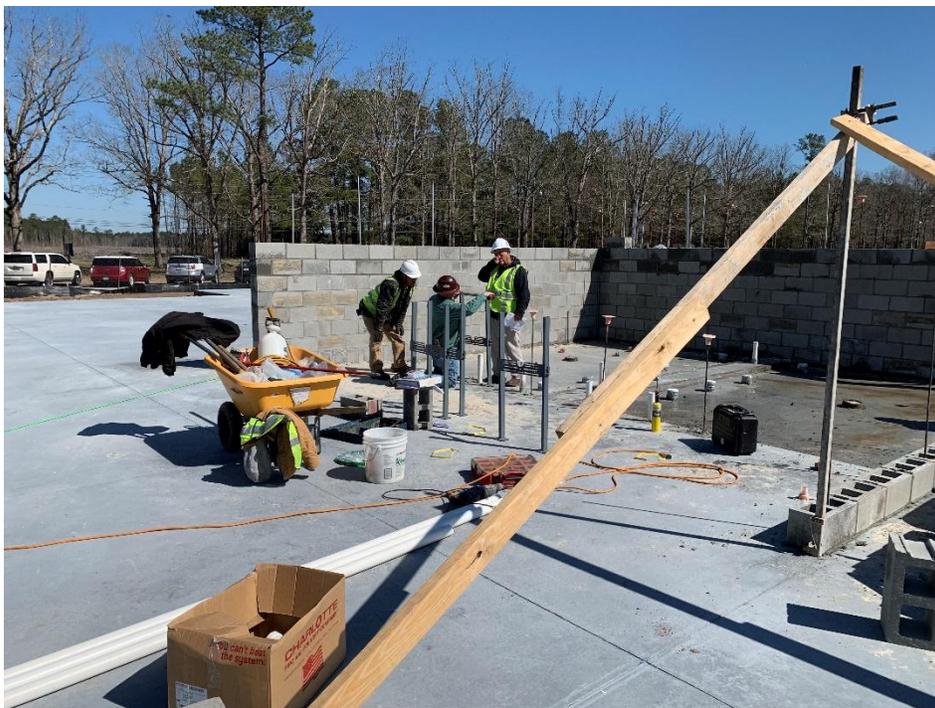
Plumbers working to install bank of piping for lavatories. This is very precise placement. It is very slow work simply because of the precision required. It is much easier and faster to route piping to and from fixed points than it is to route it to fixed points in midair. The fixtures have to go in after the walls are in place and the piping runs inside the wall.

This picture of the group restroom in the eighth grade wing. This picture was taken on Wednesday. The boards are braces for the corner post the masons use to pull strings to lay the blocks to keeping the wall straight.

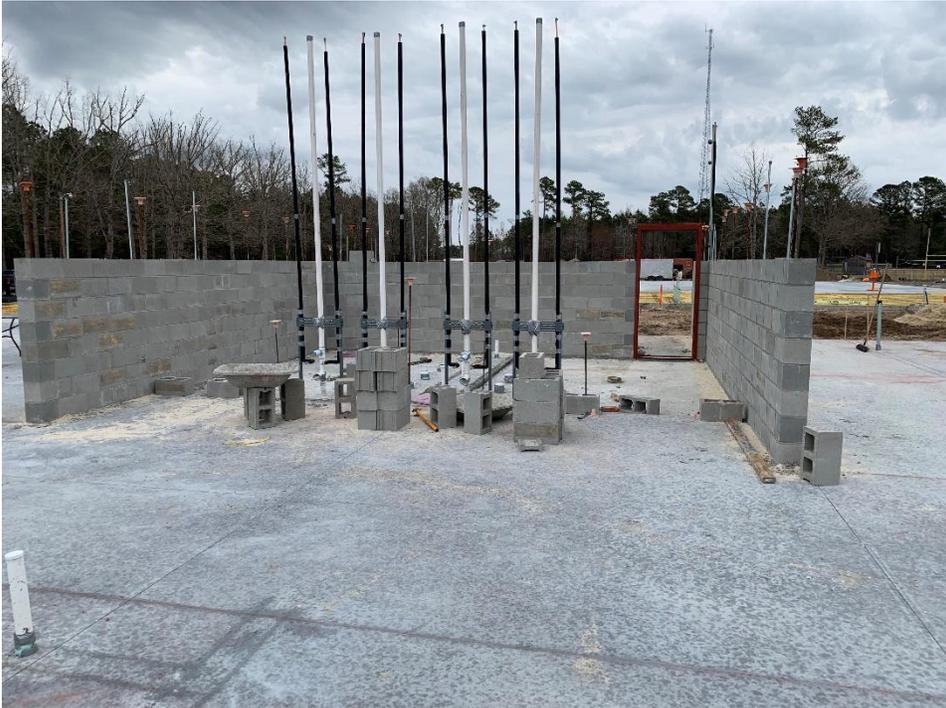
Group restroom taken Friday, April 5, 2019. The white pipes are vents to make the lavatories drain properly. The black pipes are insulated copper pipes.

Supply water, hot and cold, comes from the overhead to alleviate some of the problems we have experienced in the past with pipes leaking under concrete. The wall on the right was one course of block tall on Wednesday. The seven course limit per day on laying blocks is to give the mortar time to harden thereby not allowing the wall to tilt or even fall over.

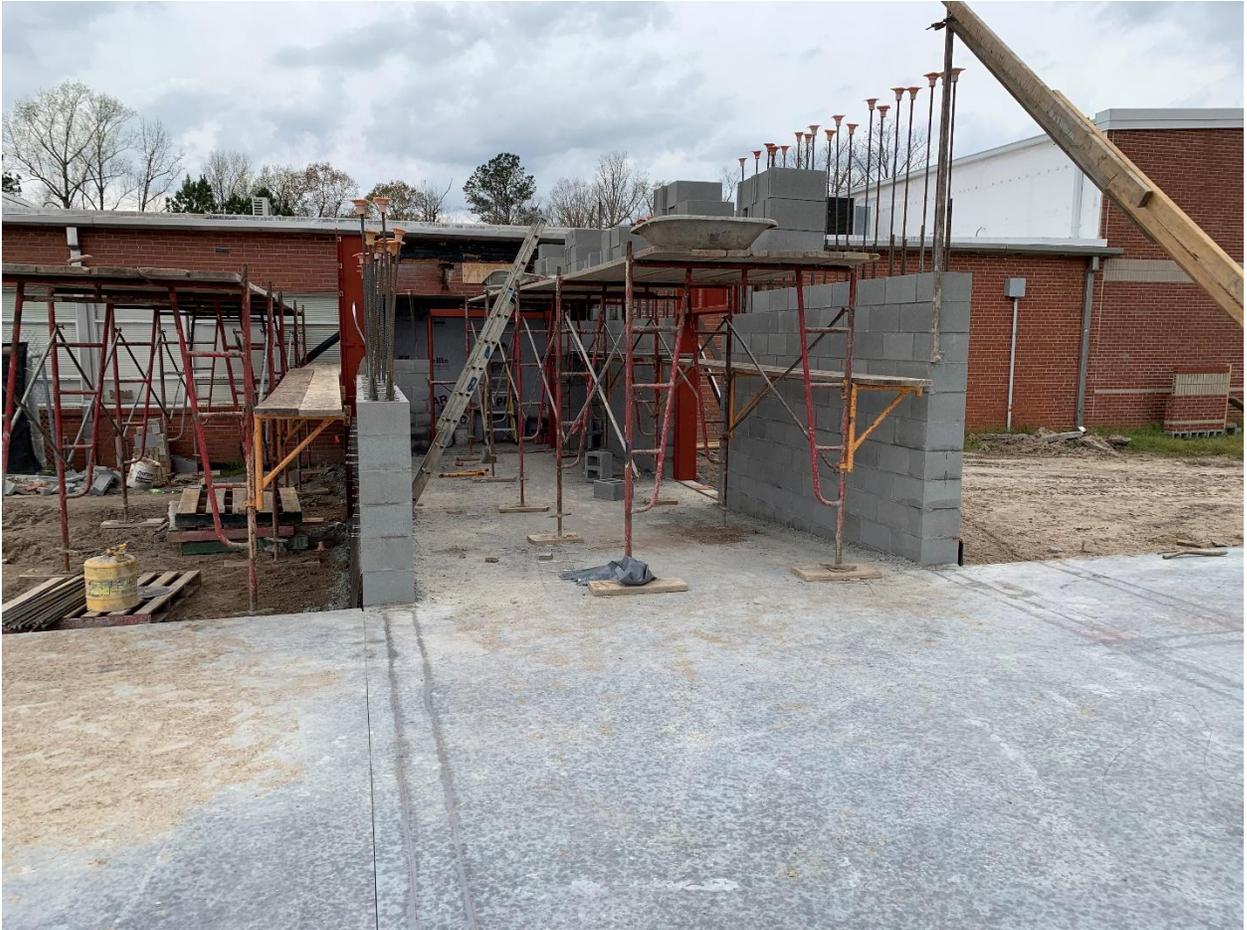
Walkway between seventh and eighth grade wings. Notice the walls are higher than they were Wednesday and the rebar is taller. Rebar is extended by wiring them together similar to what we did with haywire years ago on the farm.

This picture was taken Friday, April 5, 2019. The brick masons were not on the job. I imagine they are working four ten hour days as they are traveling from the Greenville area. Travel costs run contractor costs up quickly.
