Progress Central Middle School

Week of August 16, 2019

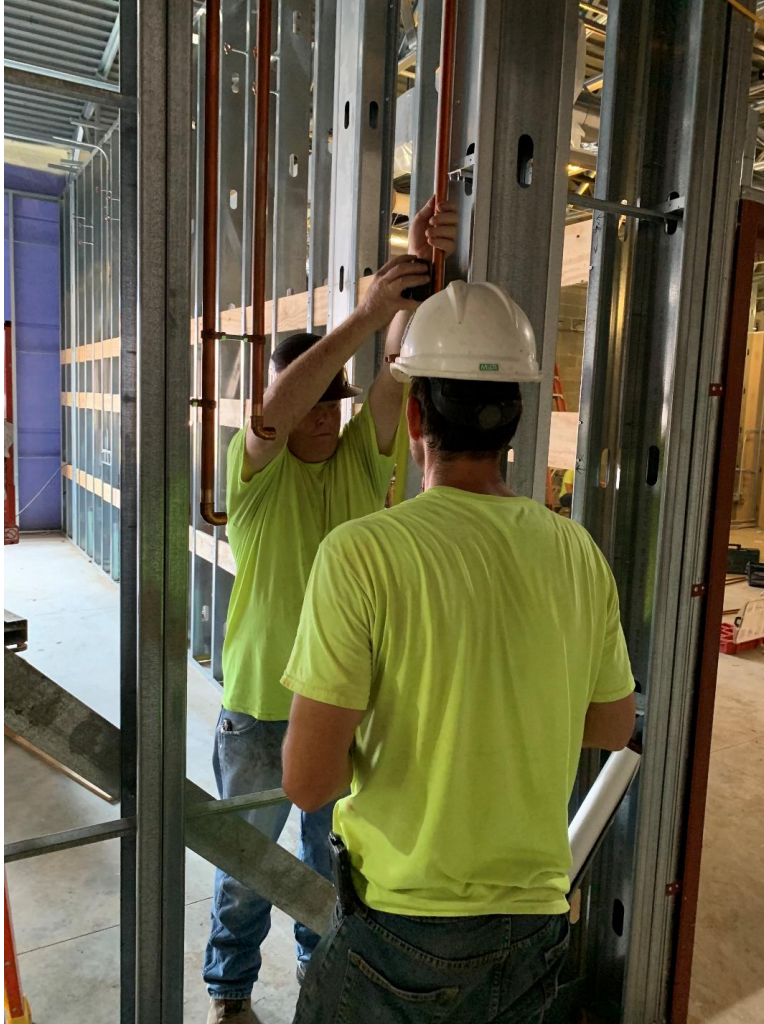
Plumbers continue running water lines. These lines are in the hallway area near the front entrance.

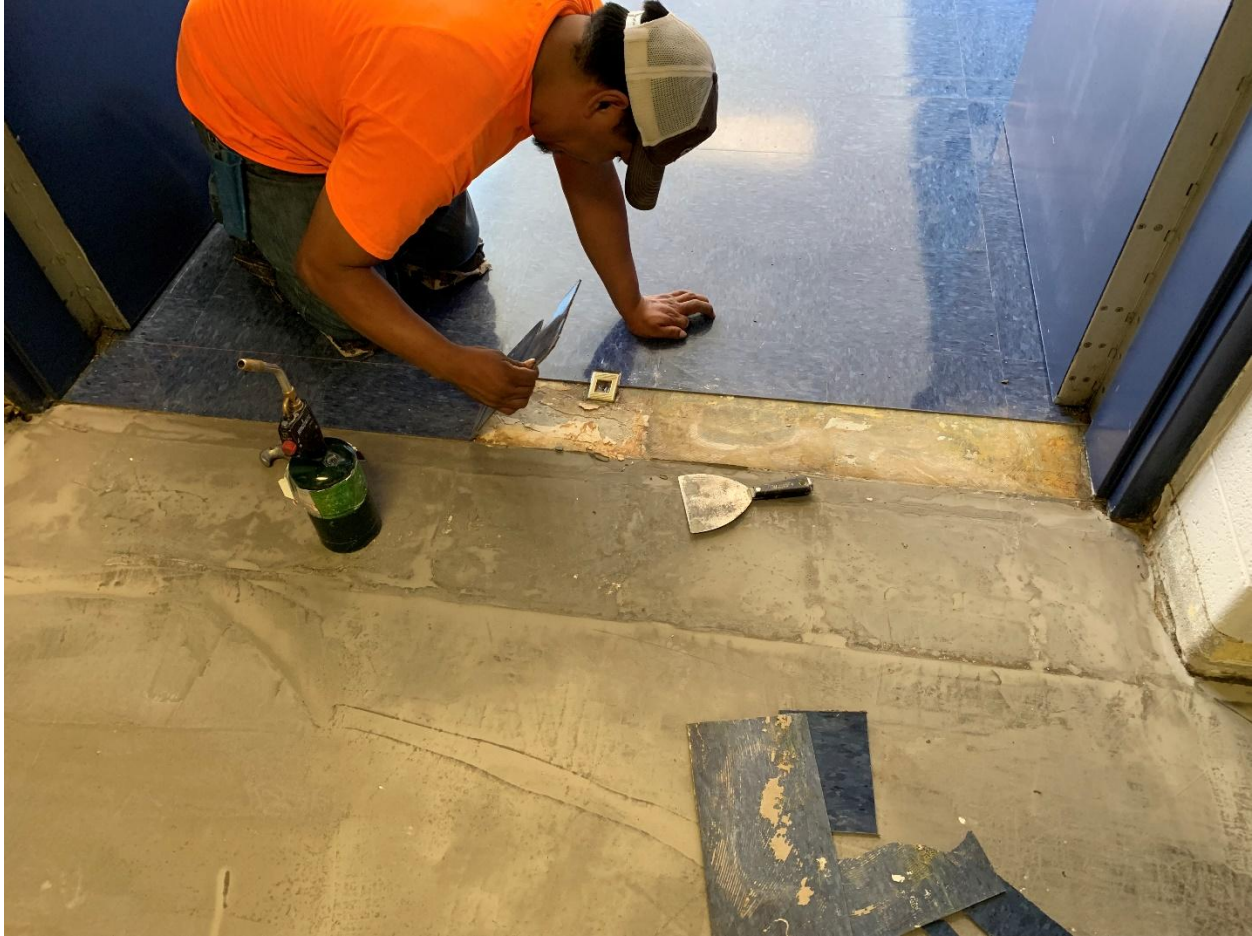
Moving over to the renovation area I see the normal effort by crafts people doing their best to take pride and do a good job. This man is removing tile at the transition between the sixth and seventh grade wings.

He is using the center lock hole for his start point on the new floor and is removing some of the old tile by applying heat then prying the tile up with his putty knife.

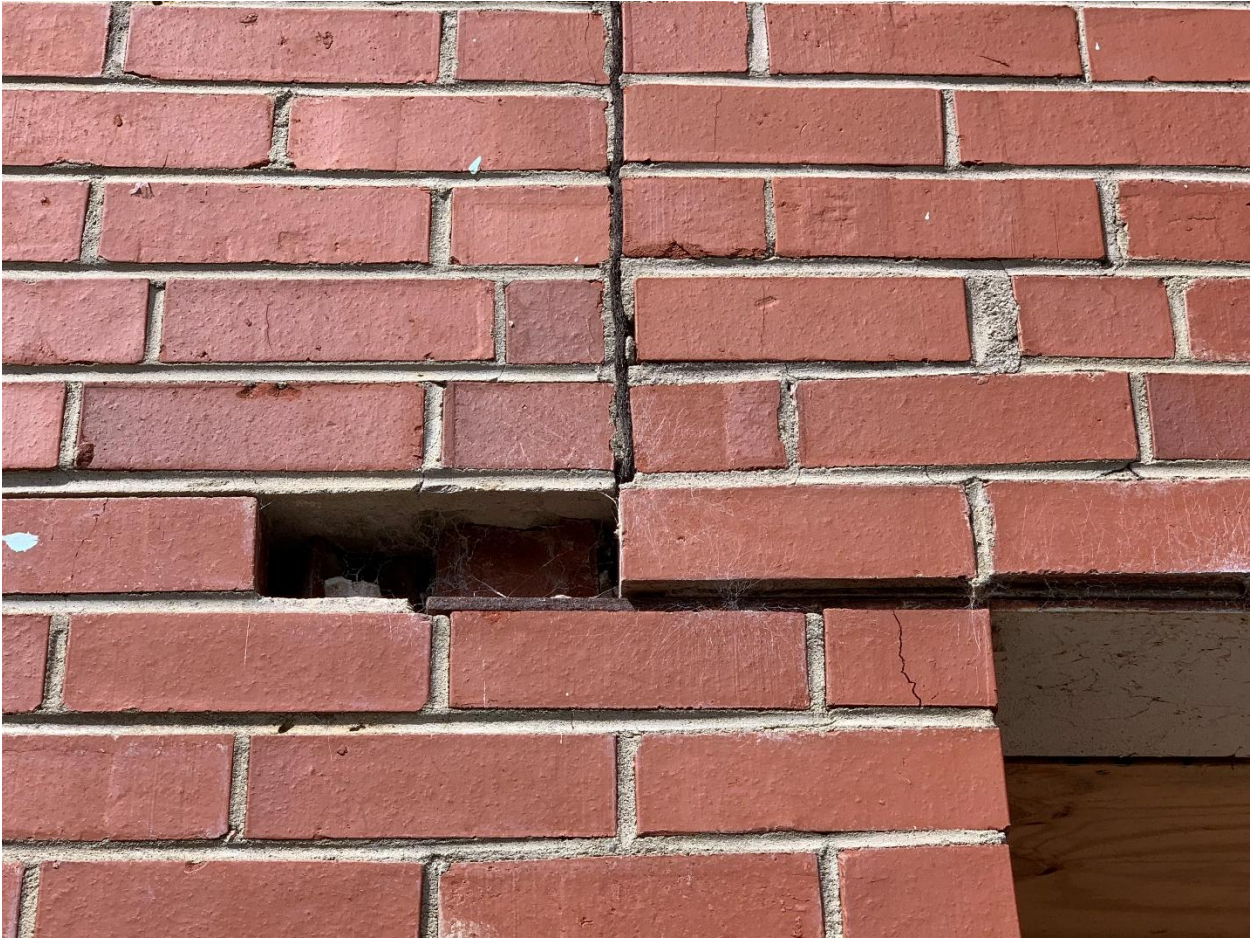
Some of the project simply involves repairs to existing structure showing it's age. The plate is the lintel supporting the brick above the southeast door to the

seventh grade wing. One brick has actually fallen from the wall.

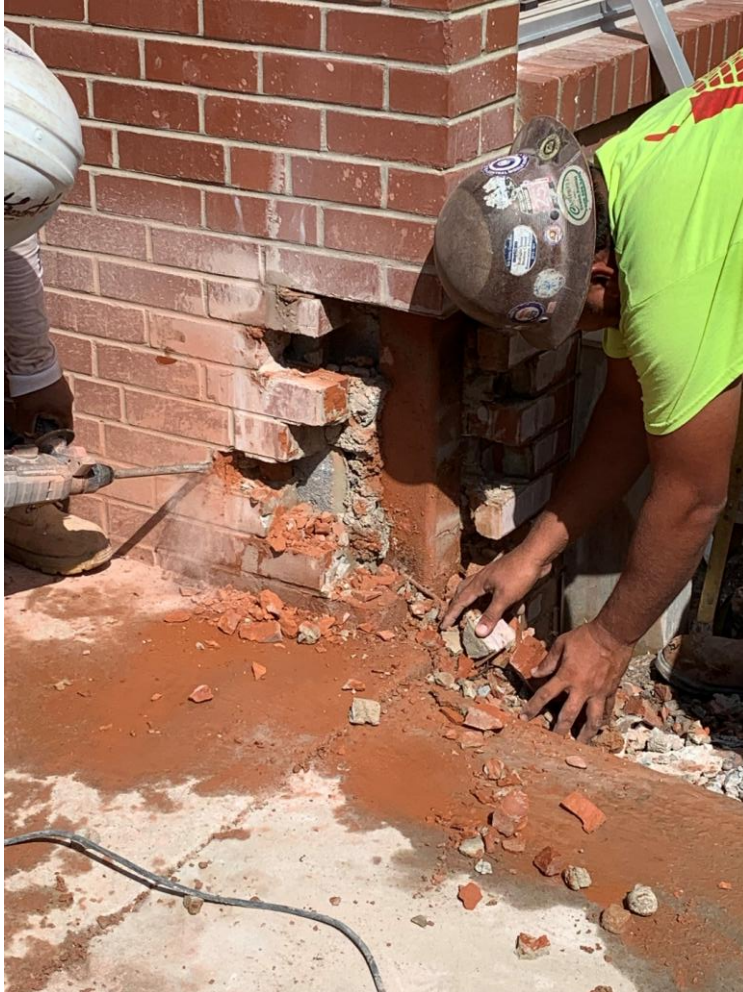
The right side of the same door had some deficiencies these workers are removing to replace the brick and get it as it should be.

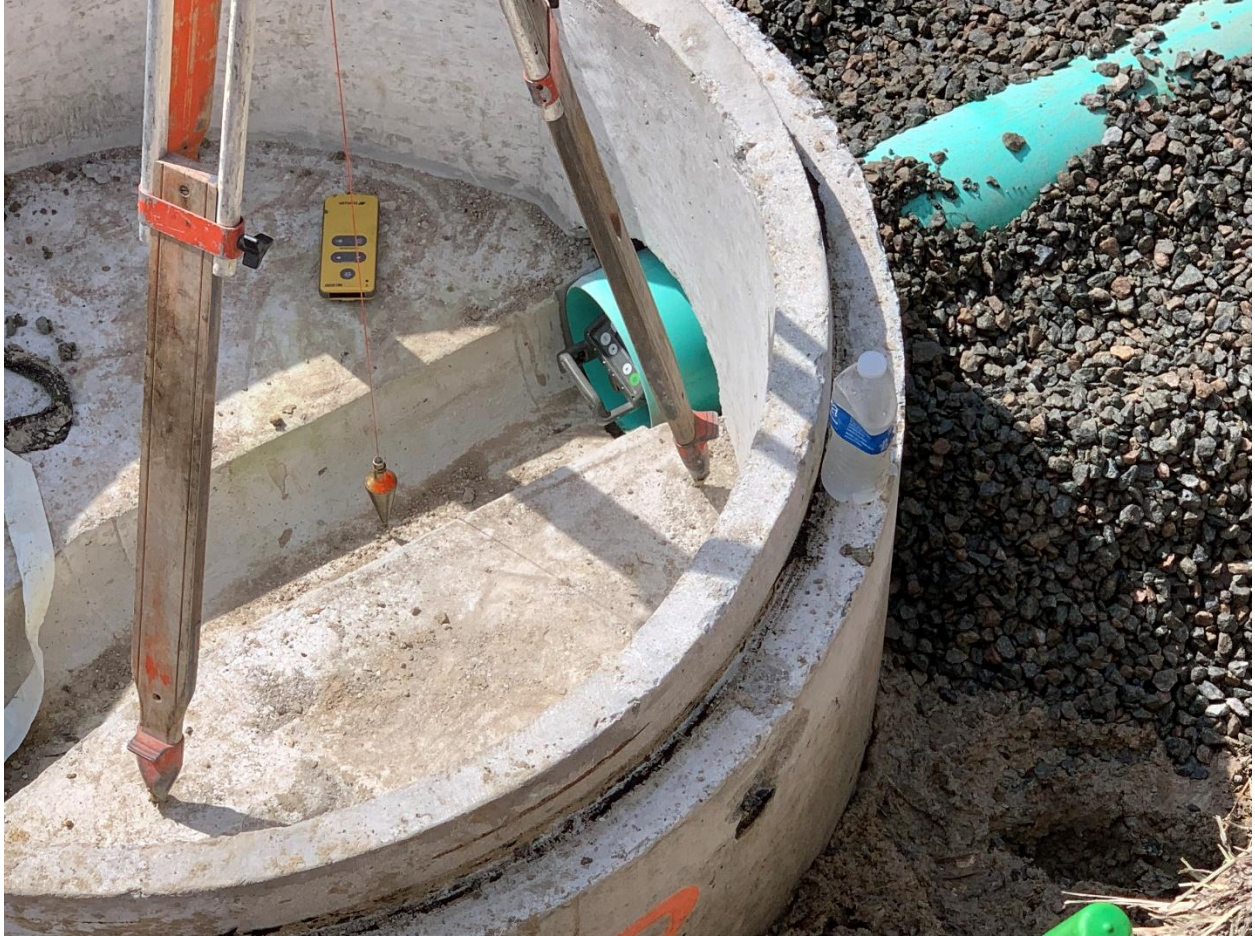
Some very precise work has been taking place the last couple of weeks on the east side of the school starting at the side of US-158 and running on behind the school. This transition box is for the sewer line running from behind the school to the county waste treatment lines on the north side of US-158.

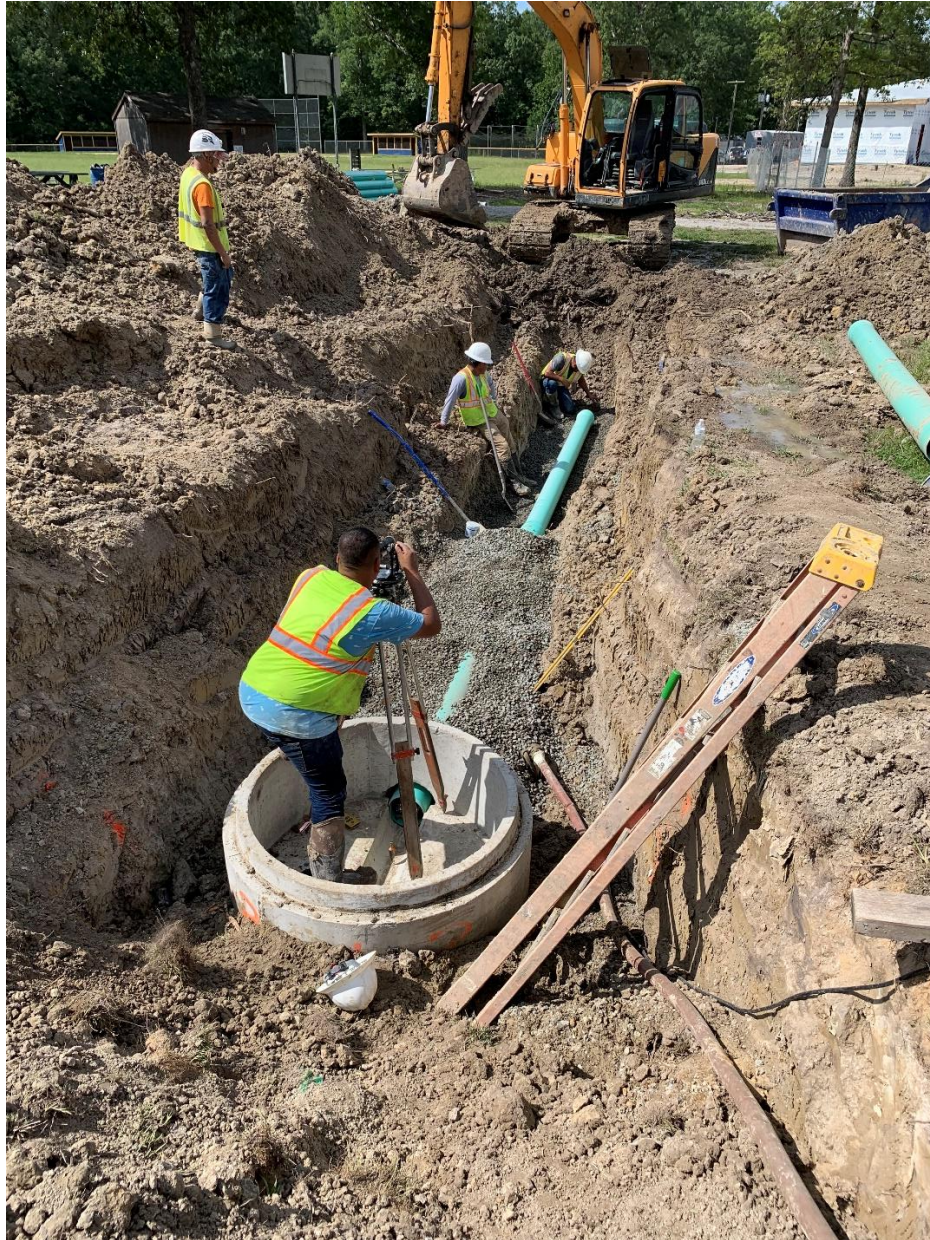
These lines have a 0.41% grade, which, according to my math, is approximately one half inch drop per ten feet of run. This is accomplished by using a laser you see inserted into the end of the pipe. The laser projects a beam to a target installed in the other end of the pipe to let the installers know when they have that other end at the proper elevation.

The man on the transit is double checking the elevation and the location of the pipe left and right to keep it perfectly straight. The pipe is bedded in #57 stone and initially covered with #57 stone as the dirt removed from the hole is too lumpy to get a good bed for the pipe.

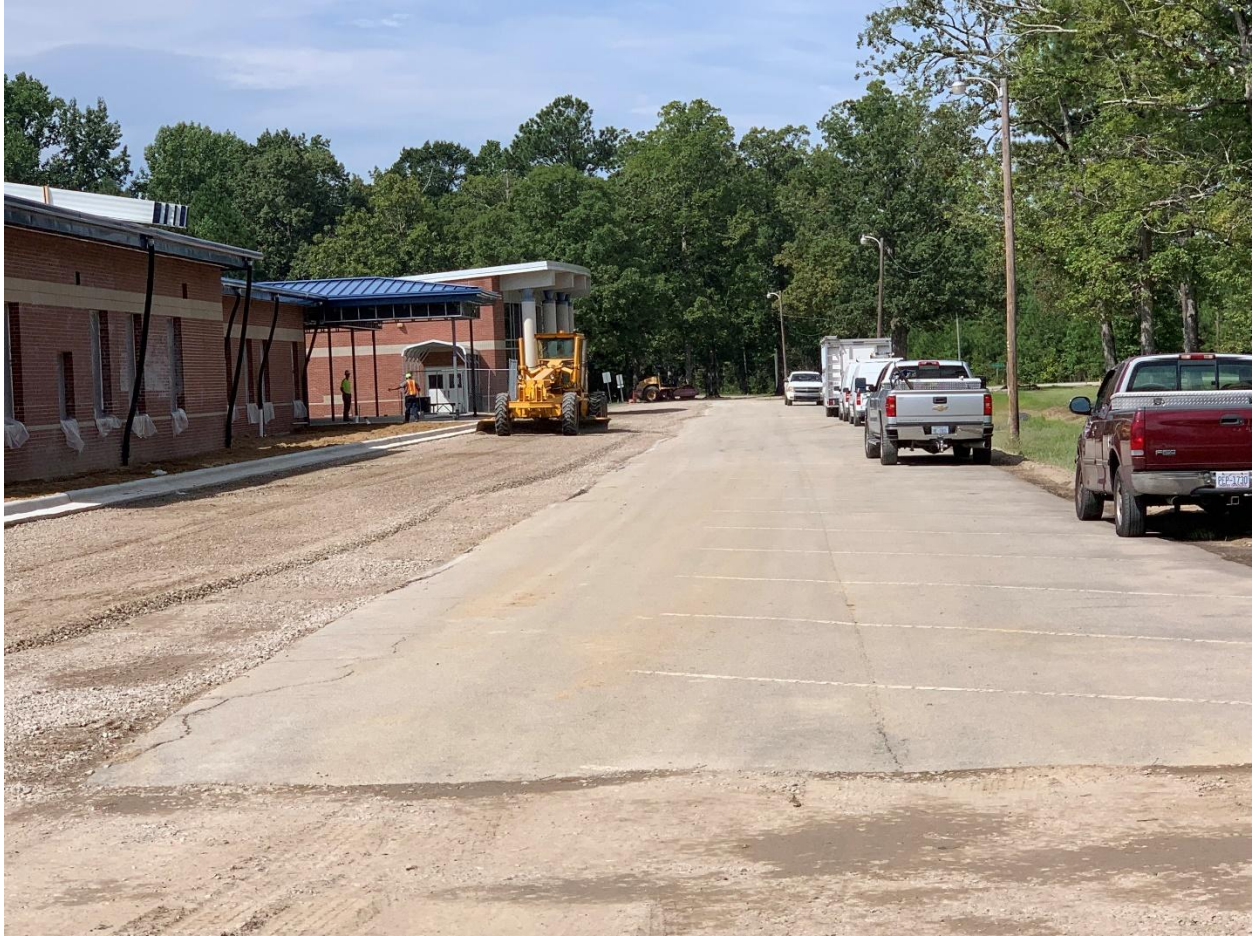
I have been telling you backwards about drainage at the front of the building. From a point somewhere behind the motor grader and on to the east the water from the drive will drain to the front swell.

The water from behind the motor grader will drain from the left edge of the existing asphalt in this picture to the north on the right side and to the south on the left side. It is now quite noticeable when standing at the new entrance and looking across the new asphalt not shown in this photo.

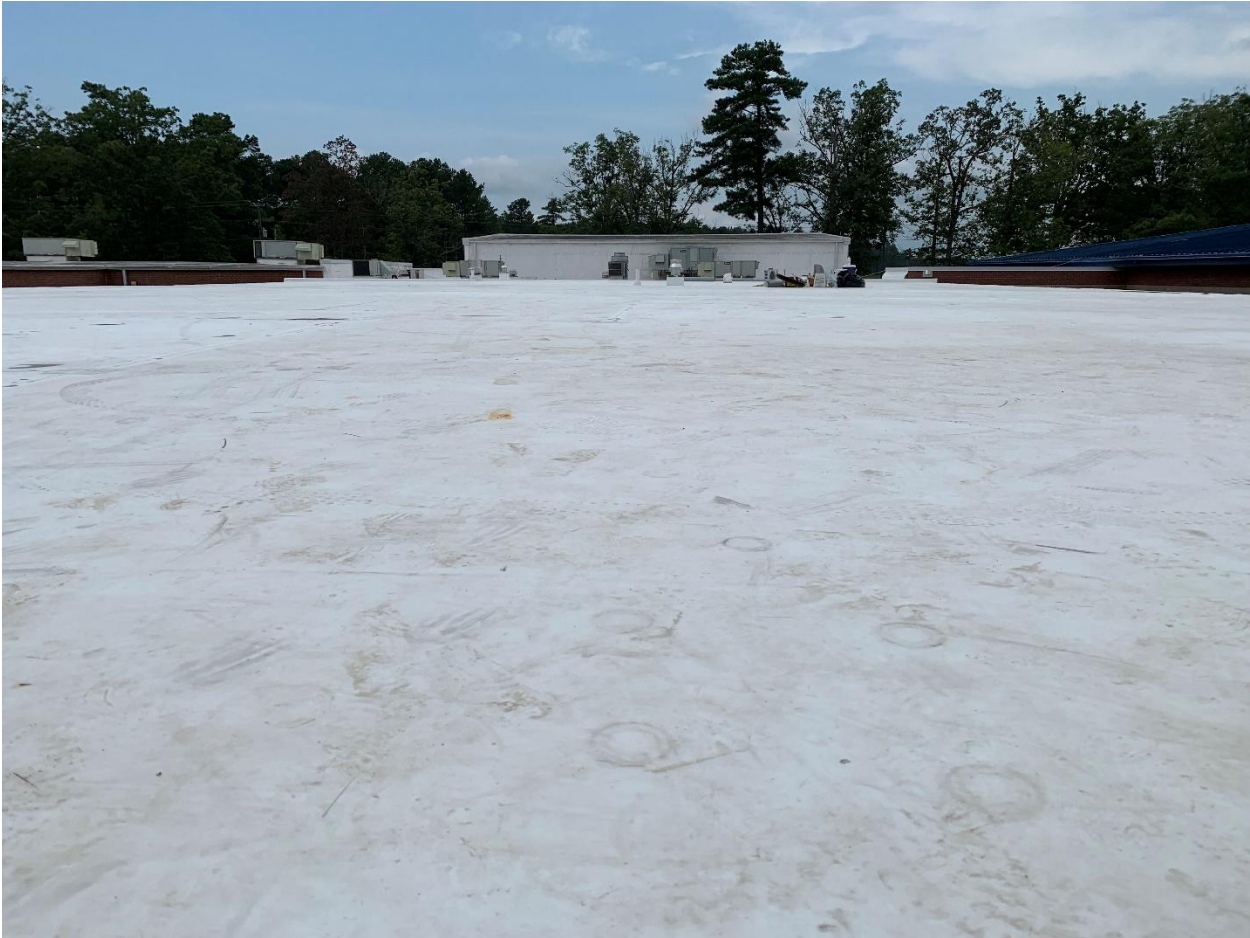
The new TPO roof is completed other than some debris removal.

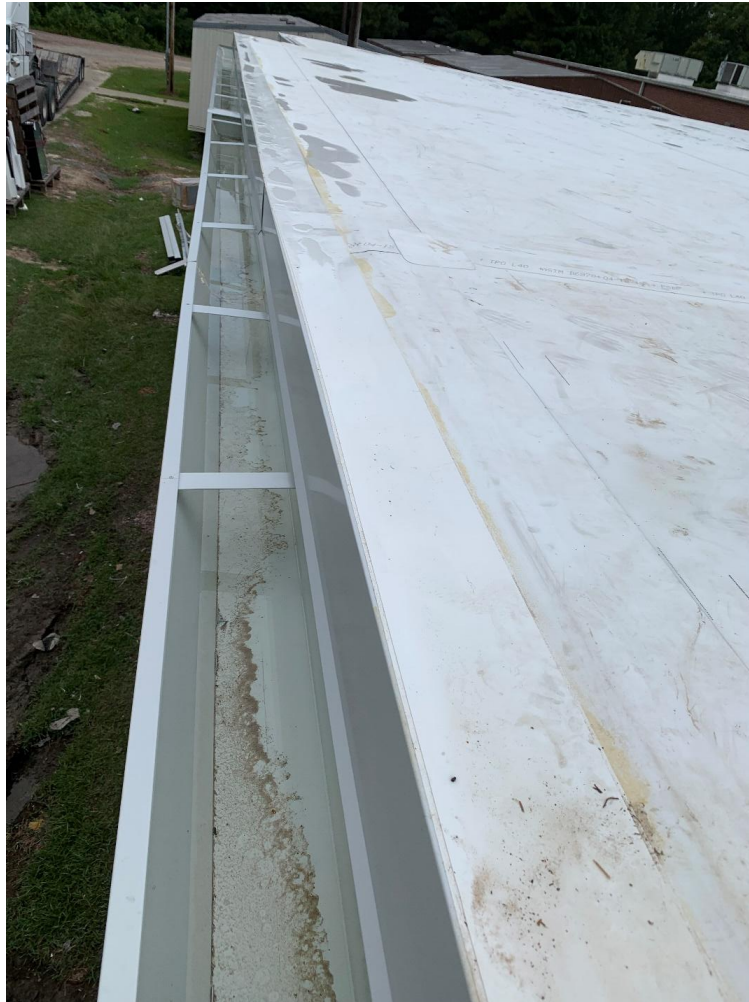
The gutters are installed and this is how the finished product looks from the top

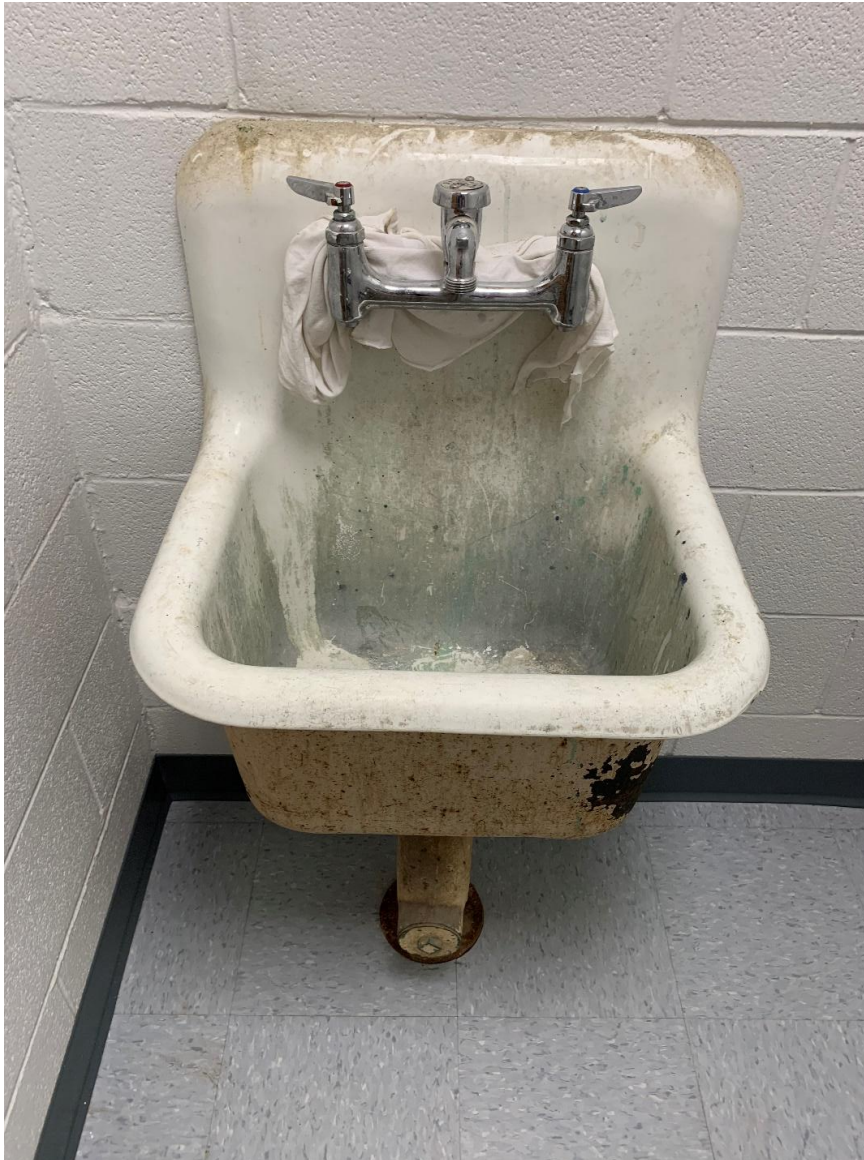
Now we need to talk about areas for improvement. This is the janitor closet on the seventh grade hallway. The pipes are dead and the large hole is where there had been a sump pump. The pipes sticking up present trip hazards to cause a Workmen's Comp claim we do not need. The open sump hole has equally negative potential. Dr. Williams and I have asked the pipe be removed and the sump hole filled, capped with concrete and the VCT floor repaired to remove all those hazards.

That same room has a very old cast iron janitor's sink.

There is quite a bit I want you to notice in this picture. This room was “cleaned” by the cleaning crew yesterday. I simply cannot believe anyone got a rag close to that sink. If you look really closely, there is a rag across the faucets. The cleaning of this sink is a fair representation of the job the cleaning crew did in the rest of the building. Before moving on to pictures of these and other issues, I asked Mr. Brian Plyler to have the cleaning crew come back this weekend and get the cleaning done right. I also requested that he have the painters clean the outside of the sink and repaint it. It is still very serviceable and much more sturdy than anything we can buy today.

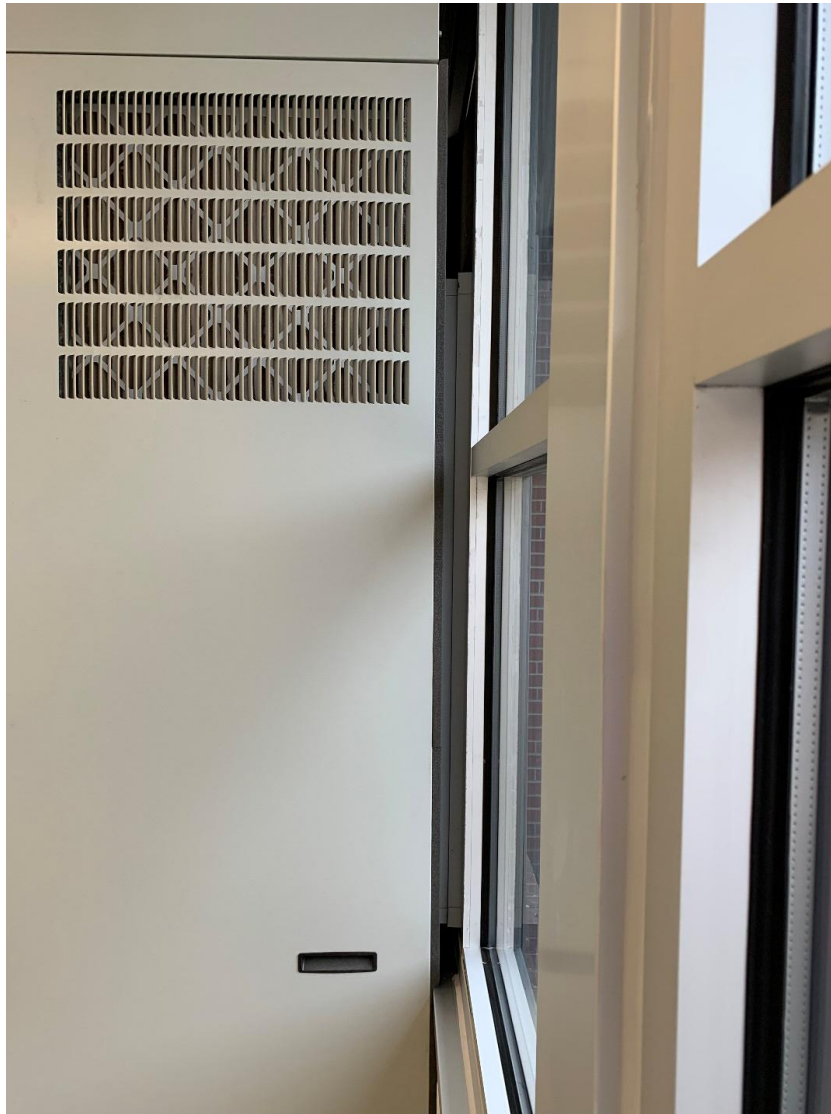
I went to the school early this morning to walk through with a critical eye looking for potential hazards and areas for improvement. The first thing I noticed is the BARD units.

They are neat, very quiet and, I think, a good choice to get mechanical off the roof. In the area between the window and the unit there is a space from the top of the window ledge and up about four inches that is open all the way across. Starting about eight inches above the center window frame there is another opening running all the way across. I discussed the issue with the window installer working in that classroom and he indicated this condition allows little hands to come into contact with some sharp metal between the unit and the window. I requested him to give us a price to install sheet metal to make one solid closure from top to bottom on each side of each BARD unit.

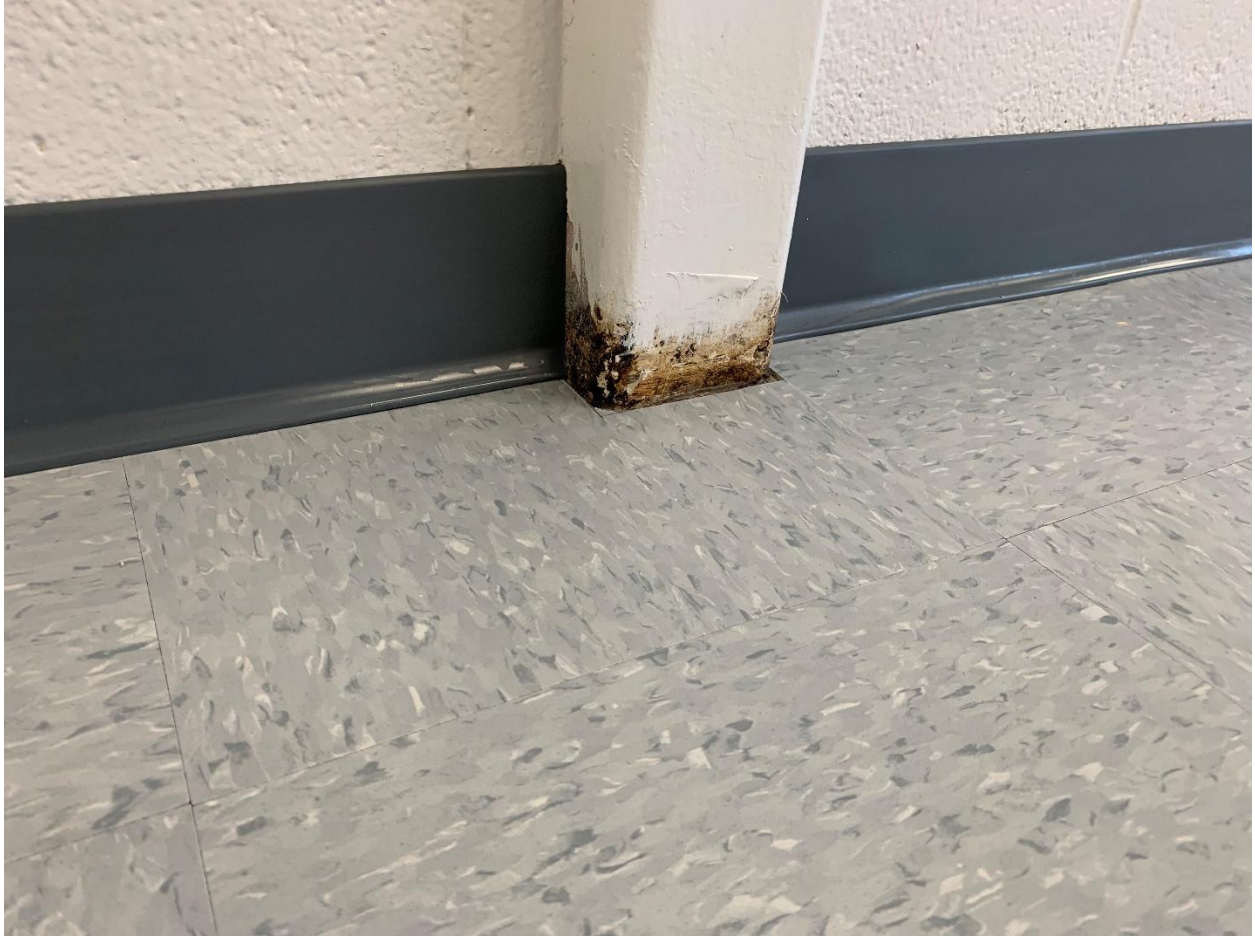
This is a column of some sort not removed during the remodel. I asked Mr. Tom McLaren, the superintendent of the remodel, to have these cleaned and painted. Tom was not on site this morning as he was suffering with an ear infection. The column

needing painting is one of four.

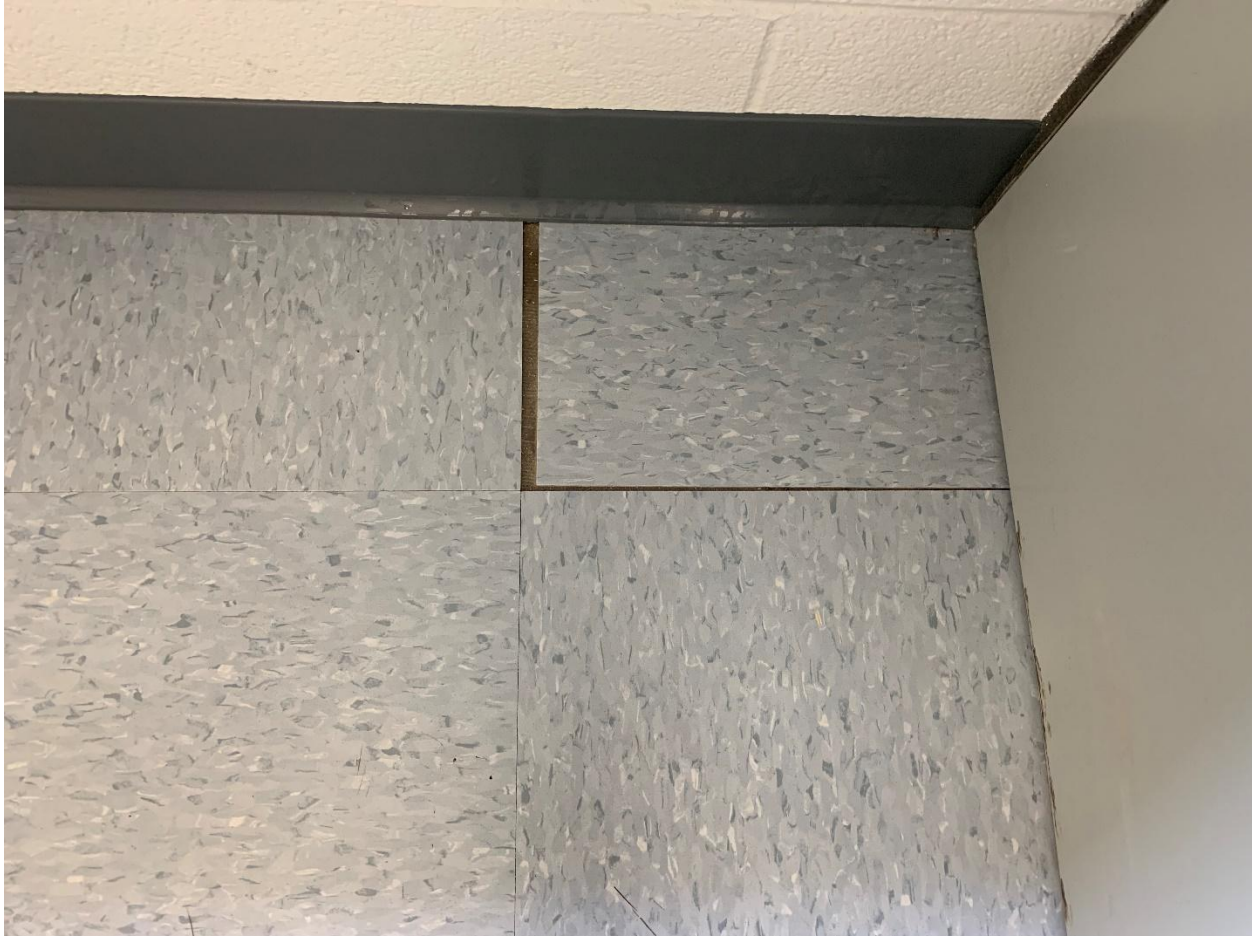
Now we will look at issues on a room to room basis starting with room 229. This floor tile simply does not fit.

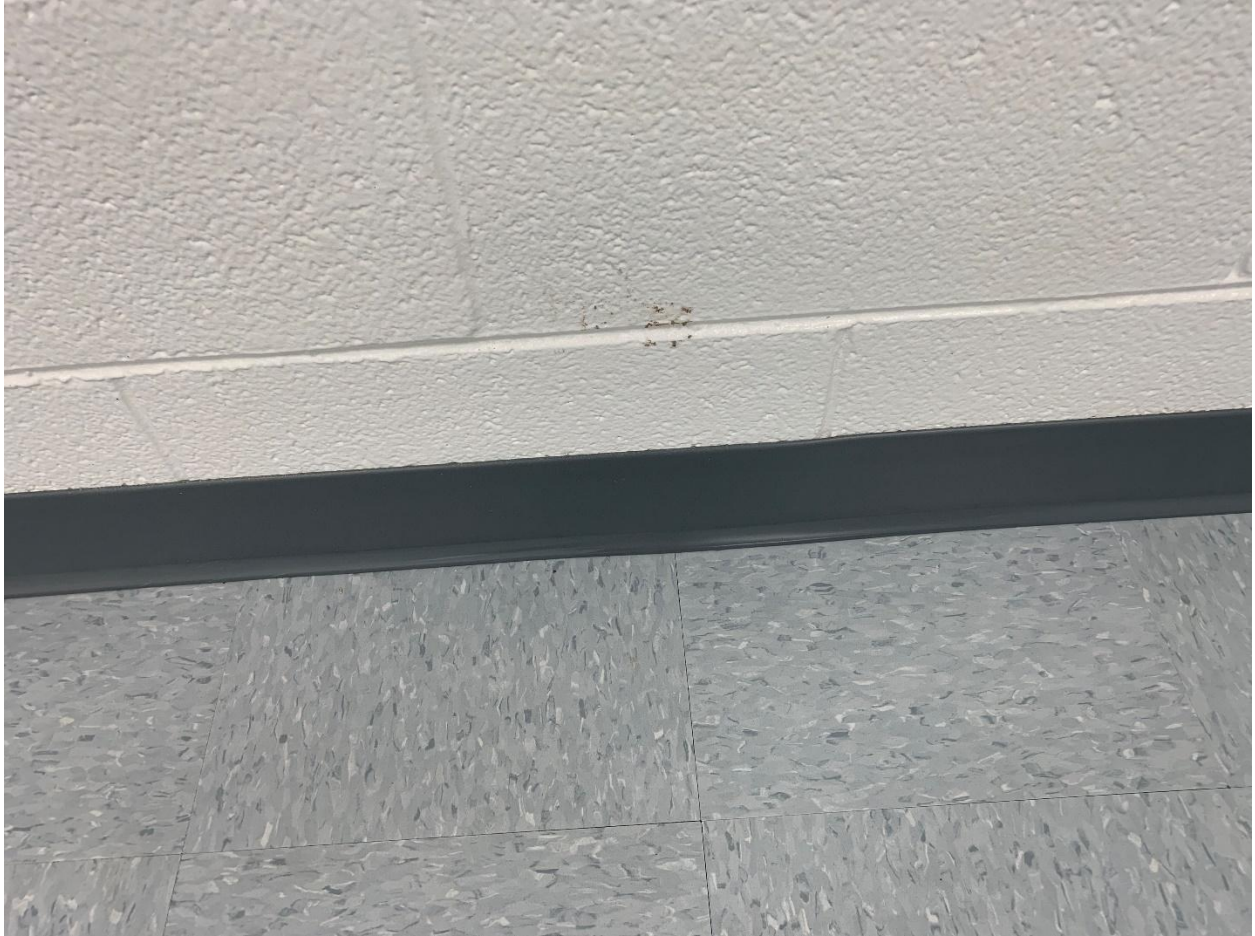
A spot on the wall for a painter to give a little TLC.

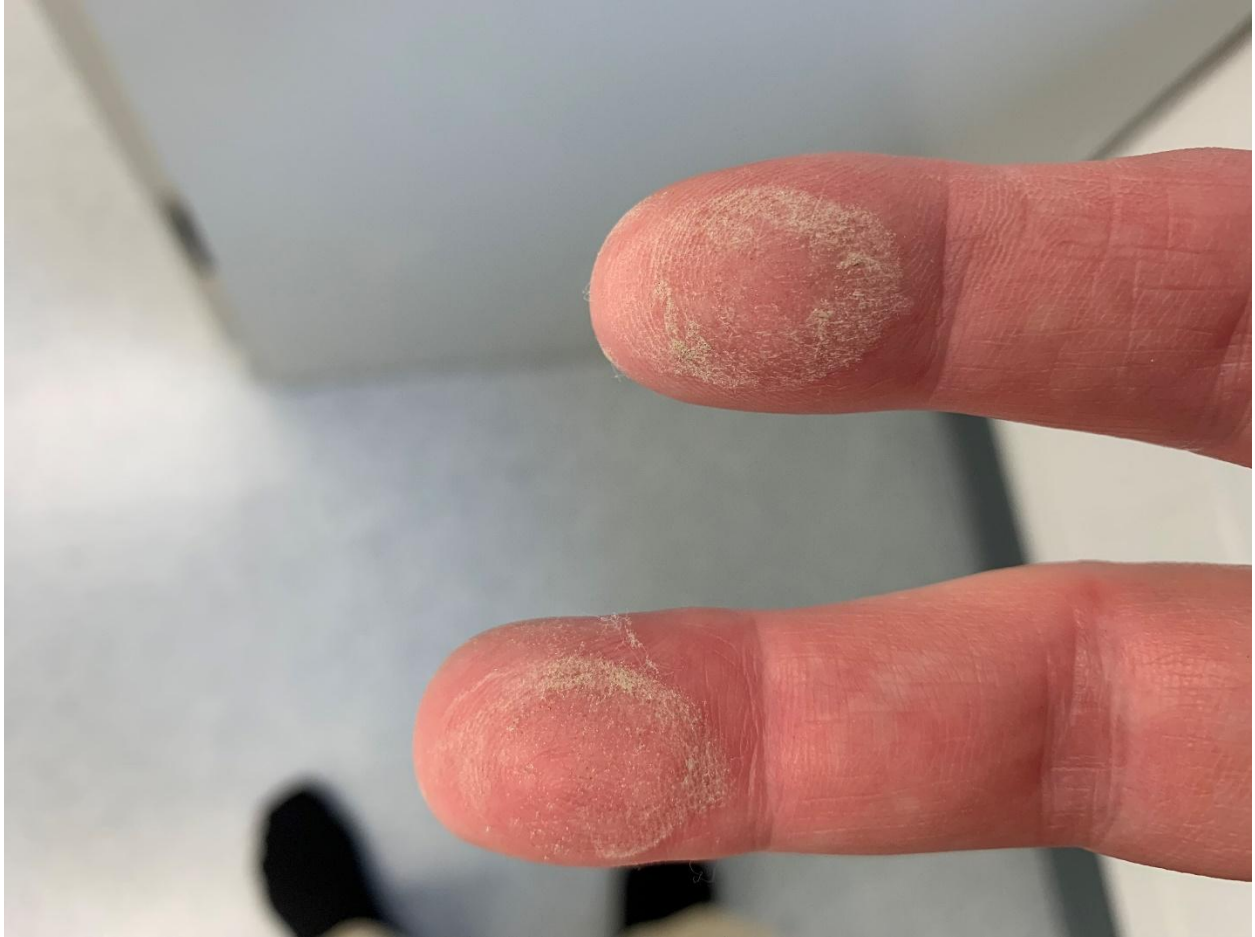
Some dust failed to jump on the rag. Notice I removed my boots at the door to keep from tracking up the floor.

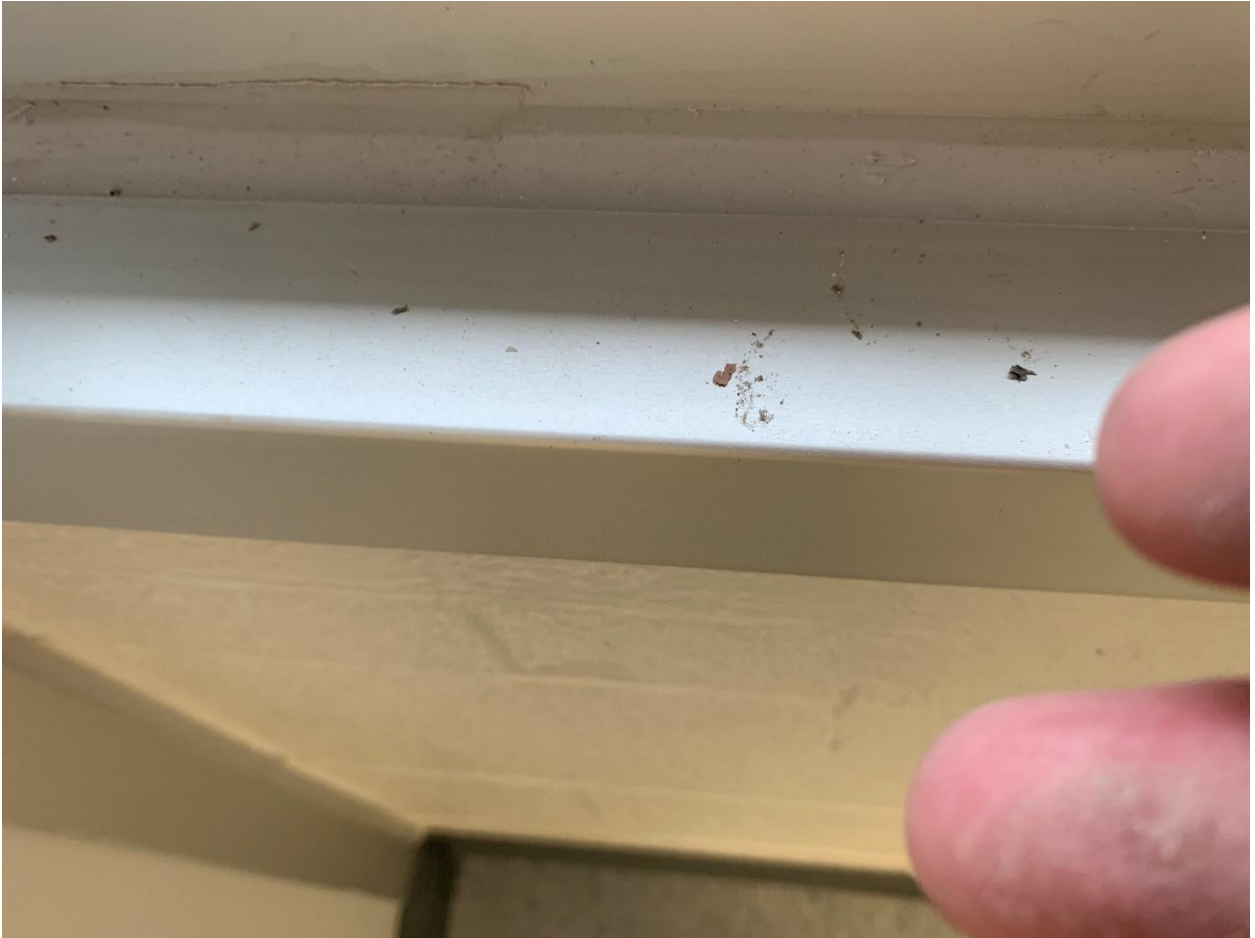
More dirt on a window ledge!

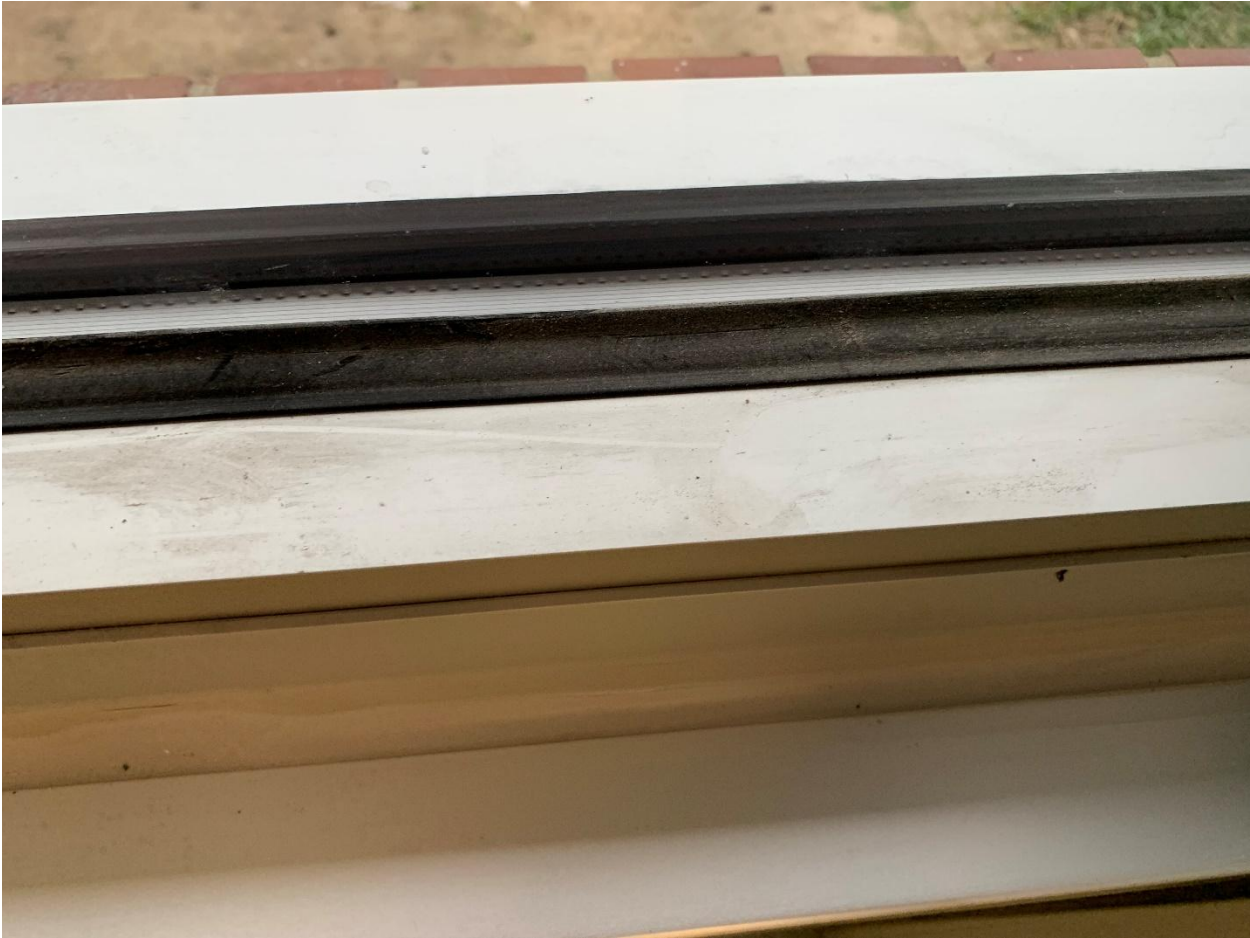
The dirt is very easy to see.

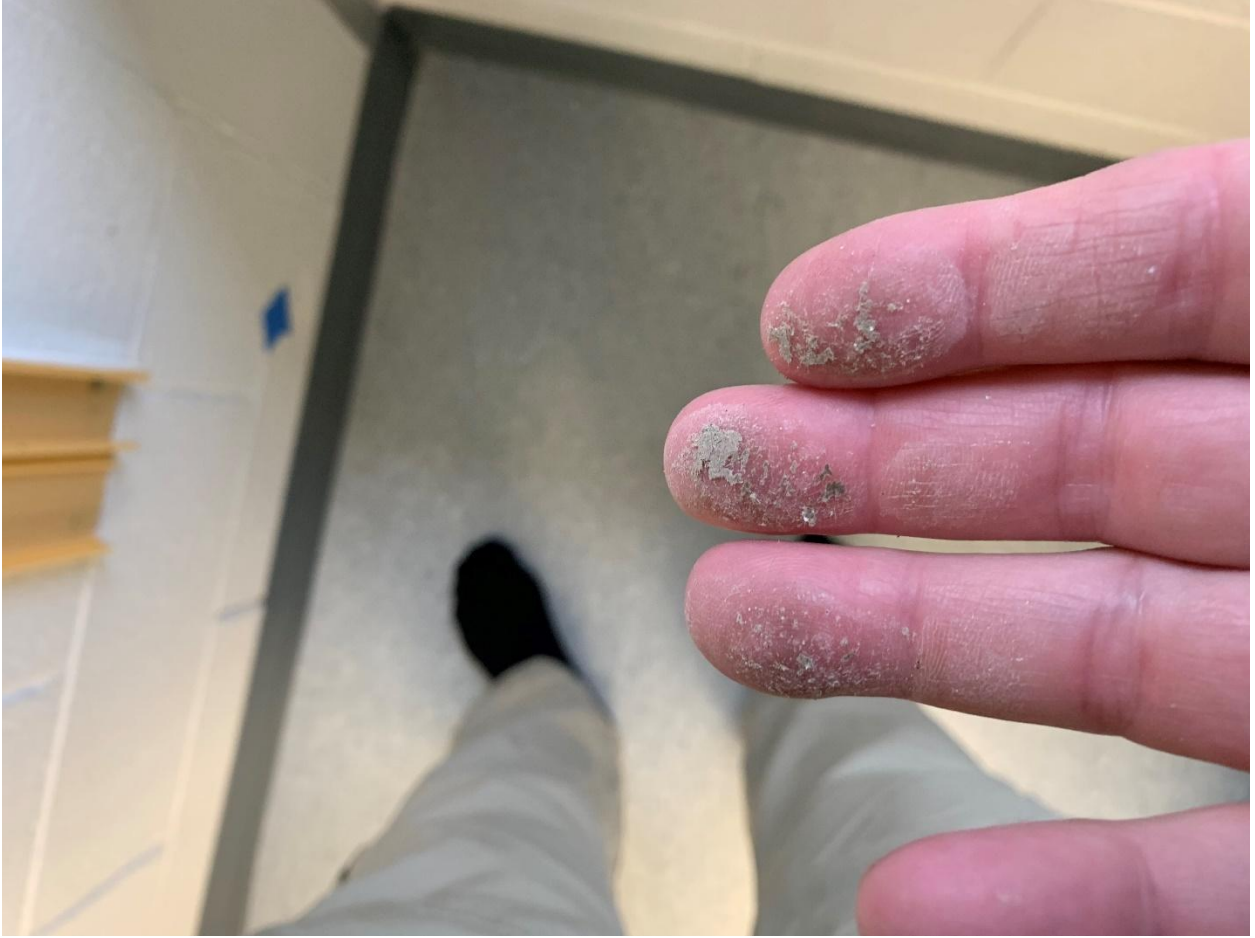
More dirt from a window ledge.

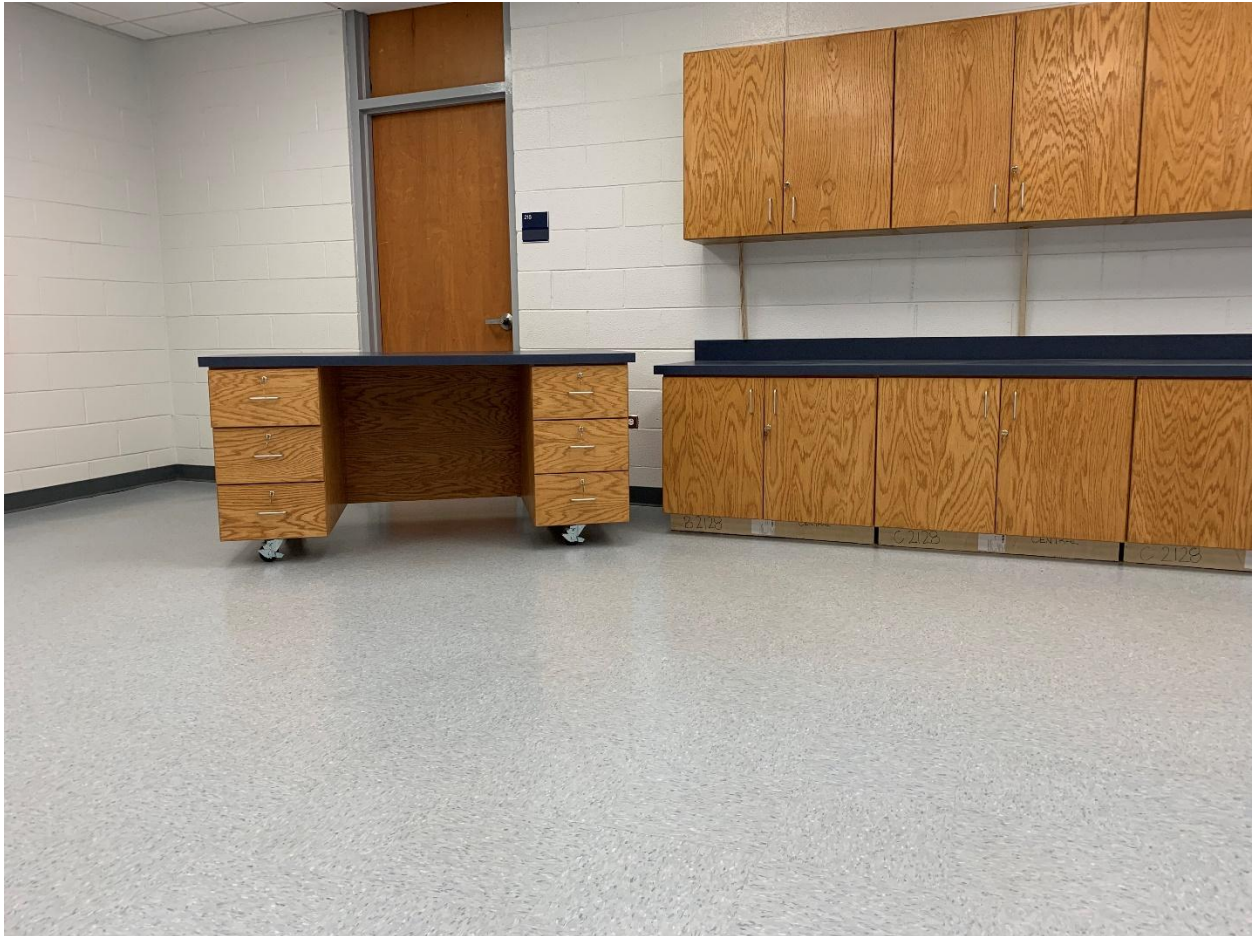
We move the desk next to the counter. The specifications called for the surface heights to be 33 inches. The desk is 33 inches while the countertop is 30 inches. To the right of this picture the cabinet becomes a single tall cabinet at the end next to the windows. The cabinets are clearly not made per specifications. The specifications were conveyed to the contractor before they started building the cabinets. We have three options on how to handle this.

Option 1 is that we accept the cabinets as they are.

Option 2 is that we require the contractor to rebuild the cabinets per the specs.

Option 3 is that we have the contractor raise the lower cabinets by using a spacer under the cabinets 3 inches taller than the spacer under them now and make new doors 3 inches longer than the doors now on the cabinets which will make the bottom of all the doors be the same elevation above the floor.

My opinion is that the space the extra 3 inches will give us inside the cabinets is not going to make a difference at all in the long run. The top of the work surface

will make a difference and should be corrected. The cabinets will not look right if the bottom of the doors are not all the same. I would appreciate your feedback on this.
