Progress Central Middle School

Week of August 16, 2019

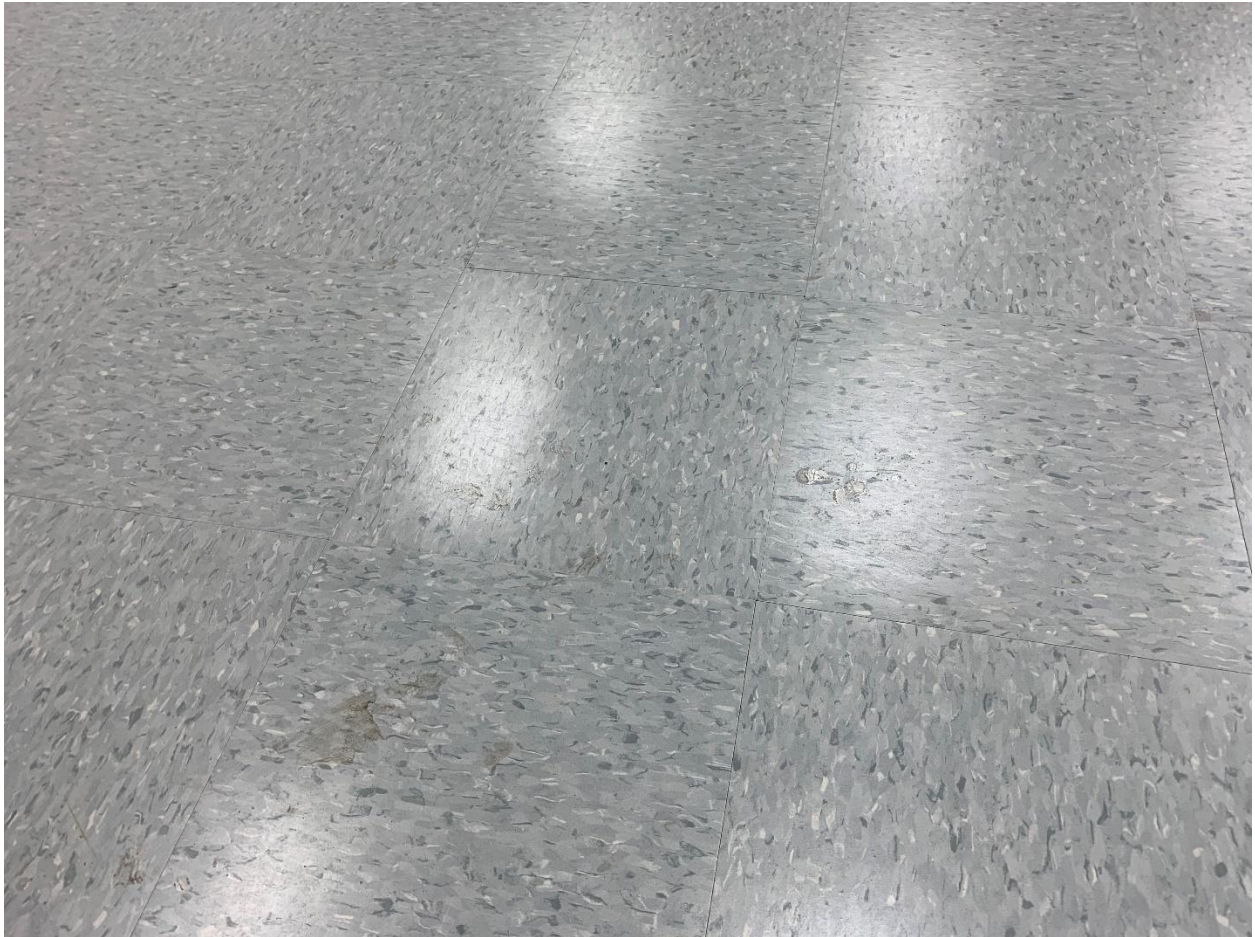
I am not sure what happened here but it appears was dripped on the floor and left.

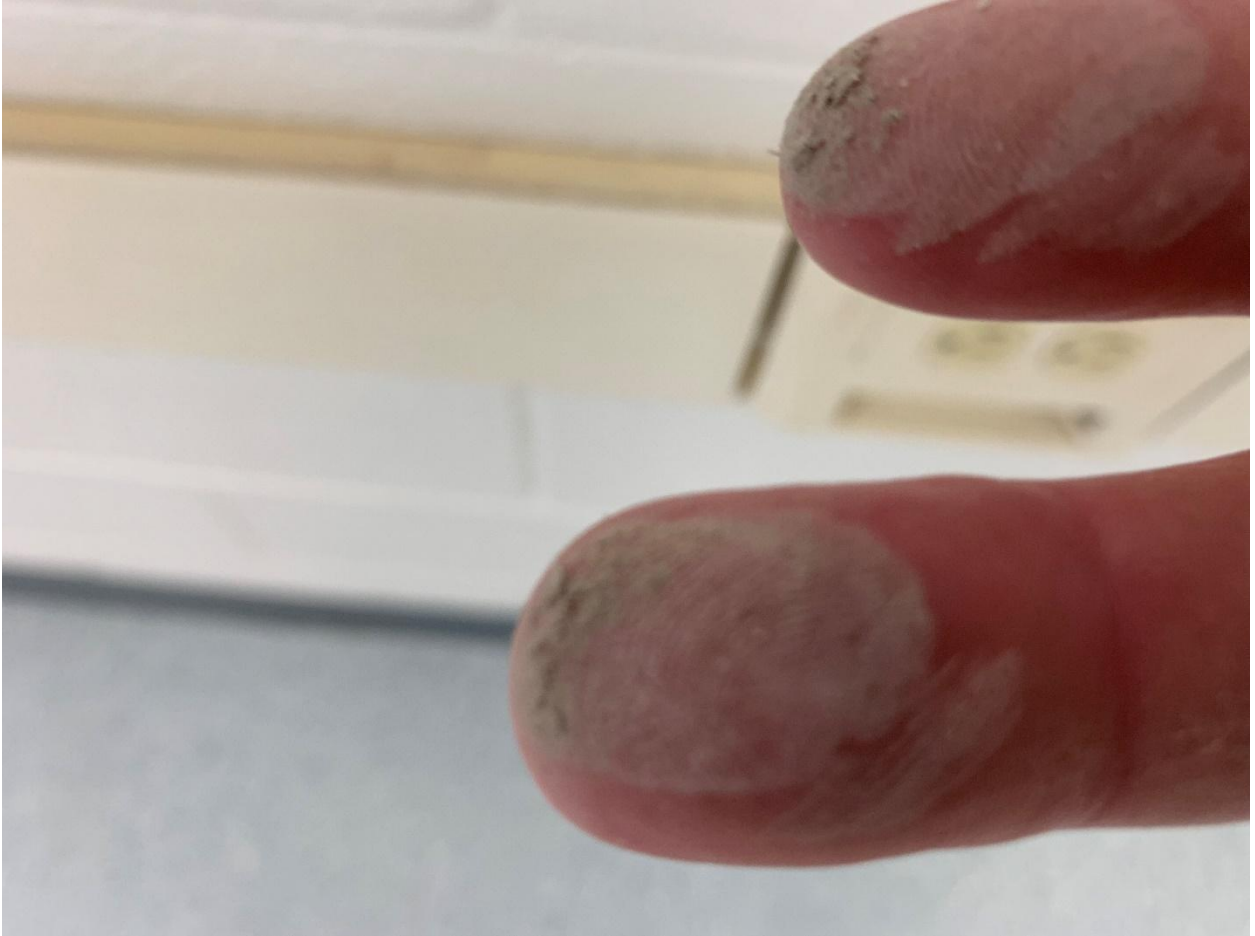
Issues with cleaning continued as evidenced by my dirty fingers.

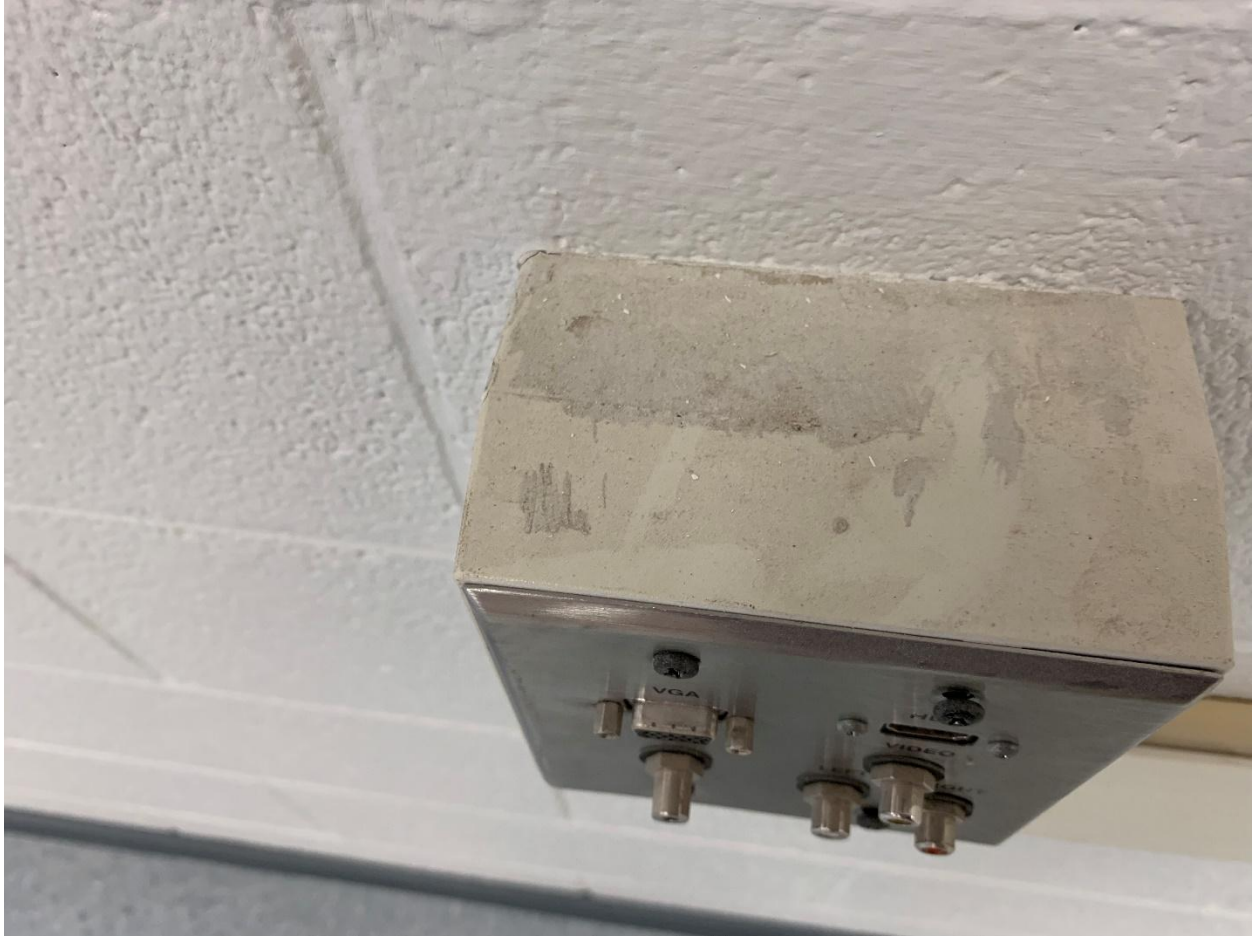
The dirt came from the very visible top of a control box on the wall.

It does not require a lot of degree work to figure out the top of that box has had no TLC in a long time. They got around to scraping the windows

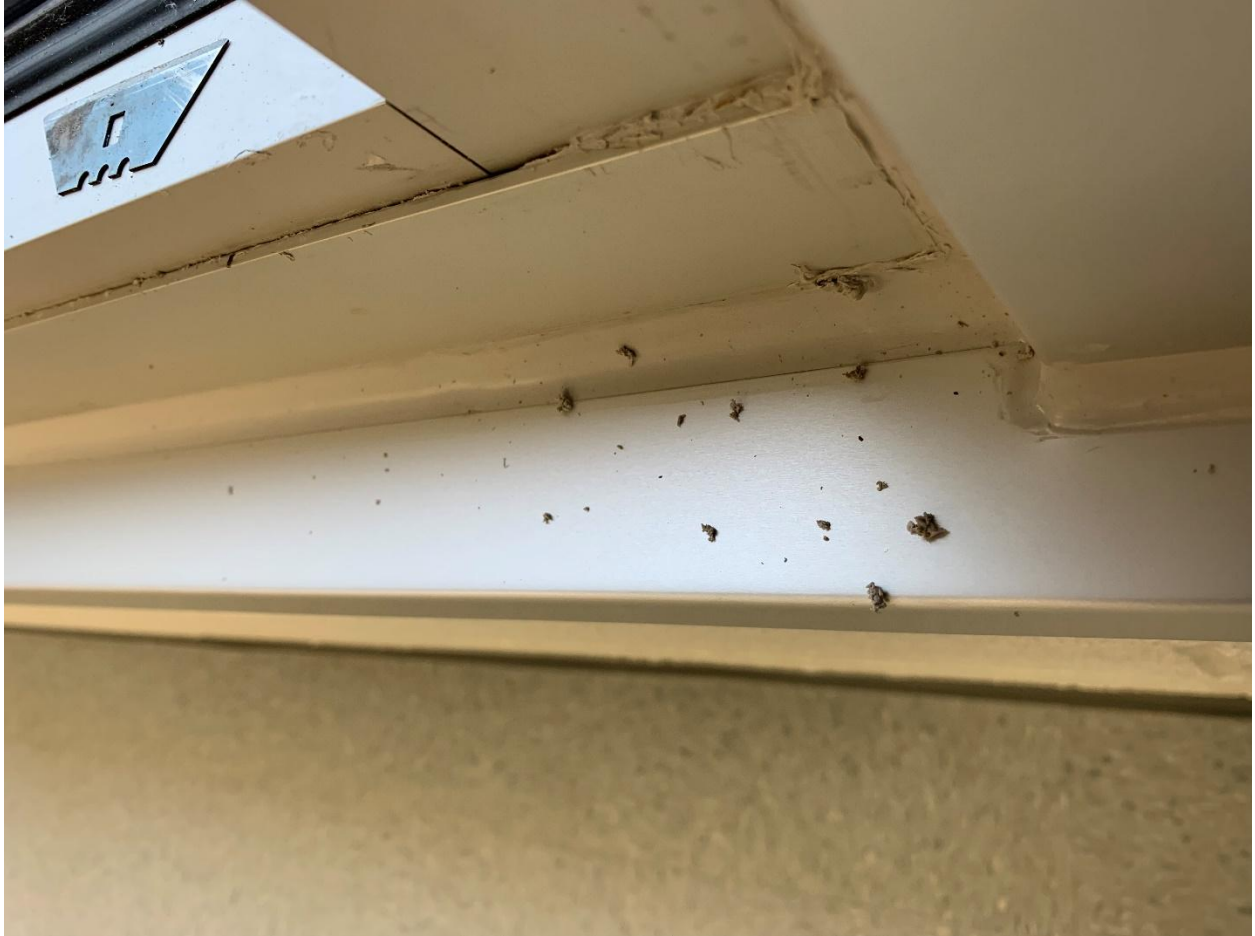
but they forgot to clean up their mess and get rid of the razor blade.

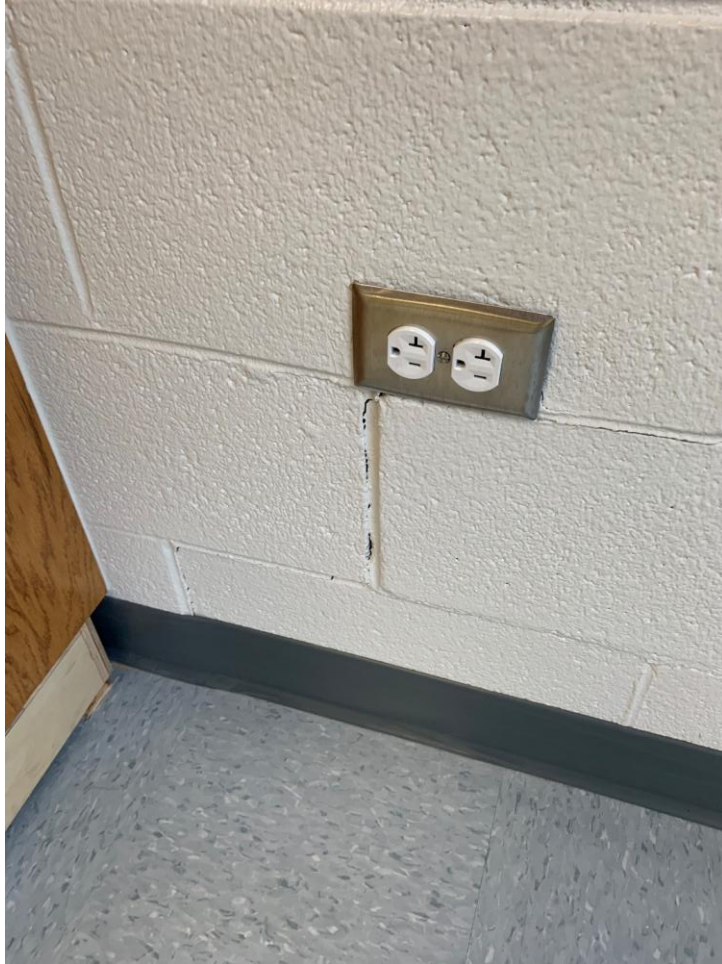
This is a small spot the painters missed.

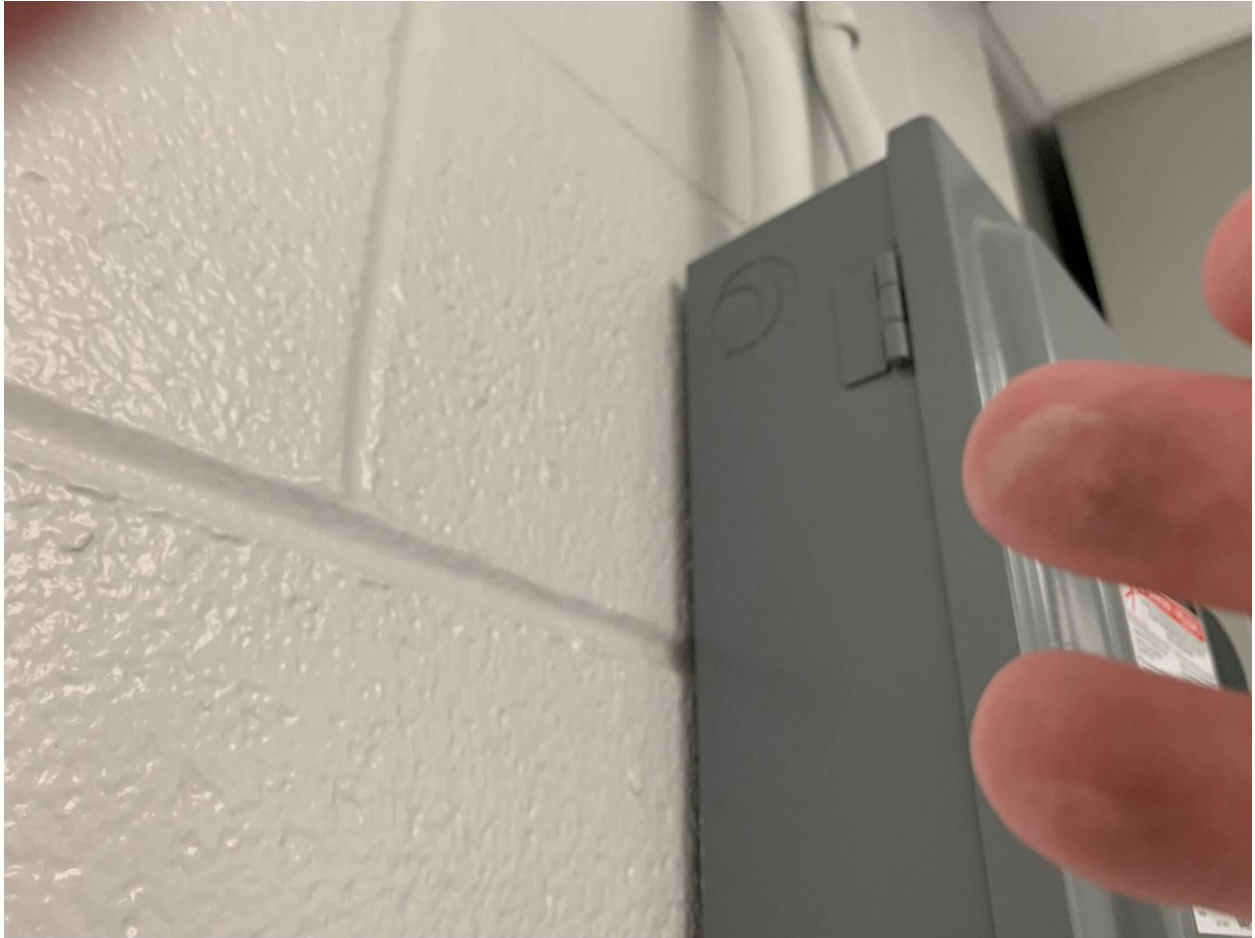
There was also a lack of attention on top of the disconnect for the BARD unit.

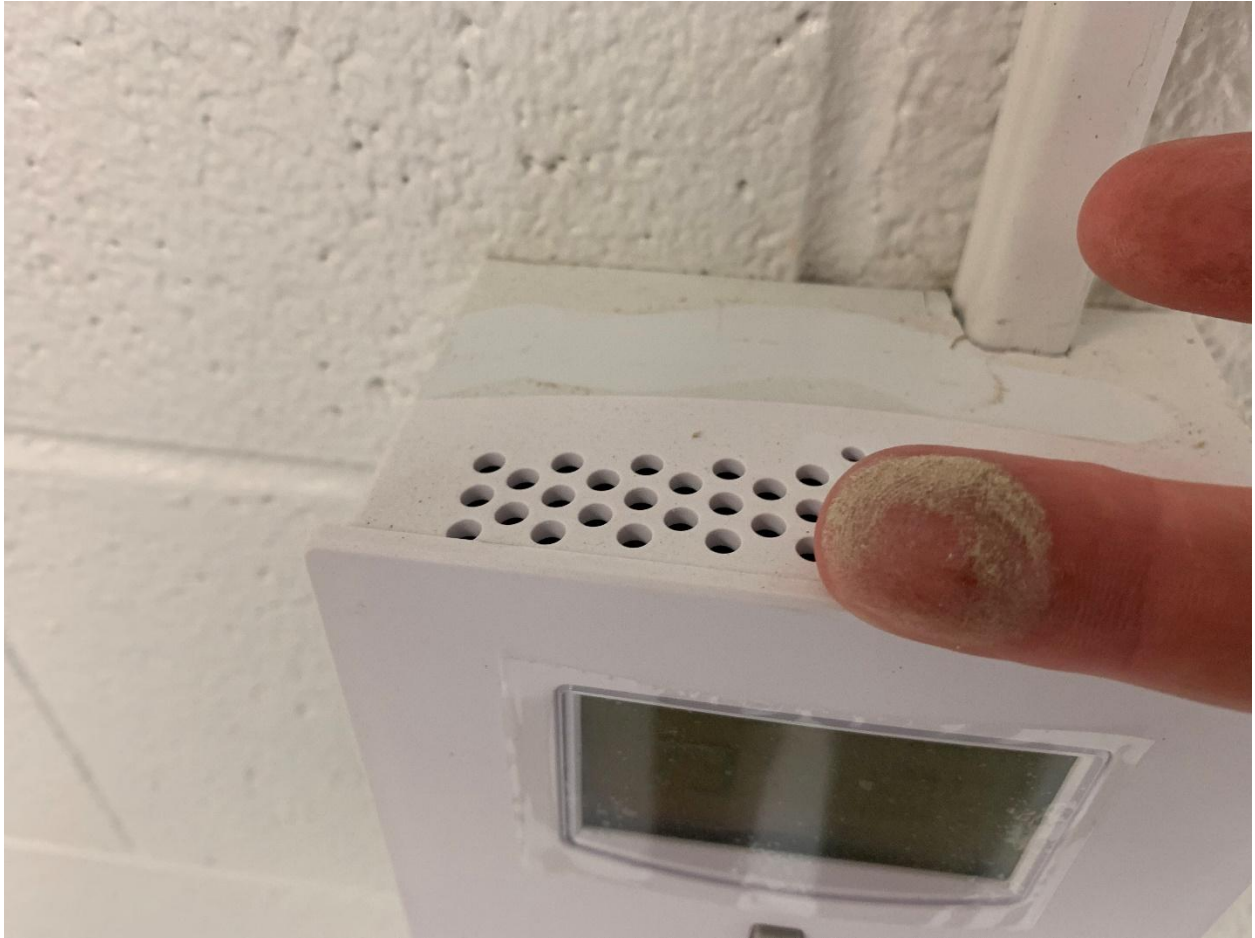
And on top of the thermostat!

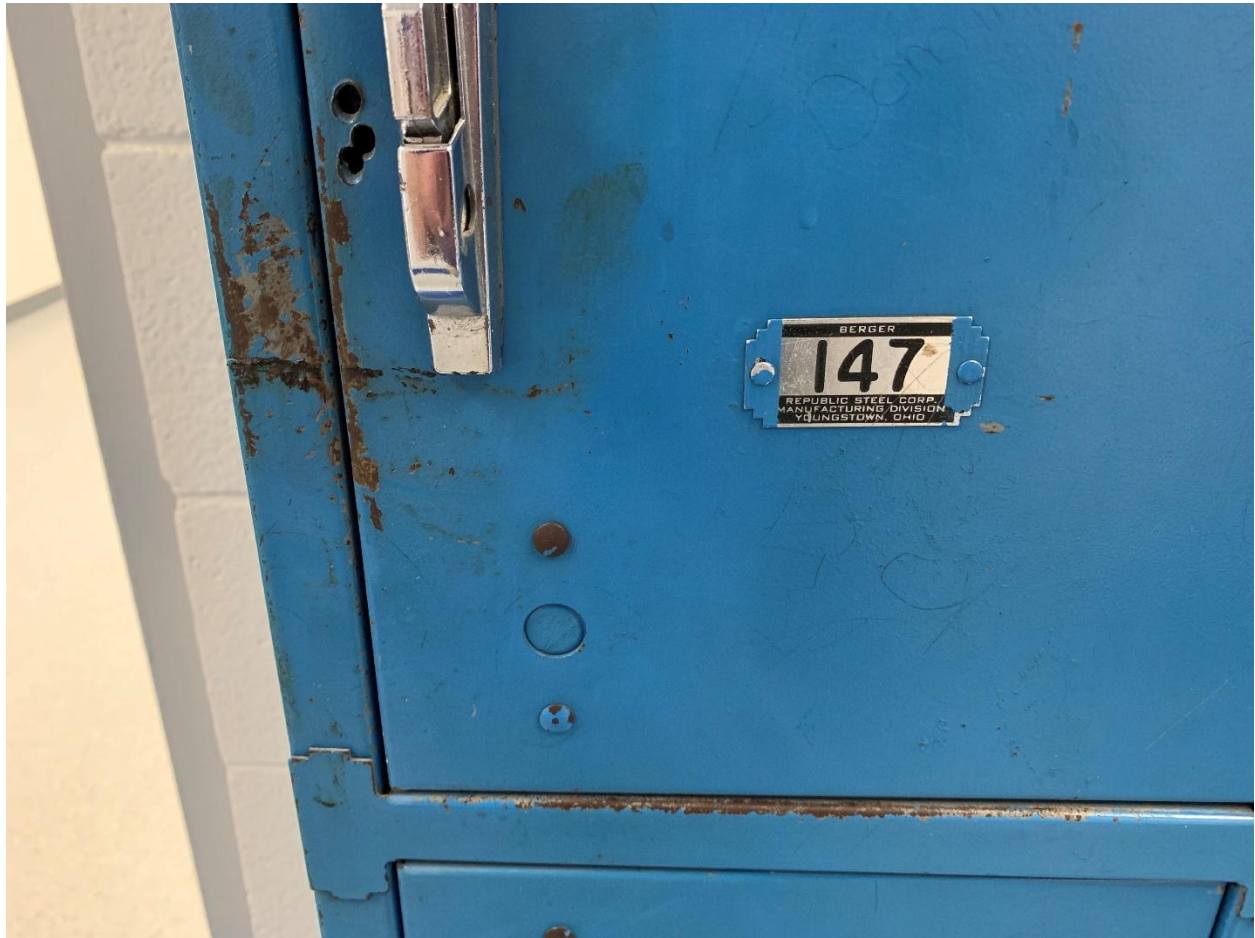
Walking past the lockers, it jumps out at you the lockers really need an upgrade of some sort. They have served well but have become an eyesore next to all the

fresh paint.

I asked Mr. Daniel Plyler to get costs for separate orders and combined orders and to get a cost to refurbish the existing lockers. There are a good number of lockers where it is evident at least one hinge has come loose from the door or the cabinet. We have to do something.

We have options.

Option 1 We leave them as they are.

Option 2 We purchase new lockers and install them ASAP.

Option 3 We get a cost for adding the appropriate number of lockers to the order for the eighth grade wing expecting them to be less expensive than making as separate order for each wing.

Option 4 We get a price from a vendor Mr. Baker is familiar with to have the lockers removed, refurbished, repainted and returned.
