# **Central Middle School**

## **Progress Week of June 7, 2019**

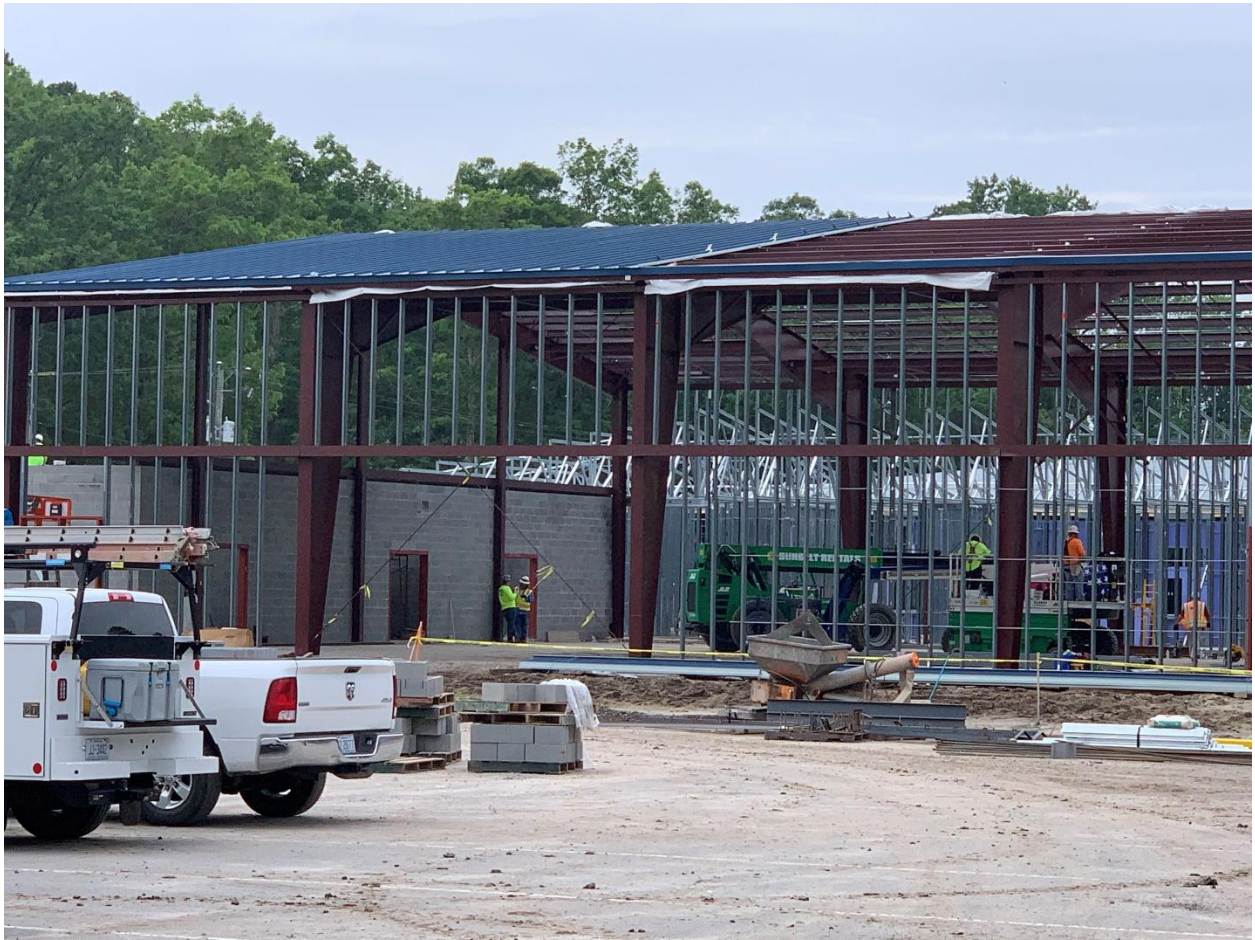
The first thing I noticed this morning is progress on the roof of the gym. It really did not hit me until I was completing my rounds that the east and west stud walls for the gym are in place. Things are really taking shape. One thing to notice in the pictures is this does not look like a state road crew with one man working and twelve supervising. There is some talking going on but it appears to be necessary job related conversation. Results indicate this to be the case.

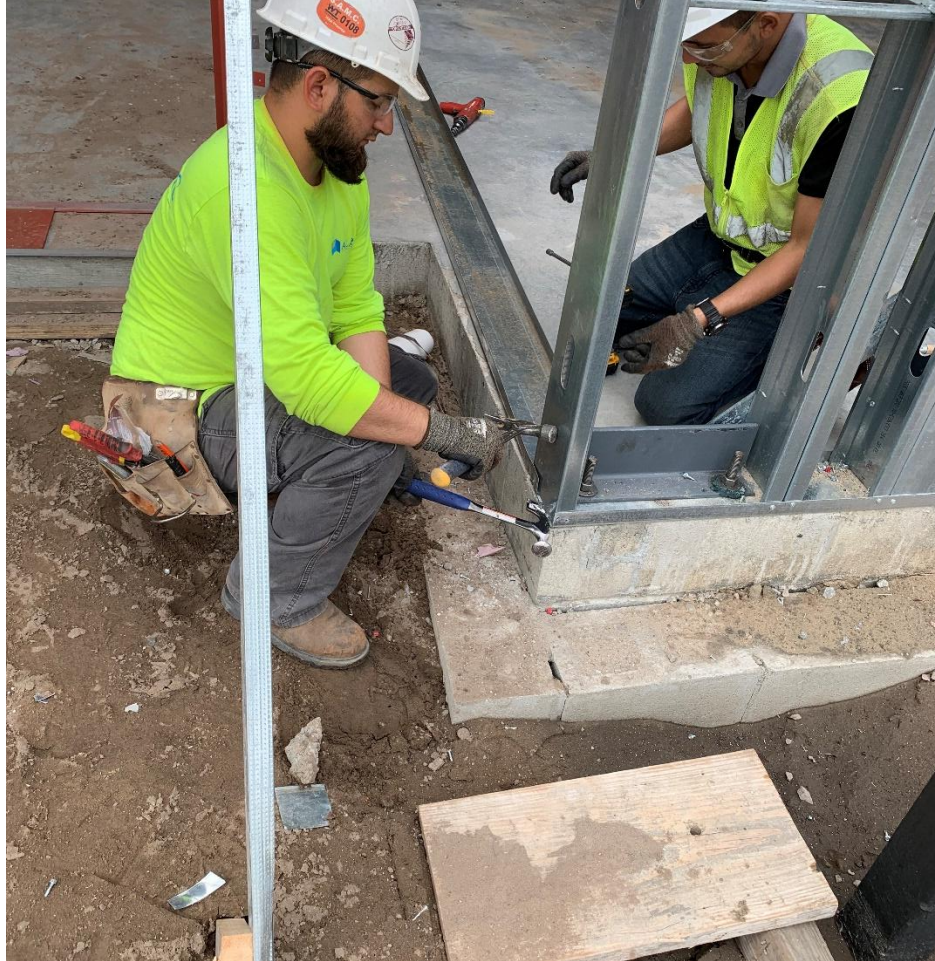
When entered the building through the gym entrance on the northeast corner I noticed two workers at a corner. The picture is taken with me facing west. They were installing a wall tray for studs to be secured to each side. The tray had to be installed under the section of tray running north and south. I had noticed the metal stud craftsmen toting hatchets and simply had no idea why a hatchet would be employed installing metal studs. Now we know!!! It is a pry bar/wedge/hammer/whatever you need when you are in a bind tool! I keep telling you I'm learning all the time.

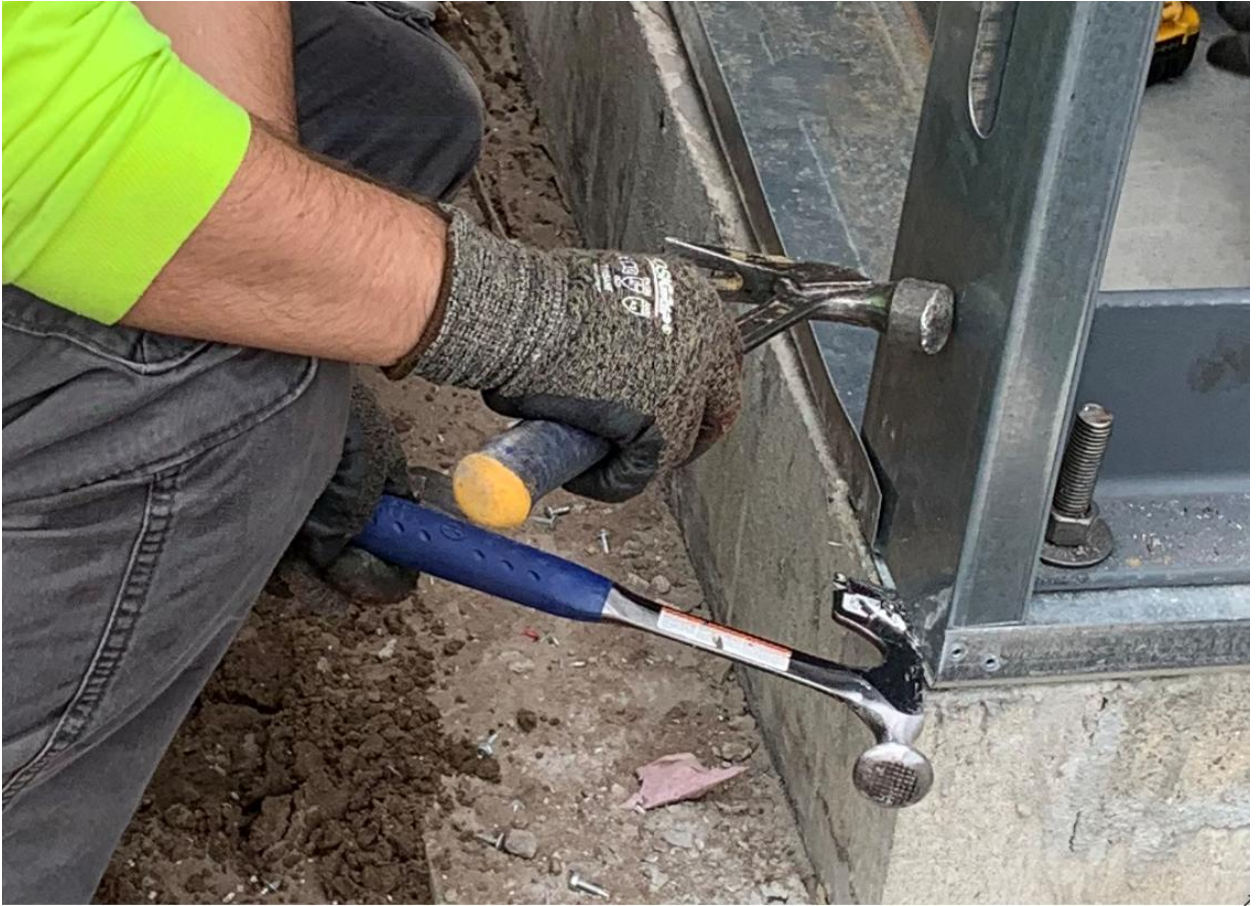
The next photo is a closeup of the above picture. Notice the hatchet used as a pry bar to make room for the tray slipping in from the west. Notice both workmen are wearing safety glasses and both are wearing cut resistant gloves. Not all work sites display this regard for safety.

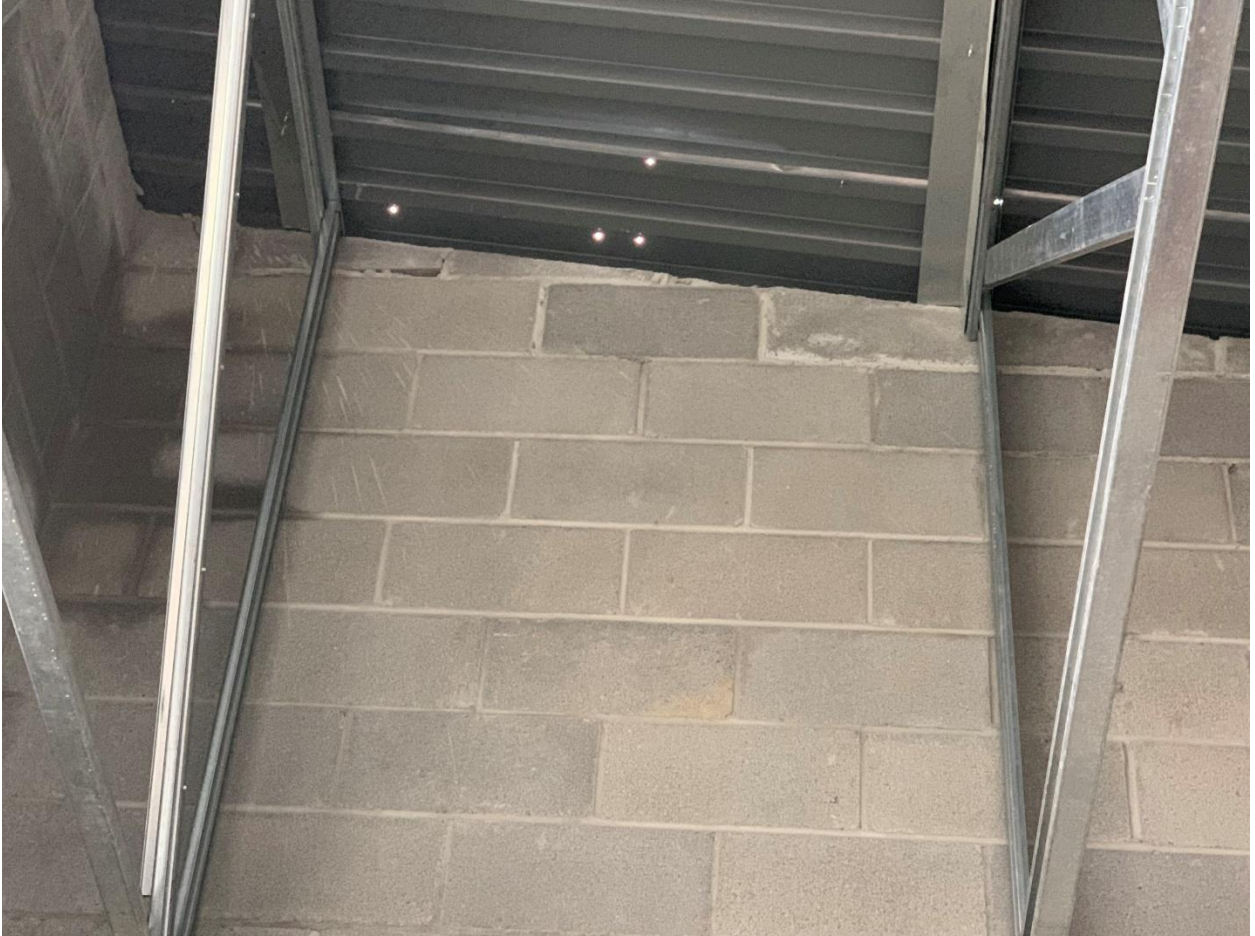
The next picture is of the east side of the north-south firewall separating the gym area from the administrative and classroom areas. In pictures from a previous newsletter I had noted the steps in the wall would be filled in after the trusses were in place to give the masons a definite point to lay to. This prevents fire from traveling through the building at this point. The wall saved a considerable amount of money because it eliminated the need for sprinklers.

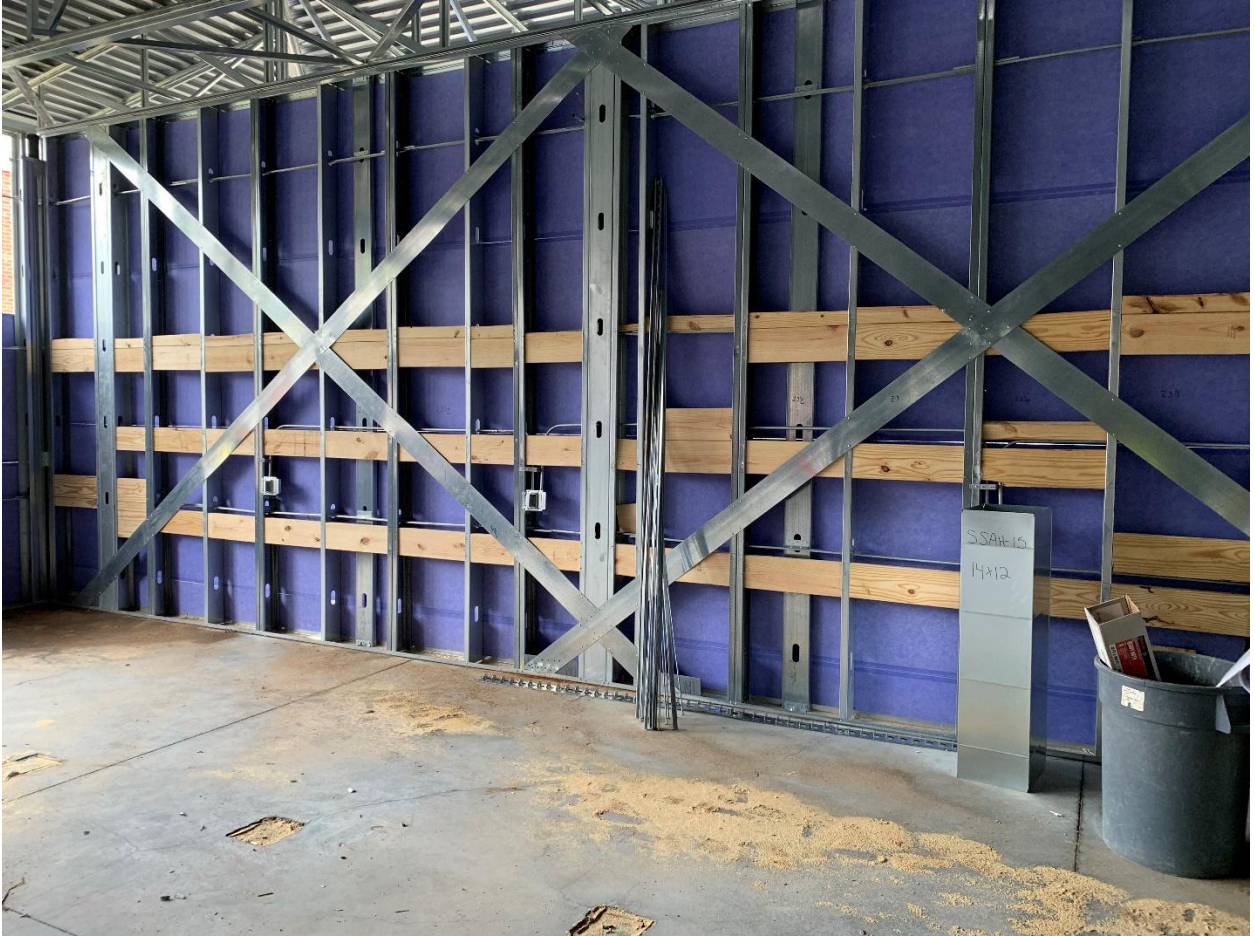
When I got to the end of the hallway through the administrative area, I was at the computer room on the northwest corner of the seventh grade wing. I had to ask why the boards were in the north wall. They are to secure cabinets to the wall. Again, I'm learning.

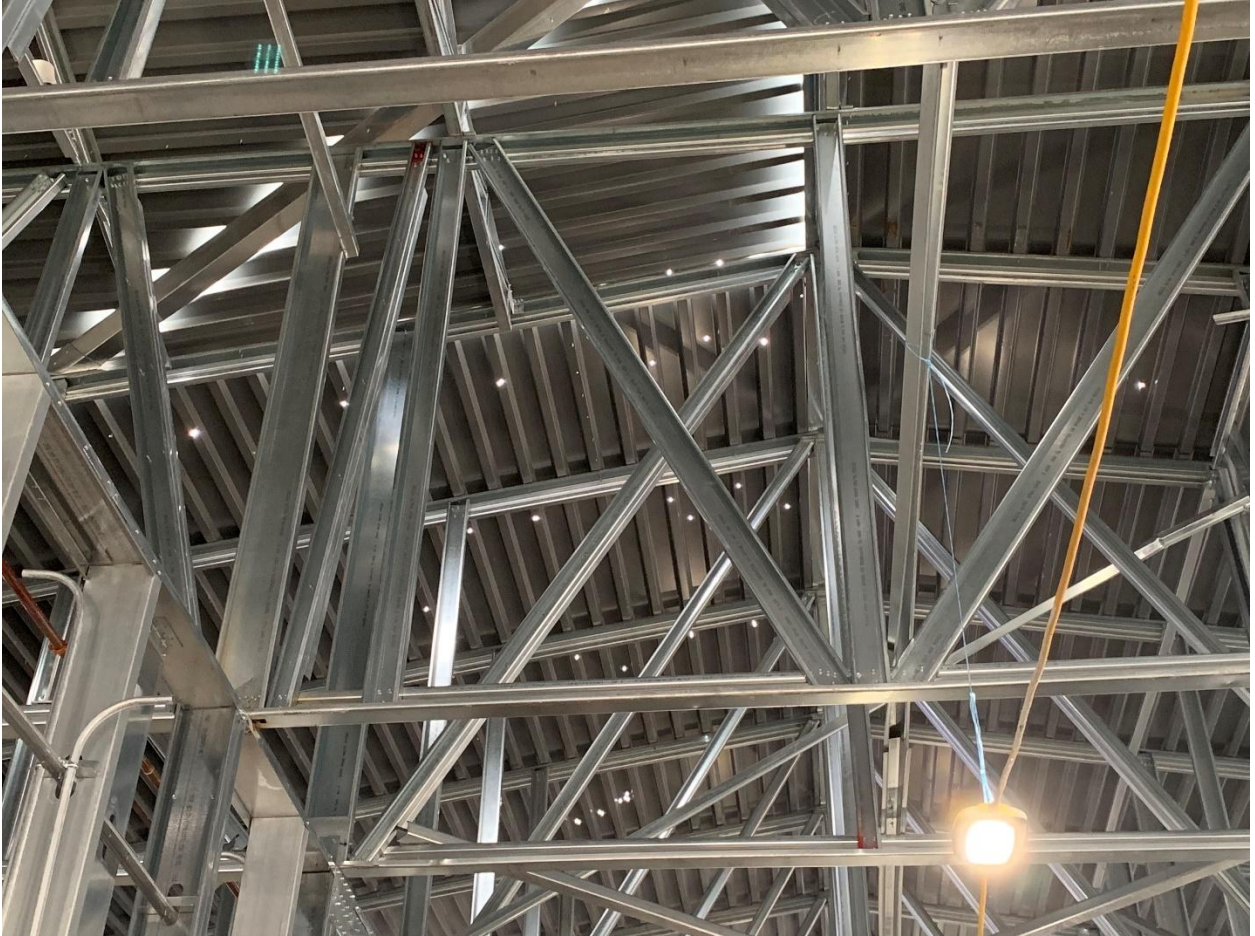
I walked down the eighth grade hallway and looked up and saw a good number of holes in the bottom sheets of the roof.

After talking with Brian Plyler I learned the holes were made when lanyards were secured for workmen on the roof. Some holes were possibly made when workmen were attaching the sheets and missed the truss location. All this will be covered with 6" thick Styrofoam insulation next week then more weatherproofing material and finally the standing seam roof.

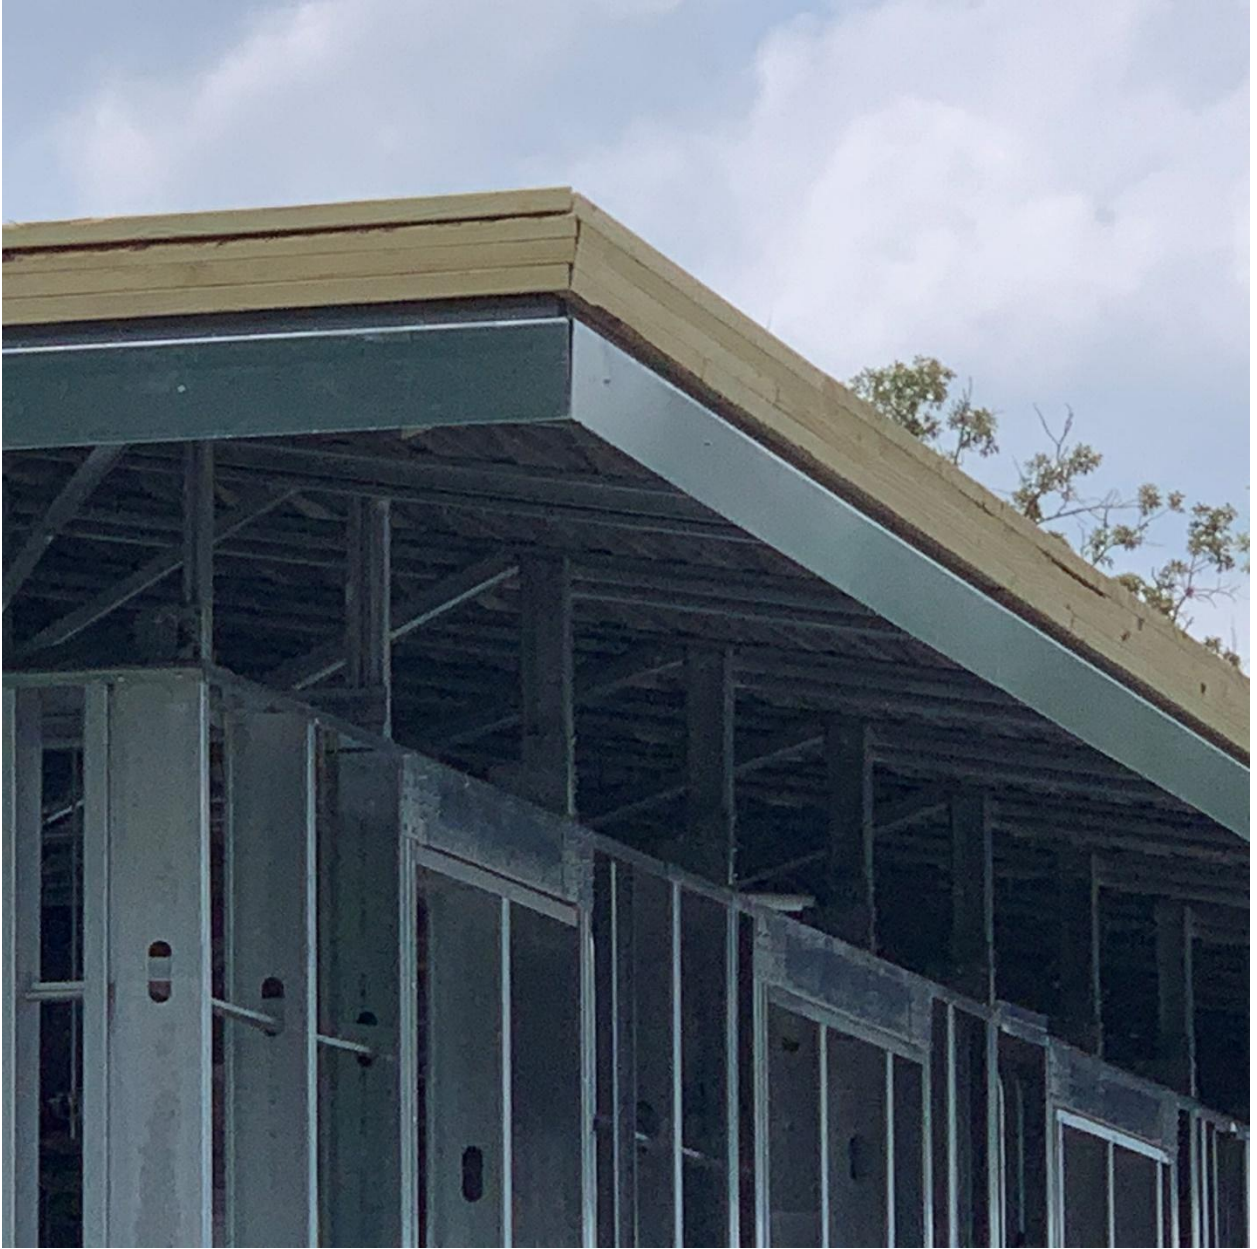
Traveling to the outside I saw changes from earlier this week when I observed 2 X 6 lumber attached at the edge of the roof sheets at the building perimeter.

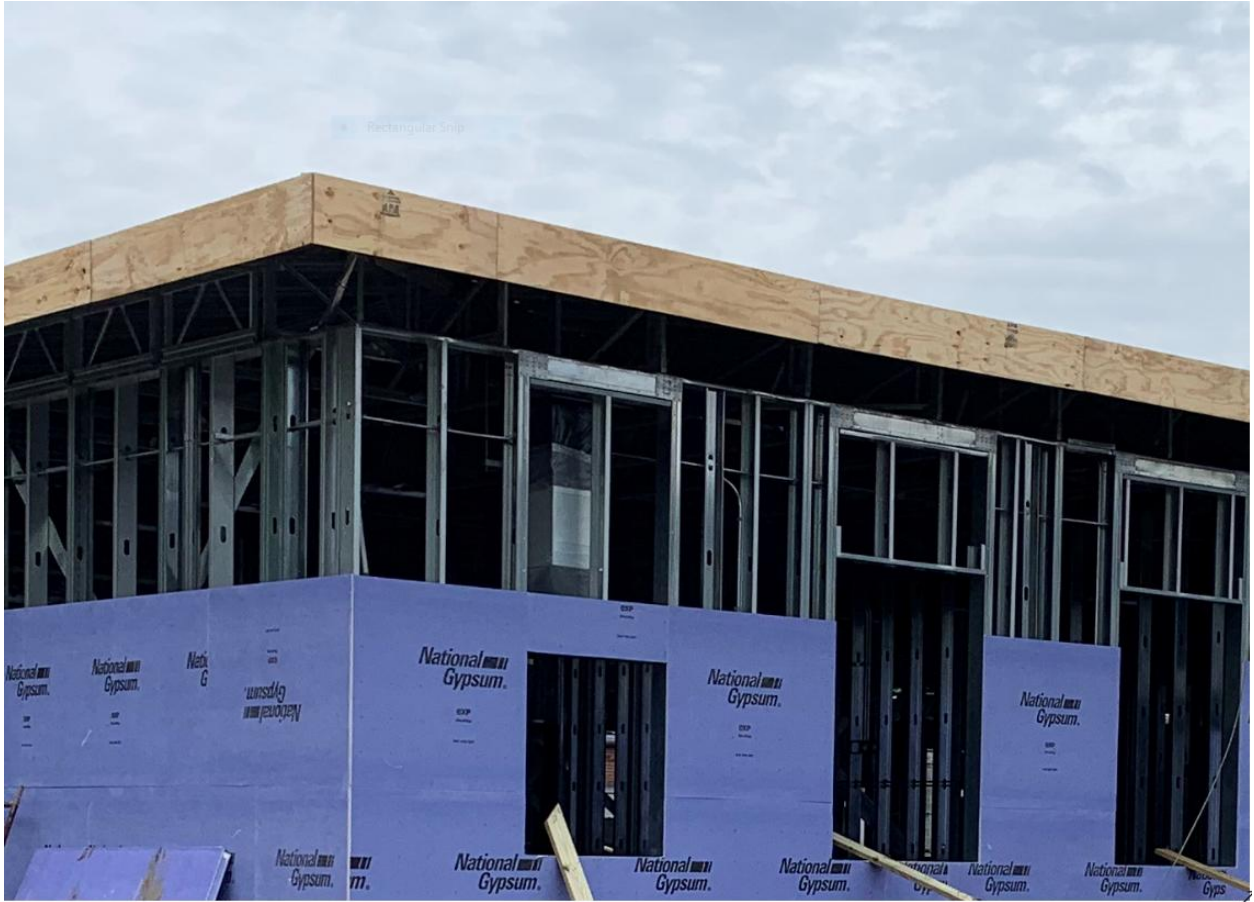
When I looked up this morning I could see considerable change in the appearance of the roof.

Half inch plywood has been added outside the 2 X 6 perimeter. The plywood covers the 2 X 6 pad and comes down to the bottom of the face across the end of the trusses to serve as an attach point for the roof edge covering. The 6" thick insulation will lay inside the 2 X 6 perimeter.

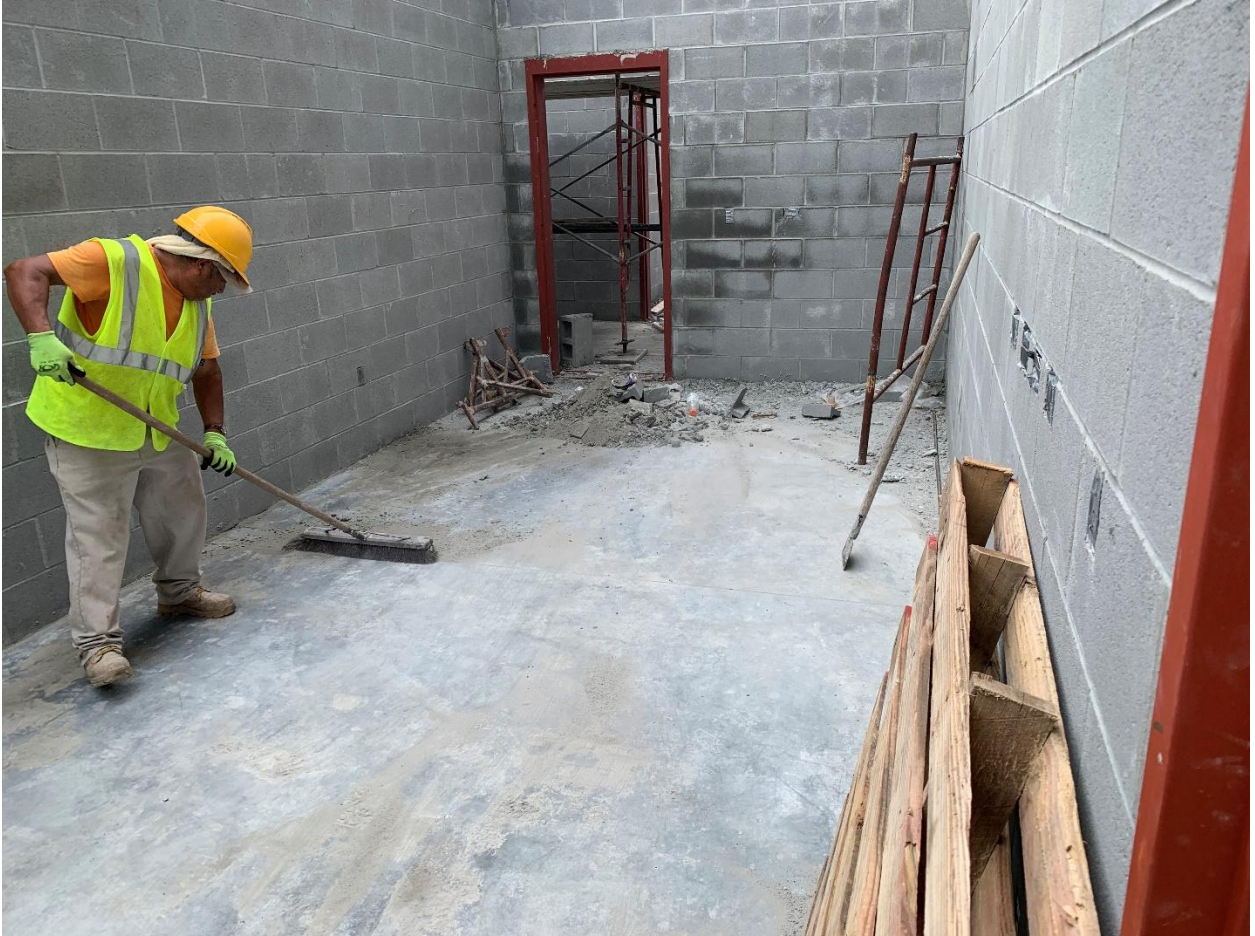
I speak frequently of housekeeping. The following picture is of a worker with the block masons doing housekeeping after they finished laying the block. This is part of taking pride in doing a good job.

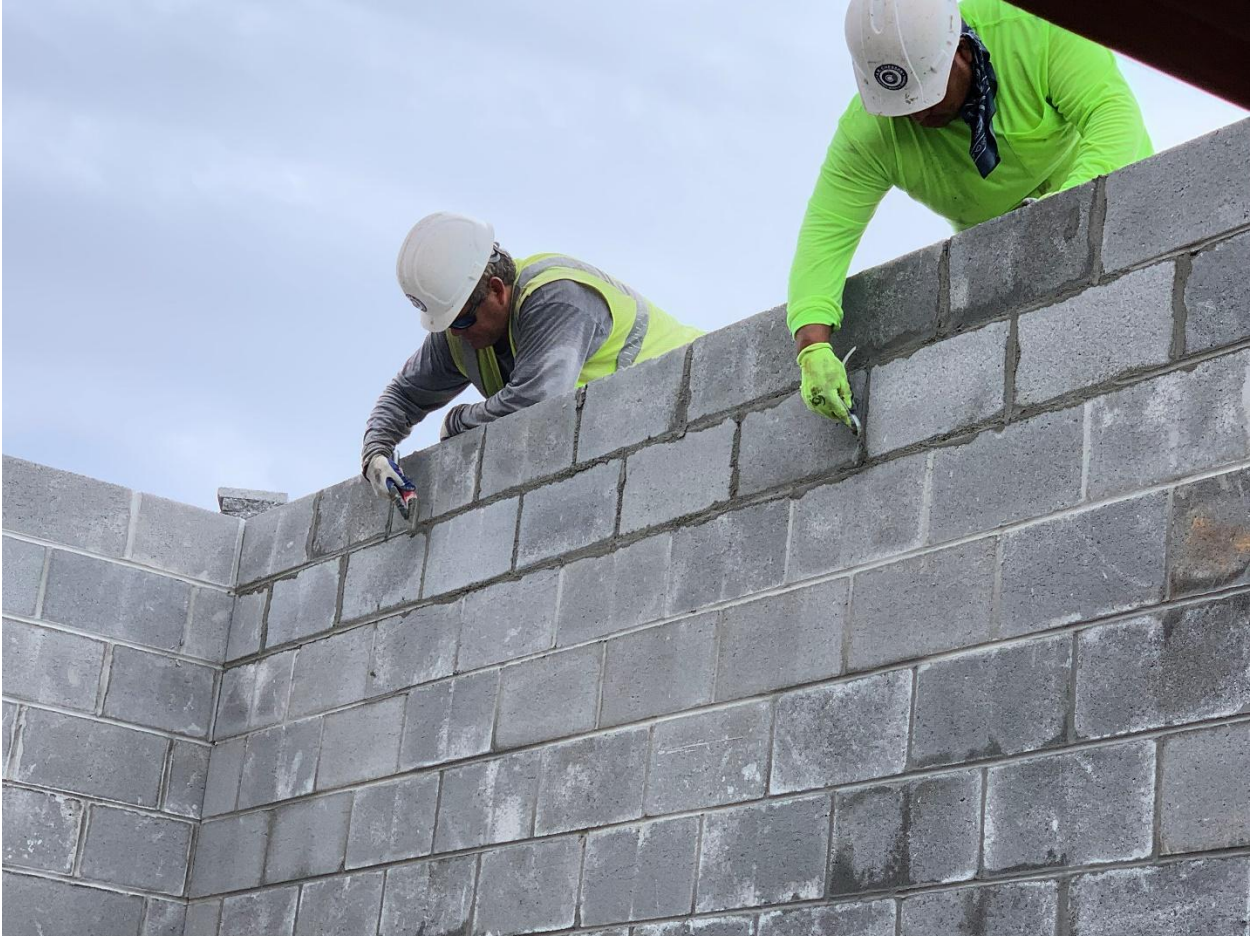
The next picture is of two workmen tooling the joints on the last two rows of block at the back of the locker rooms behind the gym. Brick will be laid on the side of the wall they are standing on. They are working from that side because it is easier to install the staging outside the wall. I did notice at least one of the workmen had a small amount of mortar in their free hand to fill in wherever it might be needed.
