Central Middle School

Week of October 4, 2019

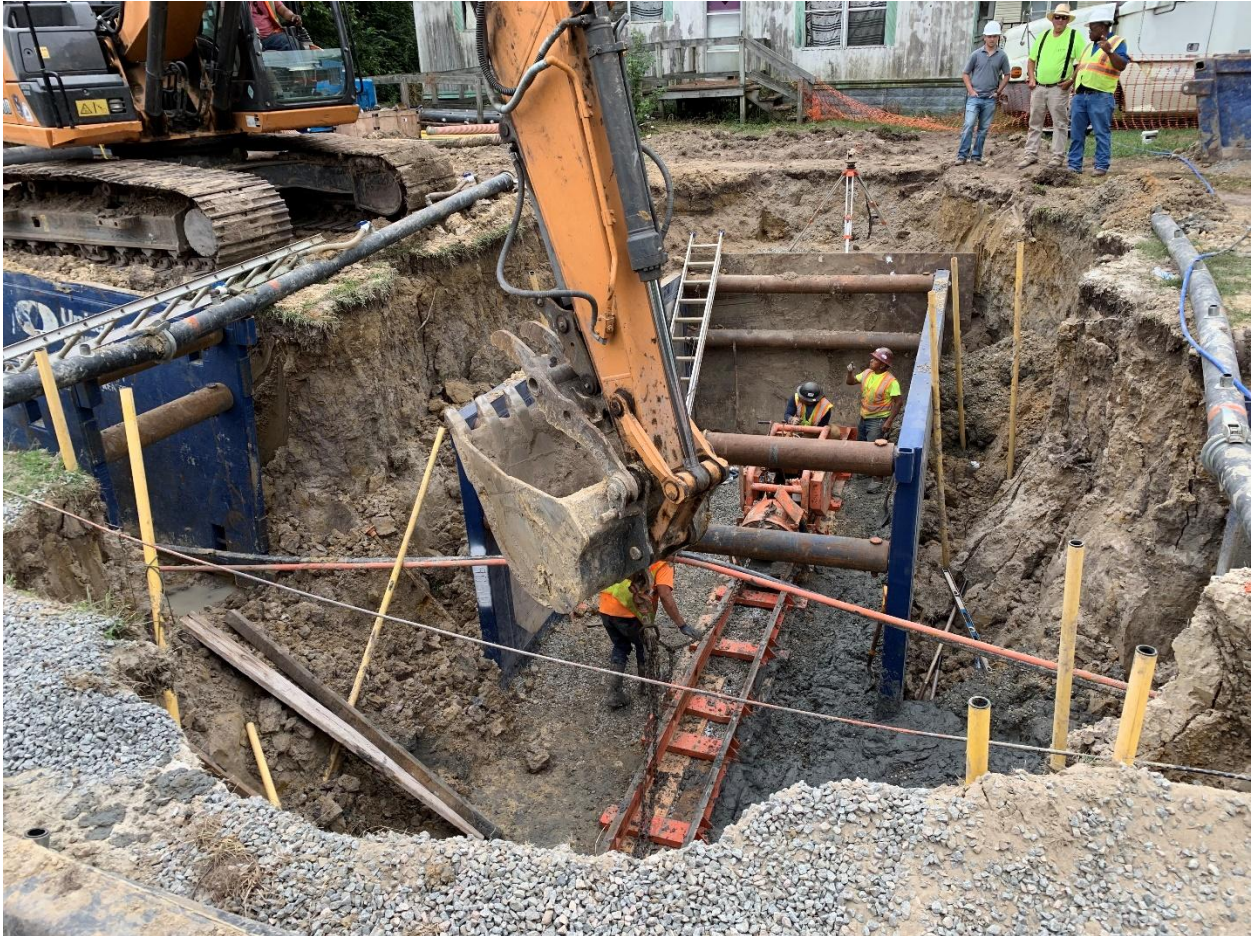
I arrived on the job around 4 pm. The twenty four inch steel casing had been jacked under the road and the drill to cut a hole through the concrete manhole on the north side of the roadway was in the casing and ready to start drilling through the approximately 5 inch thick wall of the concrete manhole. I asked an old man who appeared to have done this many times before how long the operation should take and he indicated thirty minutes.

Standing over the manhole on the north side of the highway, I could hear the drill working on the manhole and could feel the high torque areas with my feet in that same area.

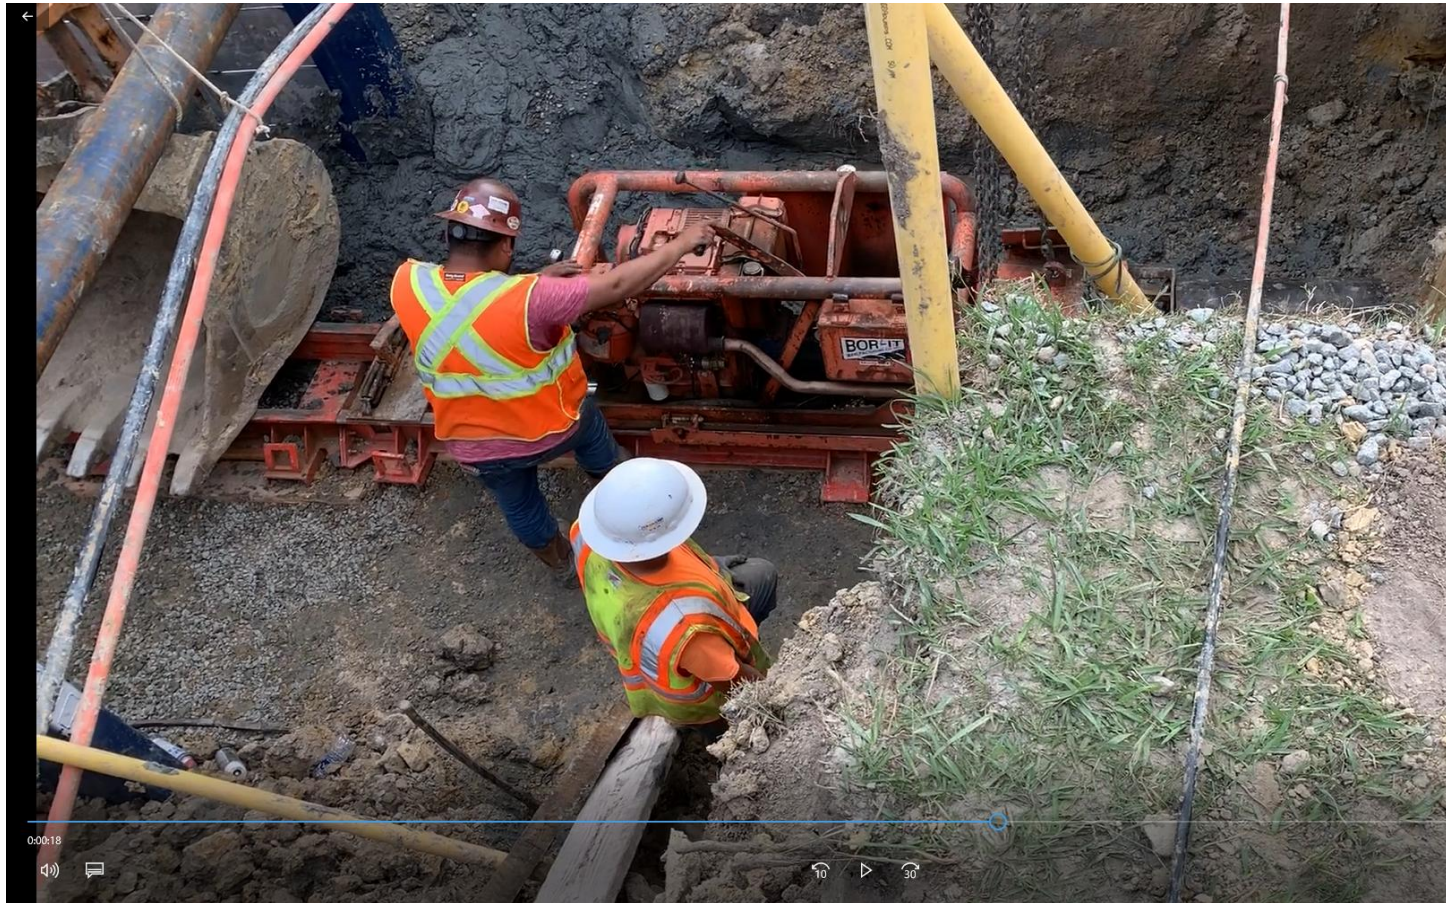
I went from side to side of the road looking and learning. The next photo is looking down at the machine located at the end of the twenty-four inch casing. The drill point is turning at the other side of the road cutting an 8-inch hole through the concrete manhole. Notice to the left side of the picture an excavator bucket is resting on the track for the boring machine. The bucket is on the track to keep the pressure on the drill from simply pushing the track and machine backwards. If you look closely just in front of the operator's right you can see something shining. That shine is the chrome shaft on the hydraulic cylinder pushing the drill. That cylinder shaft looked to be about 4-inch diameter. A little calculating tells me that machine can put roughly 880,000 pounds of pressure on

the drill. No wonder I could feel the drill working on the other side of the road!

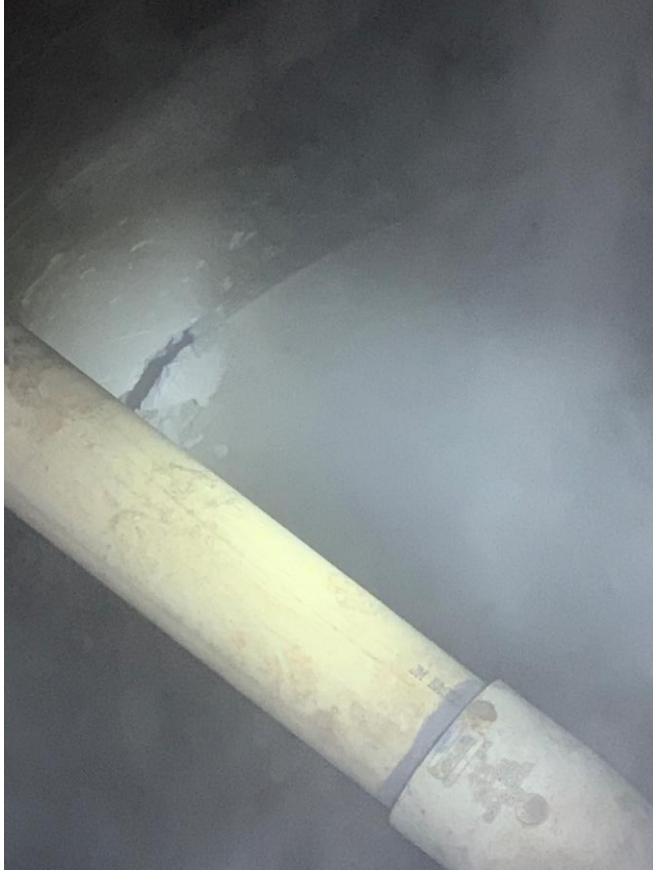
Finally, around 5 pm the drill made it through the manhole. The edge of the hole is visible to the right of the plastic pipe in the next picture.

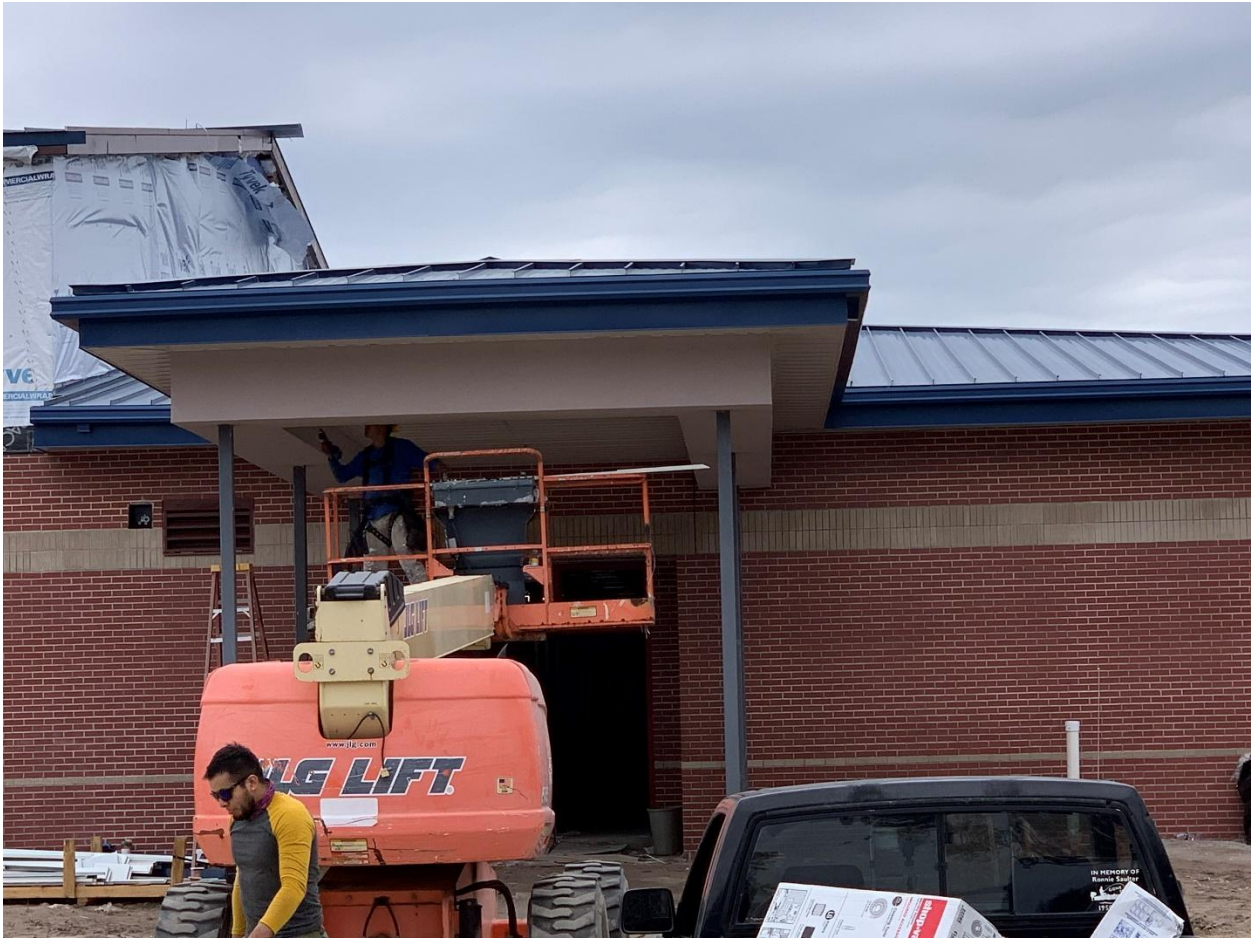
The west entrance is almost complete. The worker on the manlift is installing the ceiling of the canopy.

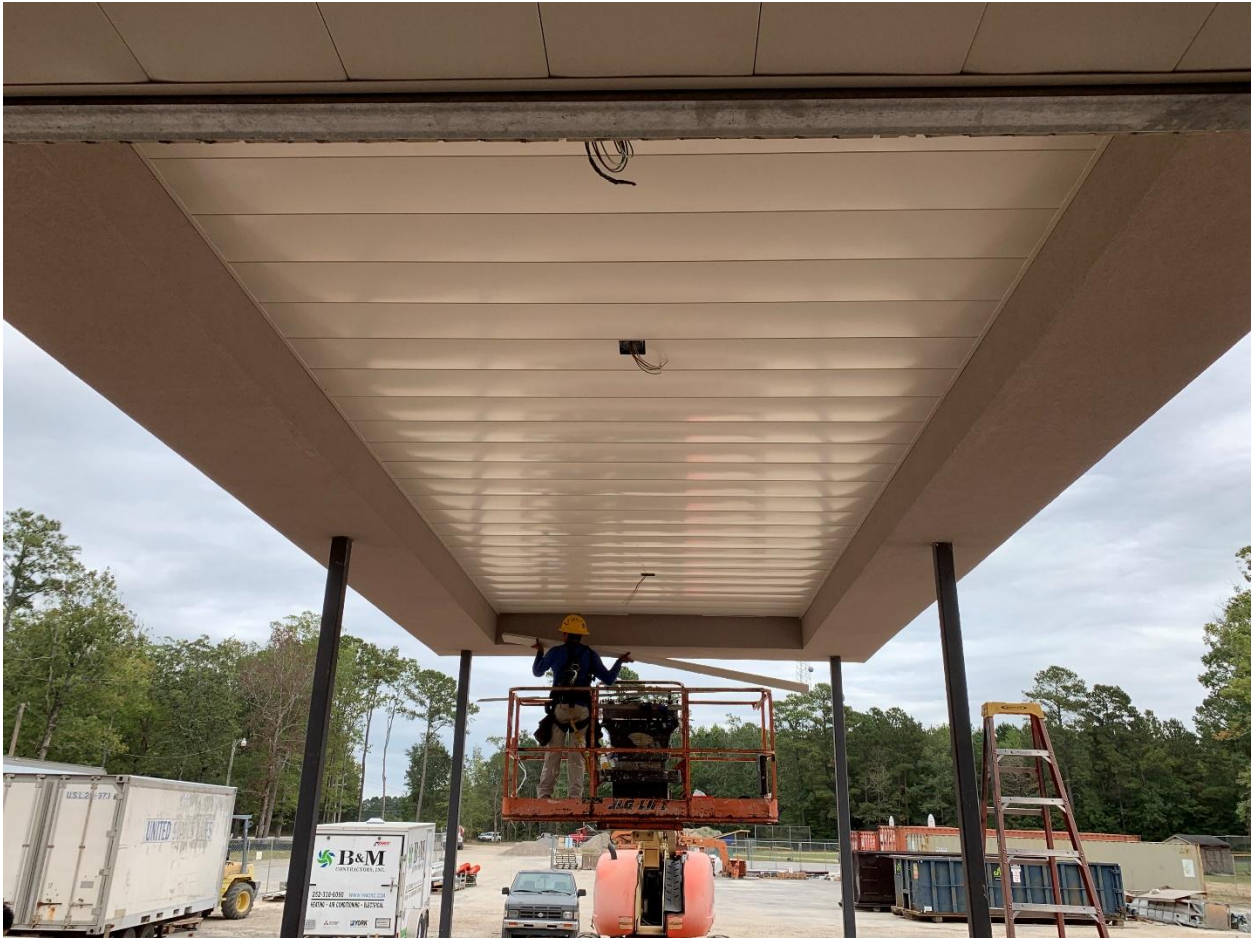
I was there just in time to take a picture of the last piece going into place.

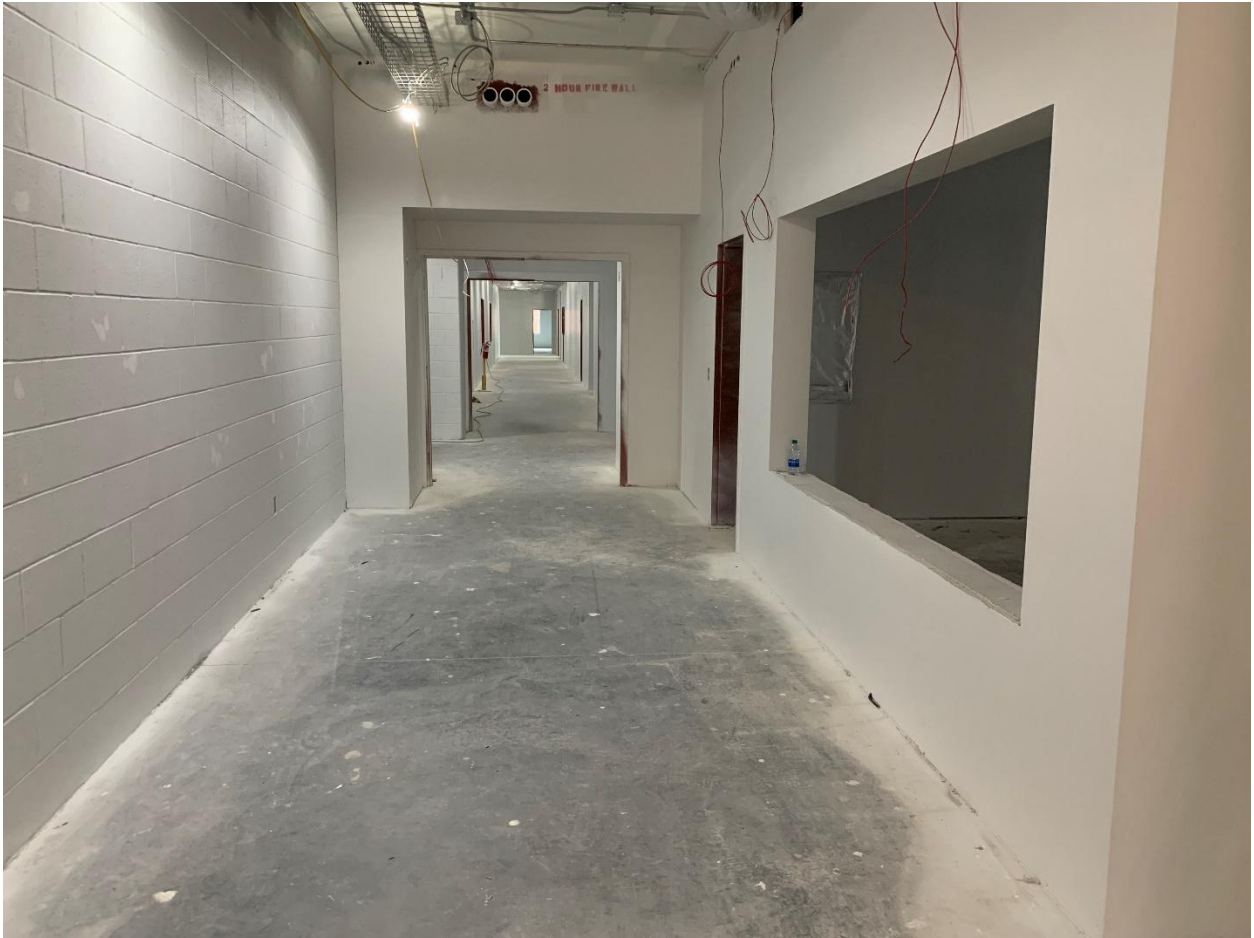
The front hallway is really standing tall. The window opening at the right of the picture is the concession stand window. The room at the far end of the hall is the computer lab on the northwest corner of the eighth grade wing. All the ceiling grid is installed in the administrative area as well as the light fixtures and duct vents.

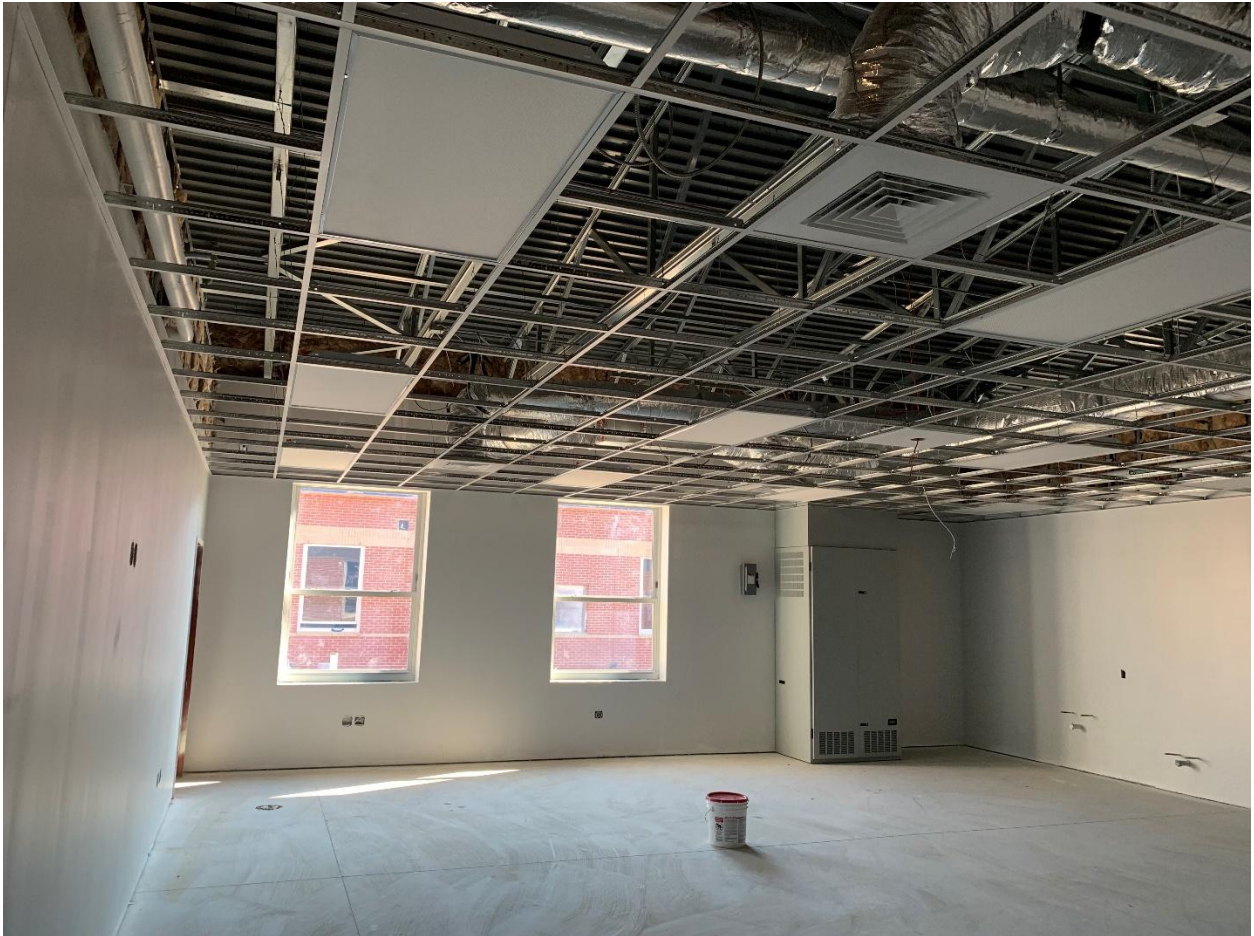
Progress is being made in the classrooms on the west hallway. This classroom is typical of the rest with lights and HVAC grills installed and connected to the duct.

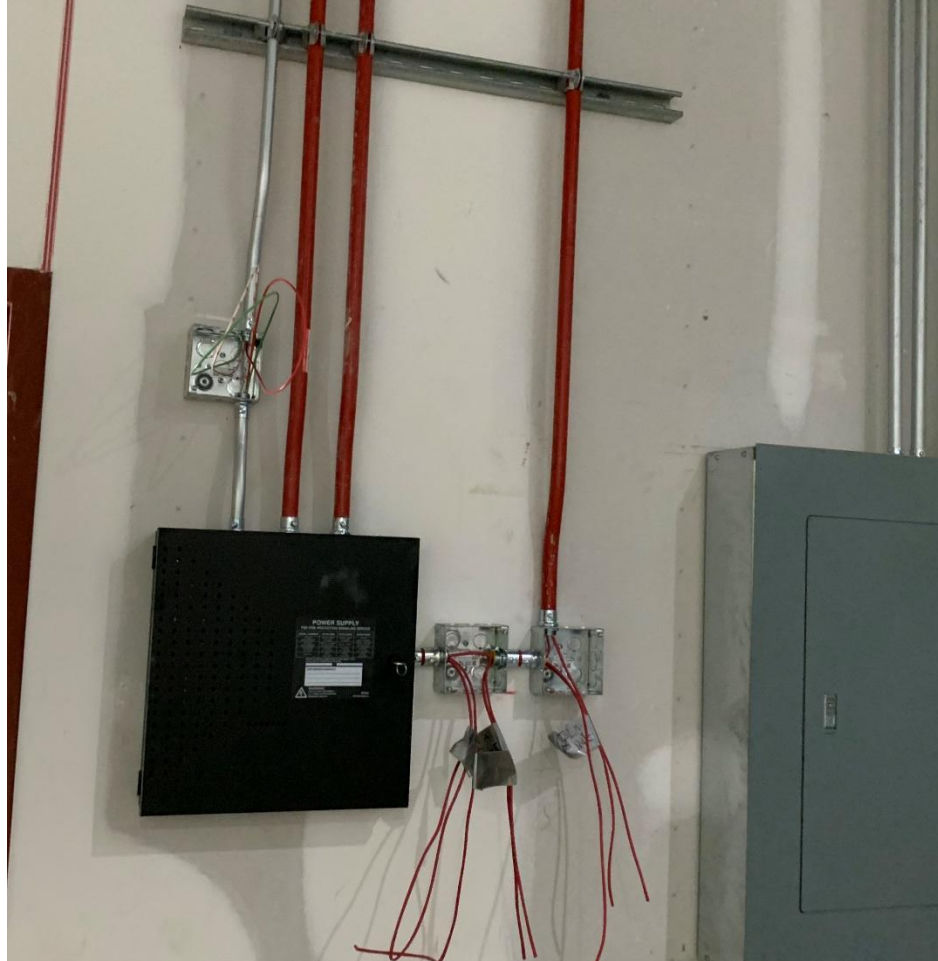
I took a quick look in the electrical room and discovered the fire alarm system. The red conduit and red wiring designate fire system. The fire alarm lets the occupants know a fire is happening and it triggers the closing of dampers on the HVAC duct across the halls to help contain the fire. I am sure other functions happen at the same time but I have not investigated to be sure what those other functions are.

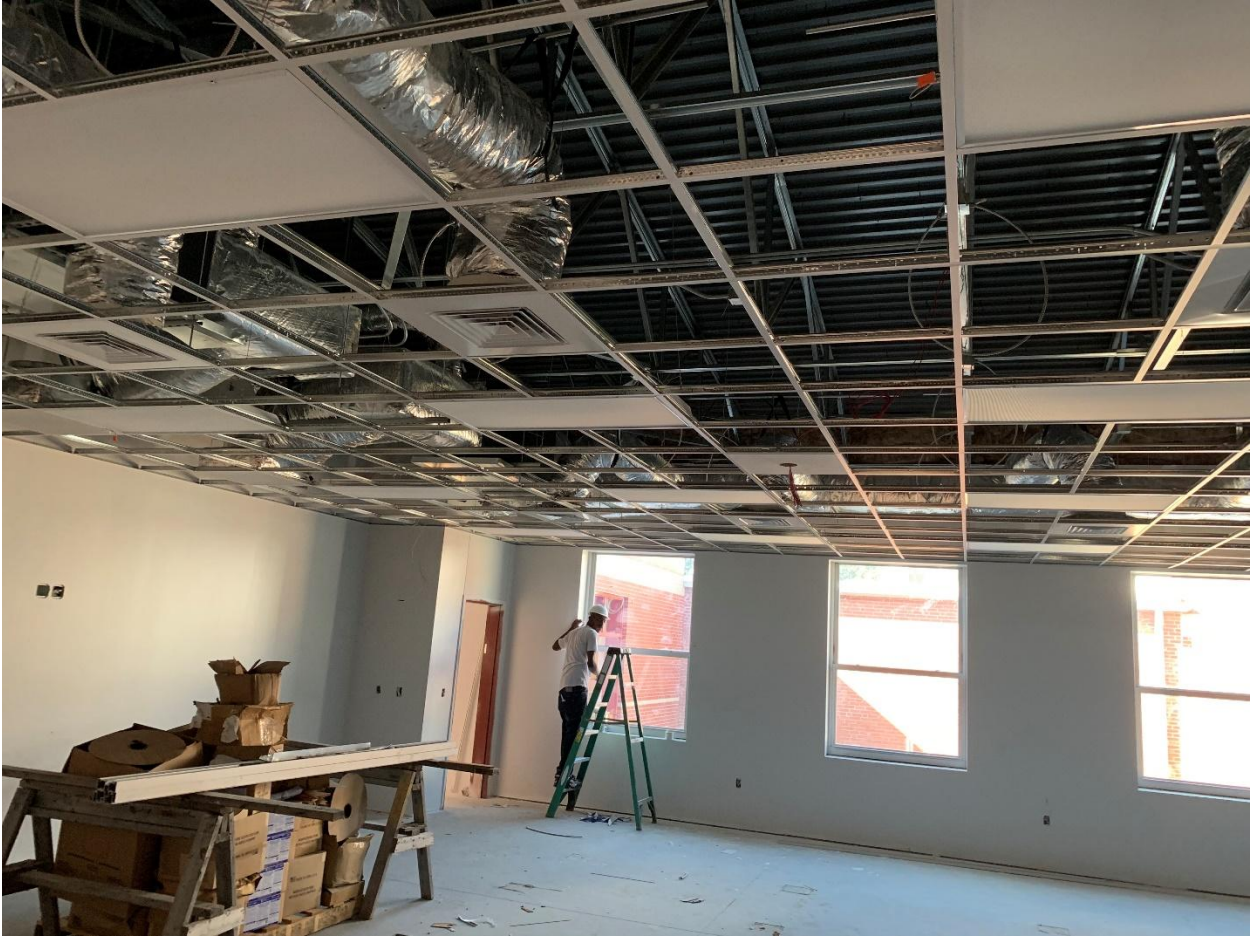
A worker is putting his touch on one of the windows in the computer lab at the northwest corner of the eighth grade wing. Notice the lights and duct grills are in place.

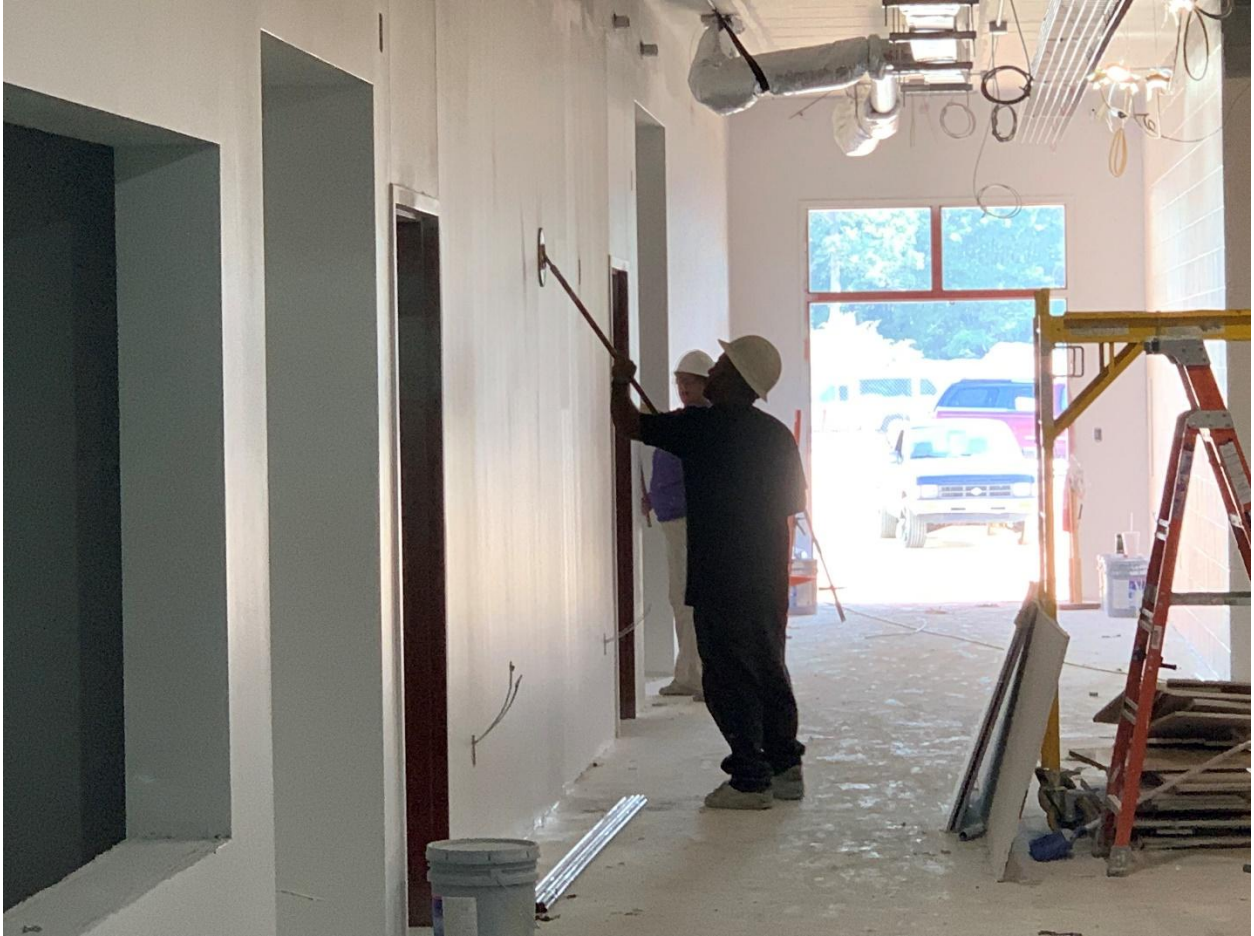
Here workers are sanding the walls between coats of paint in the area between the art room and the band room. I continue to be very impressed with the workmanship of all the crafts.

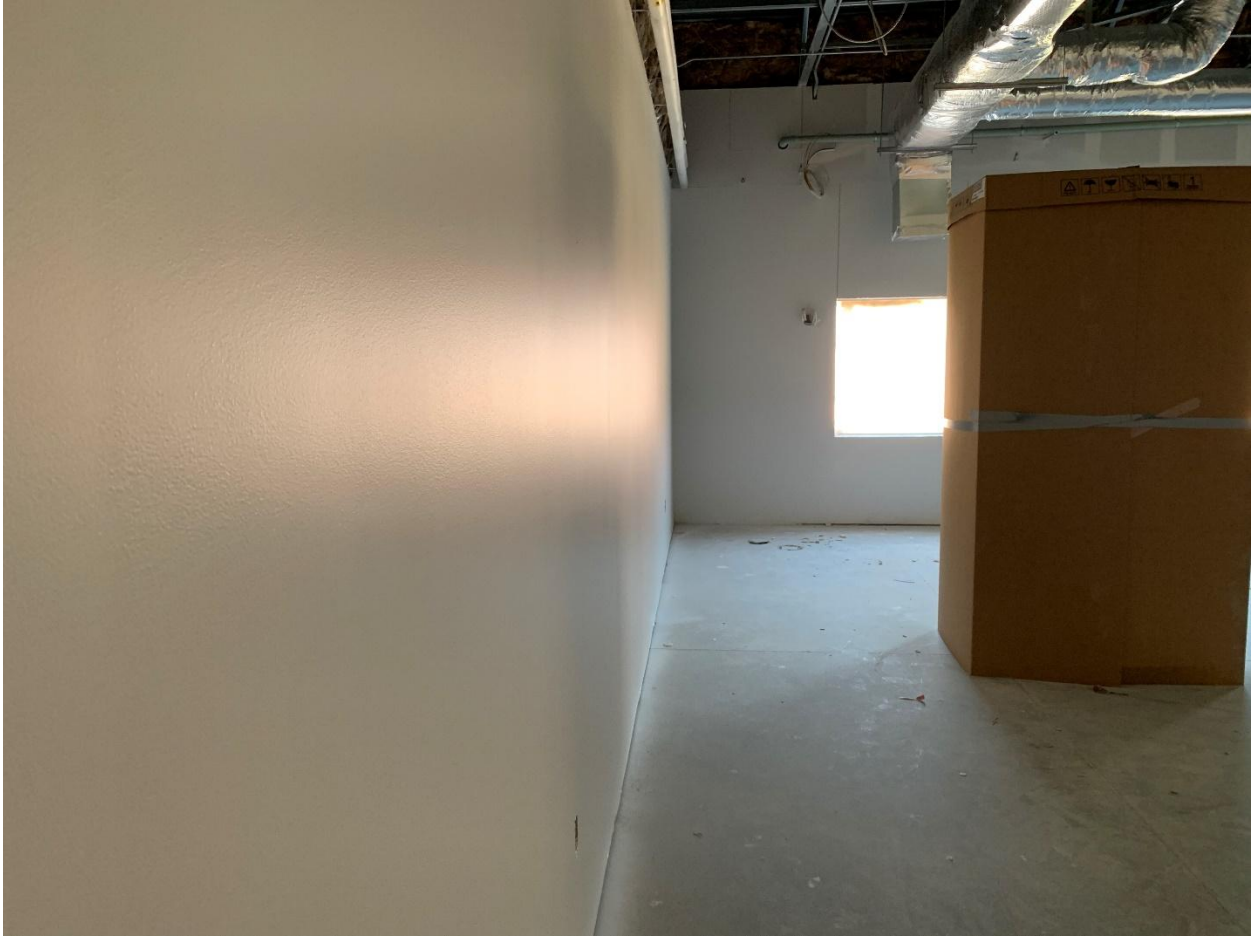
This is the south wall in one of the classrooms. The classrooms have a finish one grade below the halls. That wall looks perfect to me and will look even better when we get the windows in, blinds up and the things teachers tend to put on walls.

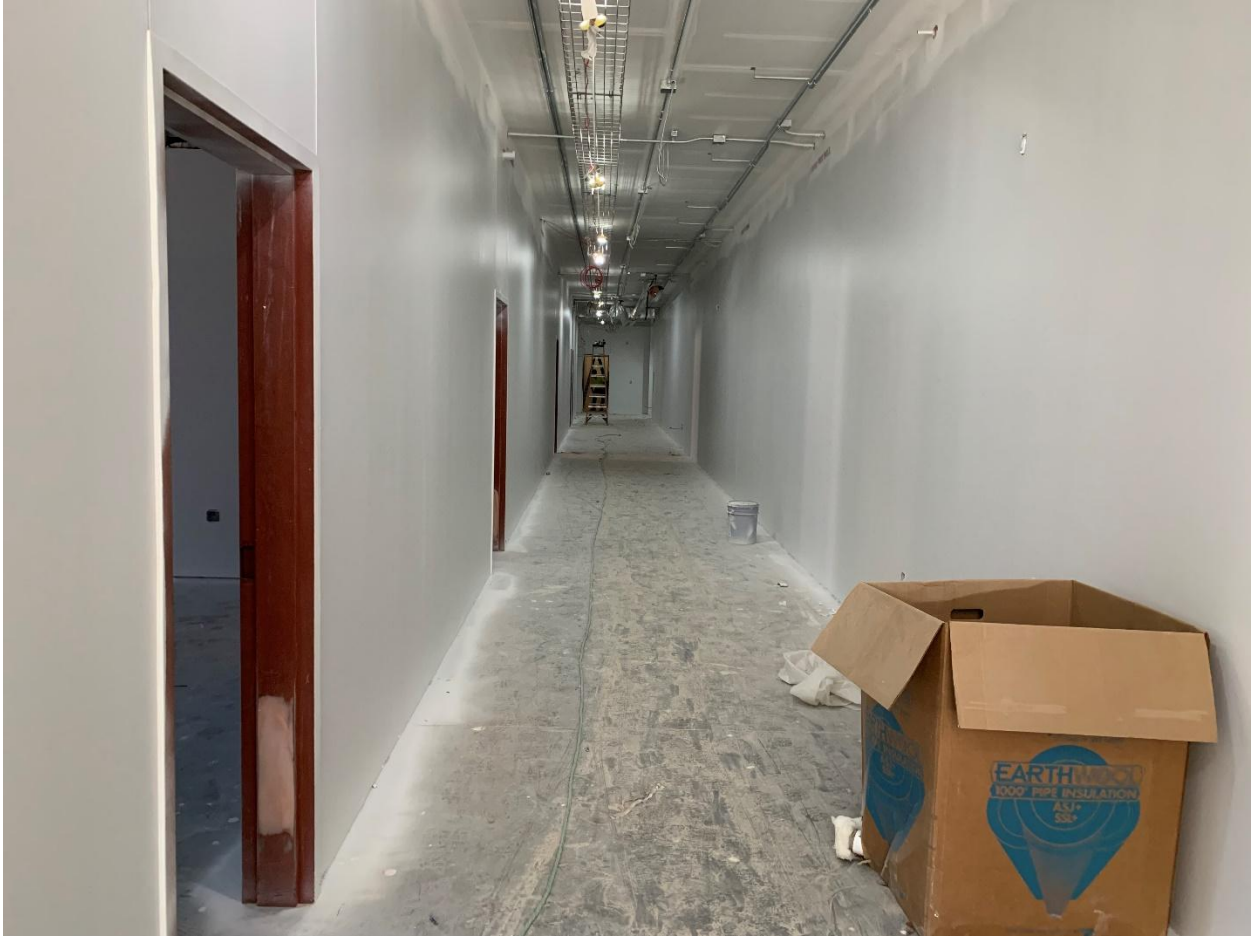
The east hallway looking north looks very nice. As you can see, progress is evident throughout the school including the outside.
