## Central Middle School Week of January 17, 2020

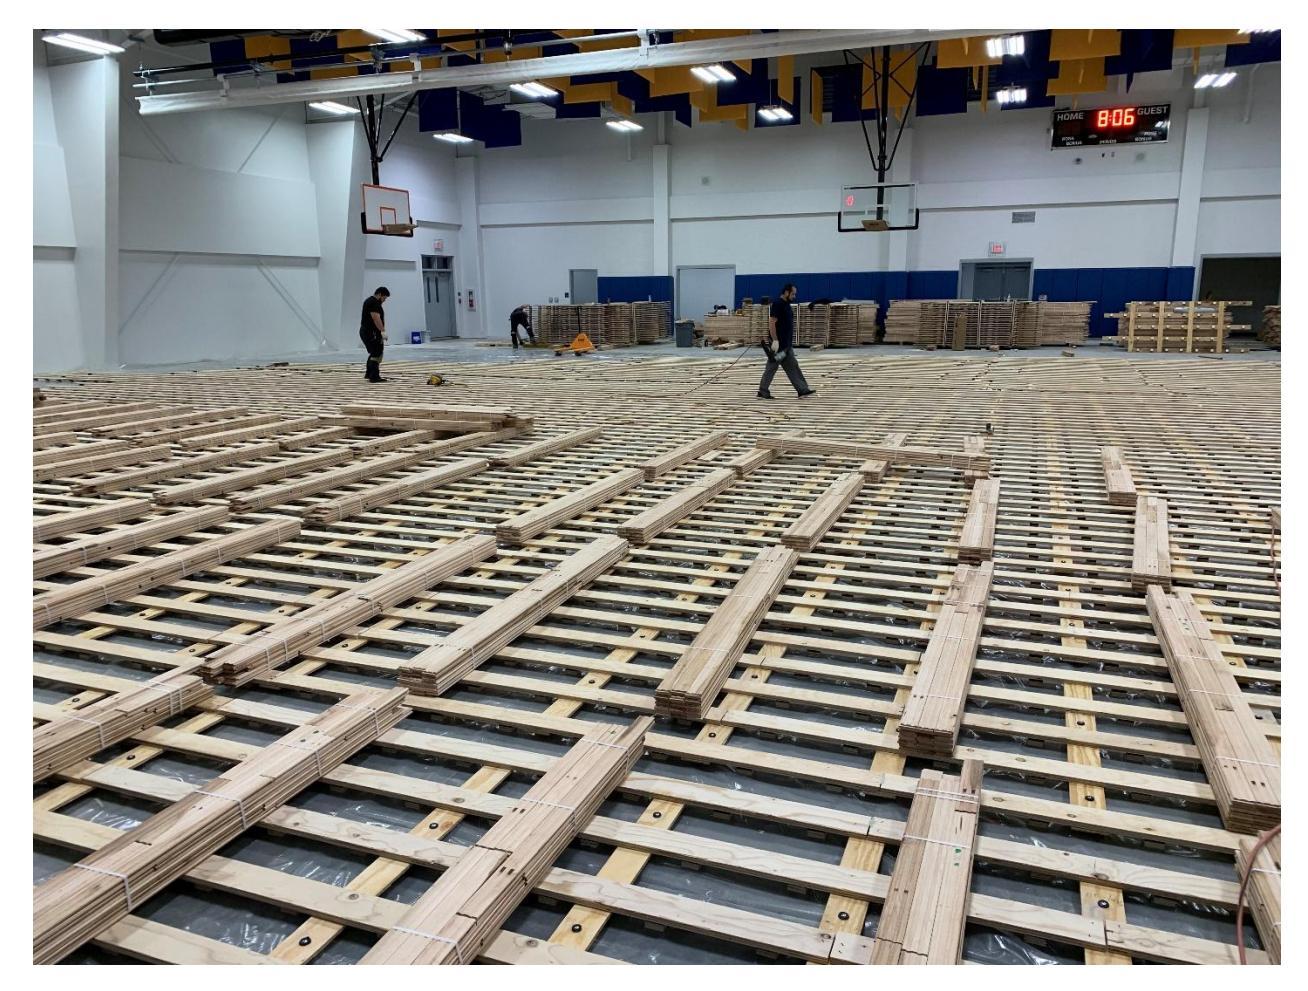
That was 8:05 on Tuesday morning. The floor was covered in plastic, over three fourths of the subfloor was laid in place and half of that bolted to the concrete below and stacks of flooring laid strategically to begin a brief period of acclimation to the atmosphere in the gym. Keep in mind the ground was covered in heavy plastic before the concrete was poured. We have double moisture protection.

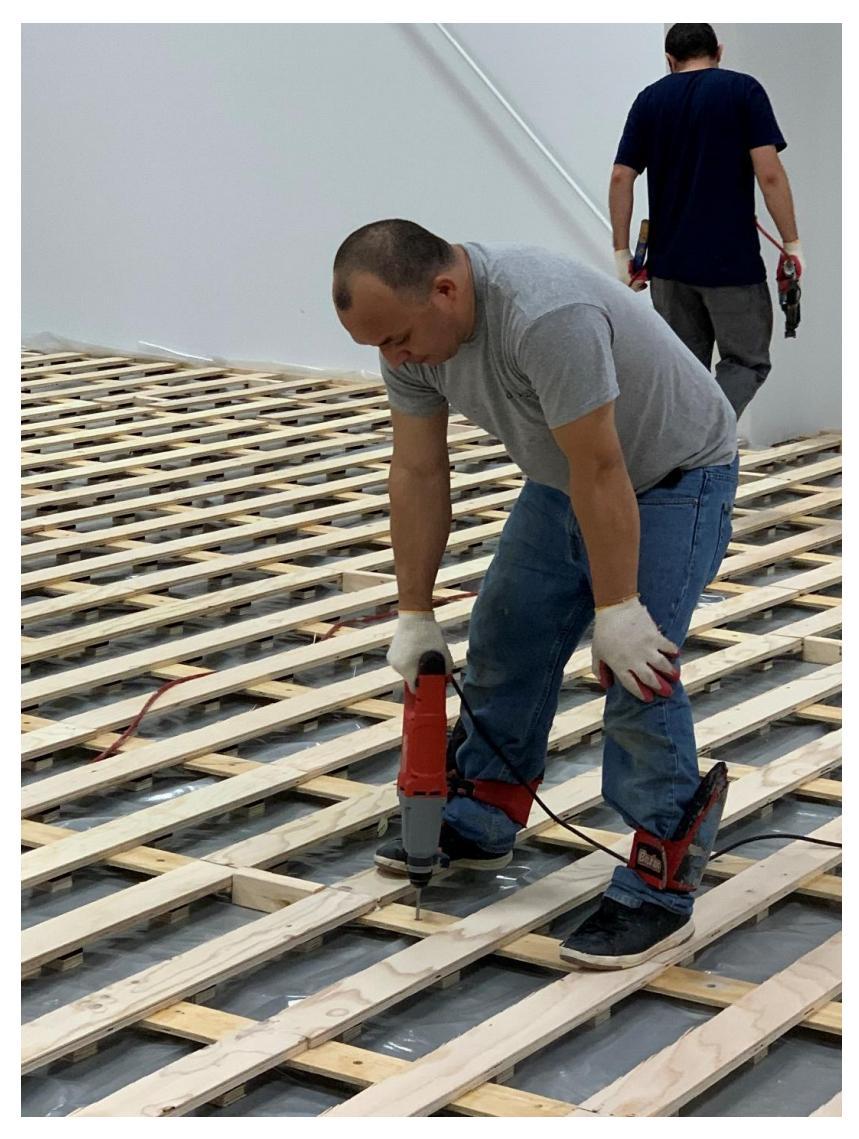
I took a close up shot of the floor to help you understand what is taking place. This is at the south entrance. I am going to try to explain how this puzzle fits together. I did not take close up of some of the things I am going to describe because I failed to even notice them until I started writing this newsletter and thought back to what I had noticed in my walkthrough this morning. All the wood below the actual floorboard is plywood. The strips with the "bolts" are not touching the concrete. Beneath the approximately four inch wide plywood above the "bolted" strips there are two blocks between each of the "bolted" boards that actually support the floor. They appear to be ¼" to ½" thicker than the "bolted" board. This morning I saw a box of the bolts. They have no threads but just a crook that is just a hump. (Think of the profile of a pregnant woman) The bolt is driven down with a roto-hammer that looks like a drill. The head of the bolt fits in the head of the hammer and has a rubber washer under the head. If you look closely you can see the spacer blocks under the boards the worker is standing on.

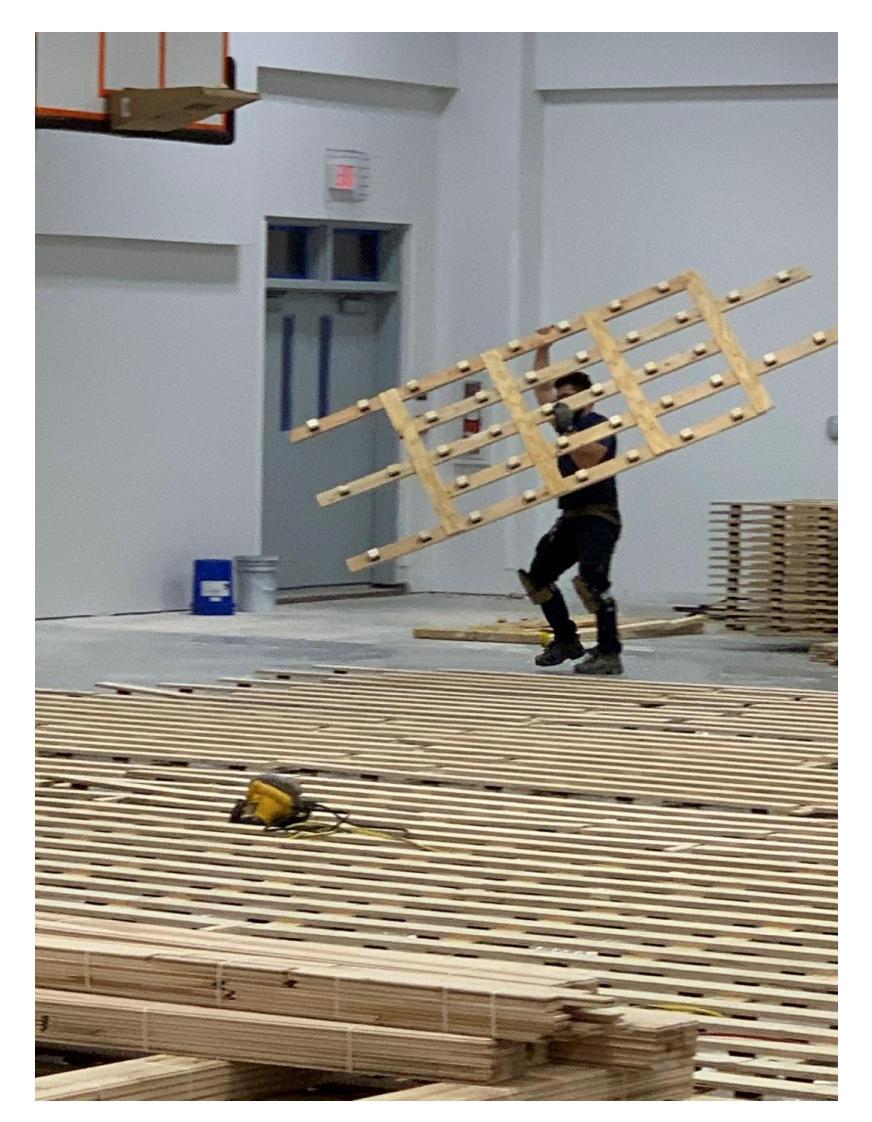
I had one of those AHHHAA moments when I pulled up the next picture. The blocks I have been talking about are attached to the back of the boards before they are laid down. The worker in the next picture is dropping panels into position for them to be nailed together and attached to the floor. The blocks are plainly visible on the bottom of the frame. I simply didn't notice them when I took the picture. My excuse is that I zoomed to take the picture and rushed to take it while the frame was in the air.

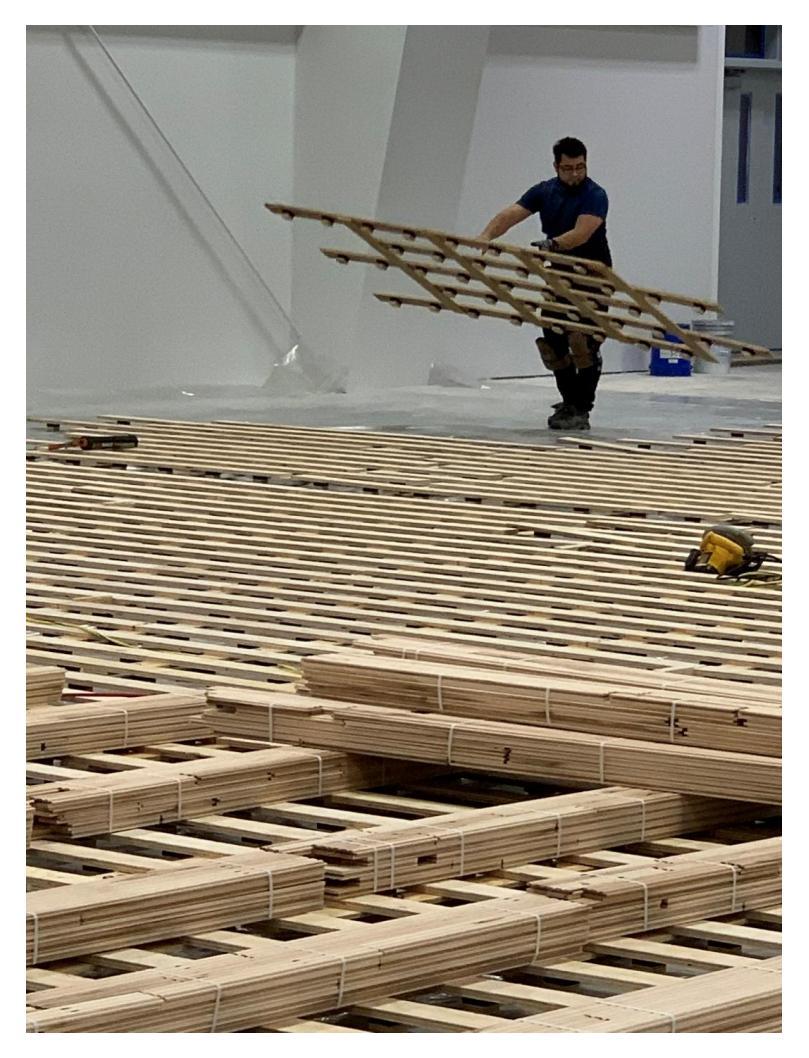
The frame is pretty much, thrown into place. I imagine this man can throw with great accuracy after throwing as many panels as he has thrown. Notice the panels are made to lap each other and tie together into a single unit.

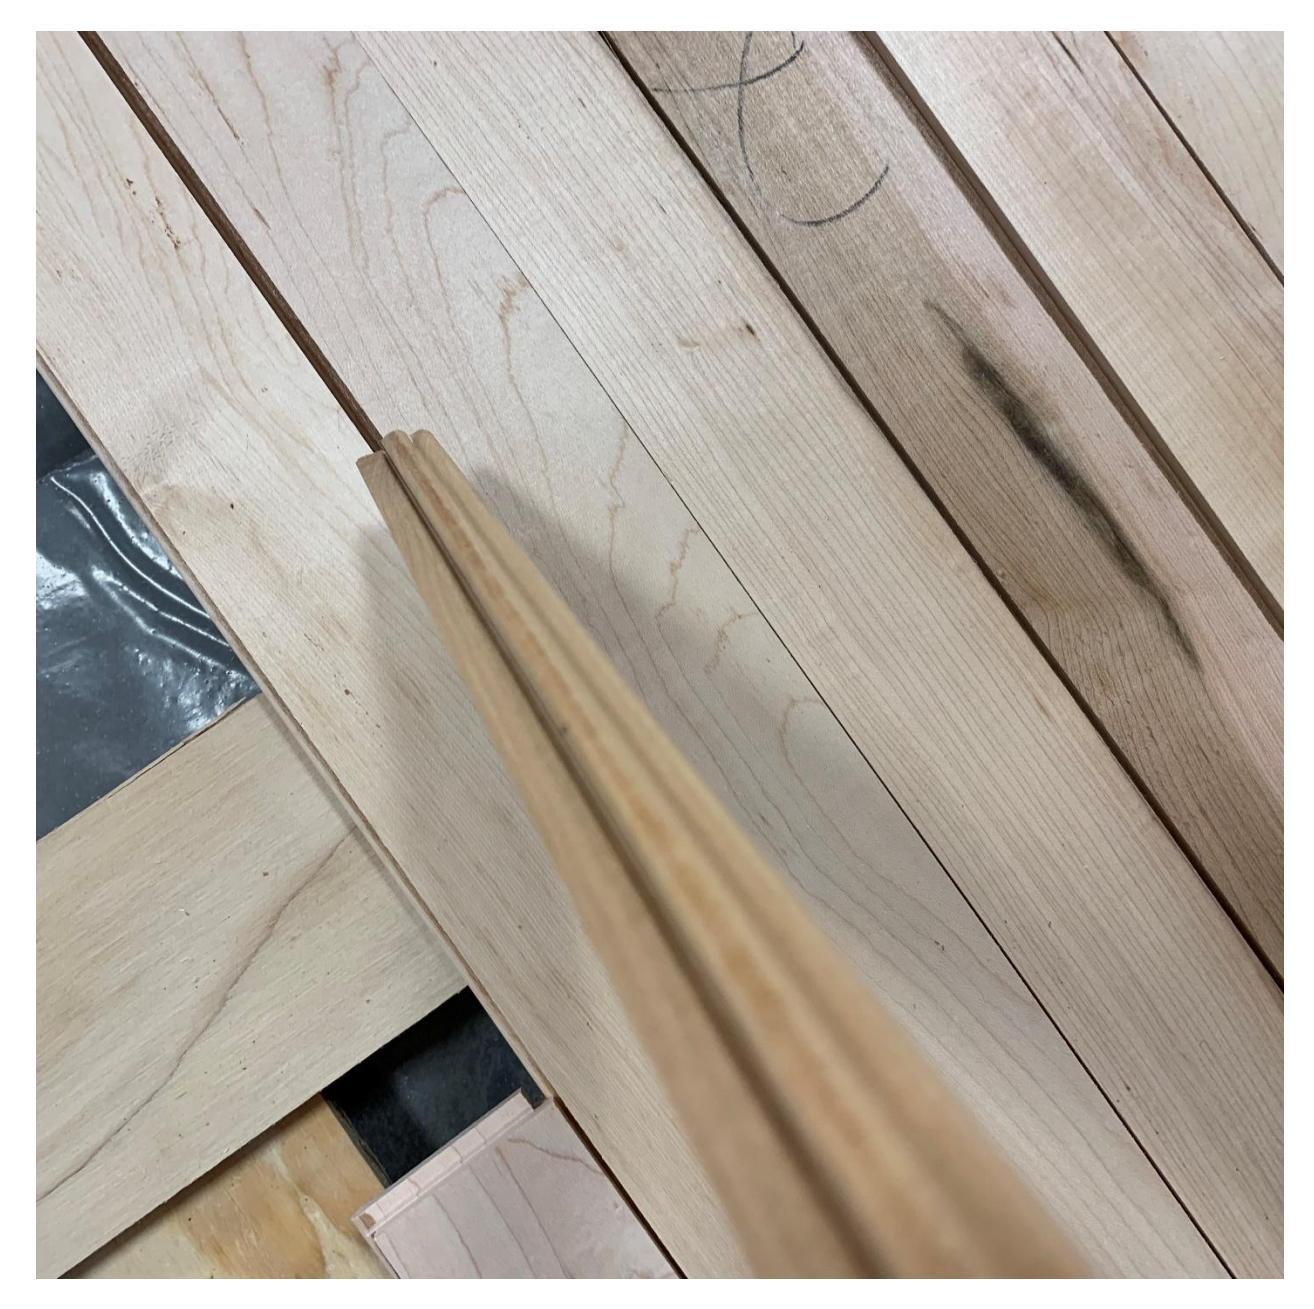
After the panels are nailed together and attached to the floor the maple flooring is sorted and laid out loosely assembled just to get the floor material in place for attachment to the subfloor. The boards are tongue and groove including on the ends. The tongue and groove makes the floor much stronger than nailing it together and maintains a level surface on all the joints. This is the tongue side of a board.

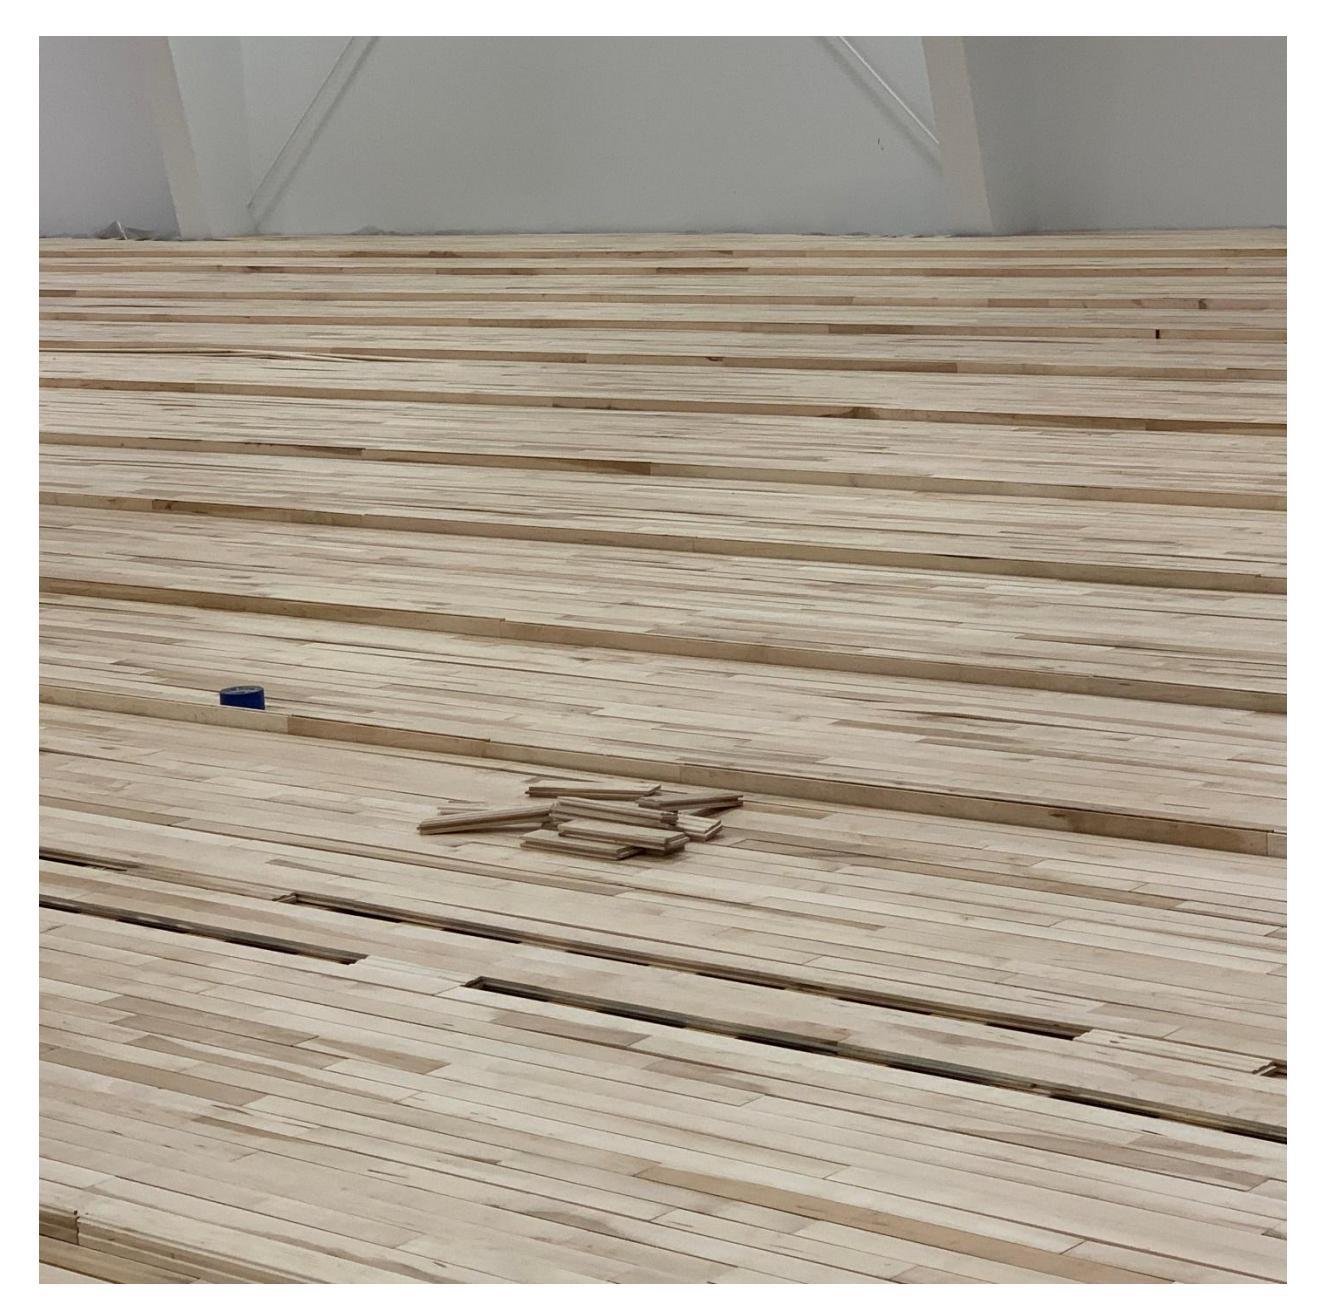
The boards are laid out so no two end joints are adjacent to each other. About every three feet a row of boards is placed on edge to allow for enough material to be laid out because the material will cover less area when the joints are tightened. I had to ask about that one!

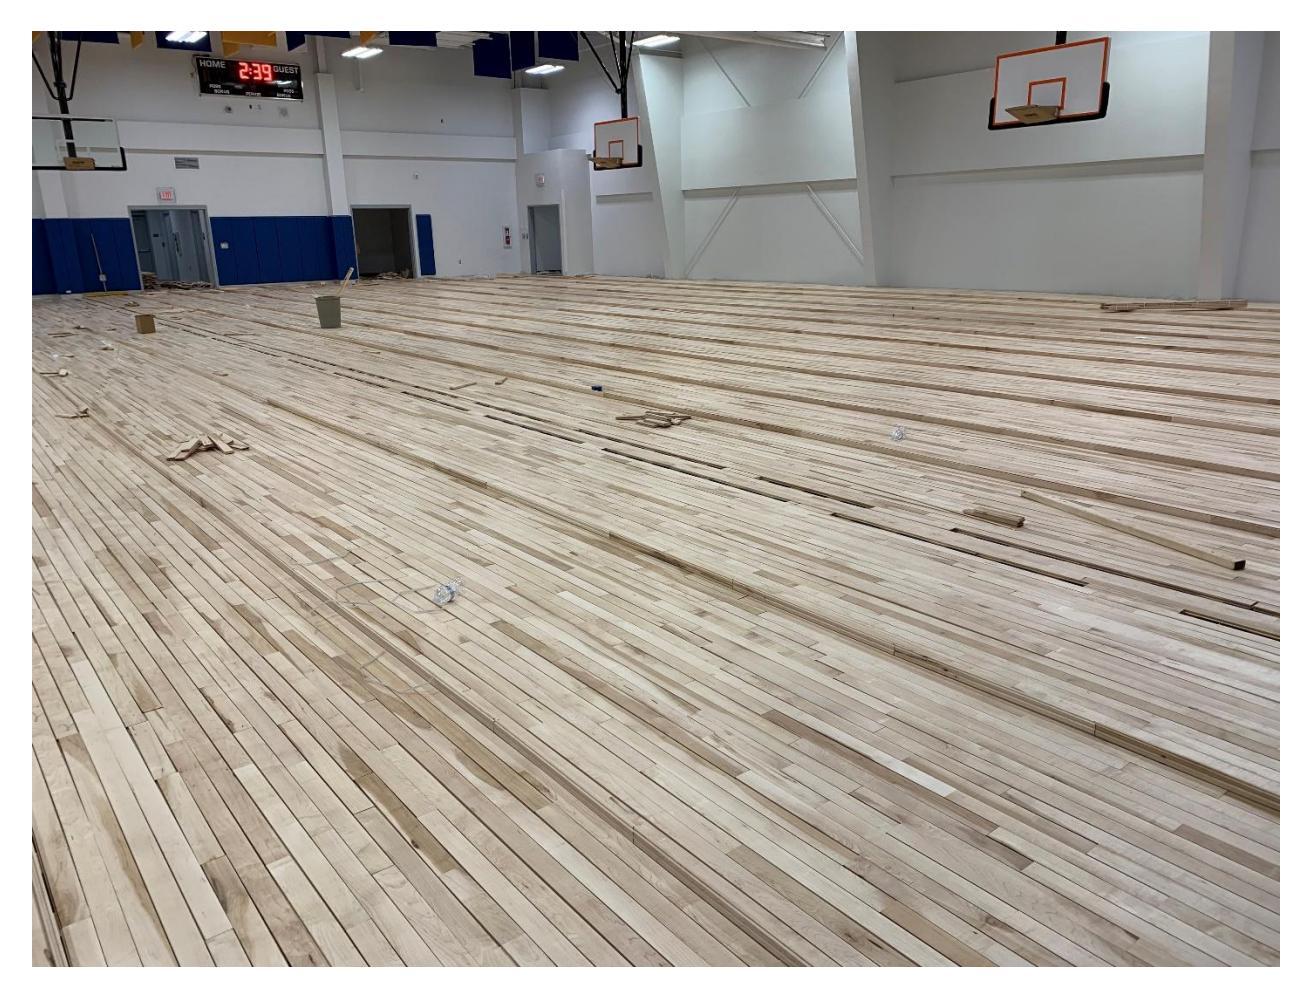
The west side of the gym with the flooring laid out and ready to be nailed to the subfloor. Picture taken at 2:39 on Wednesday afternoon.

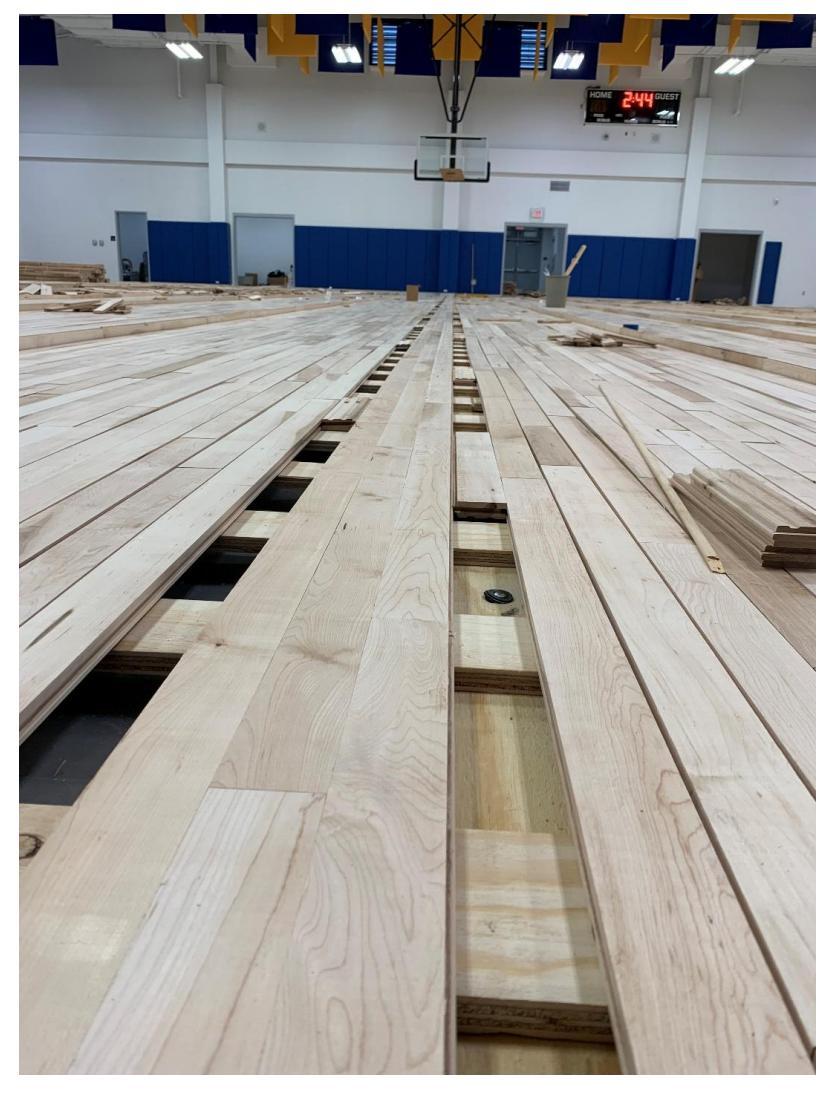
The floor starts in the center of the gym before the rest of the floor is placed down. Three boards are nailed to the subfloor to establish the very straight starting point for the rest of the floor.

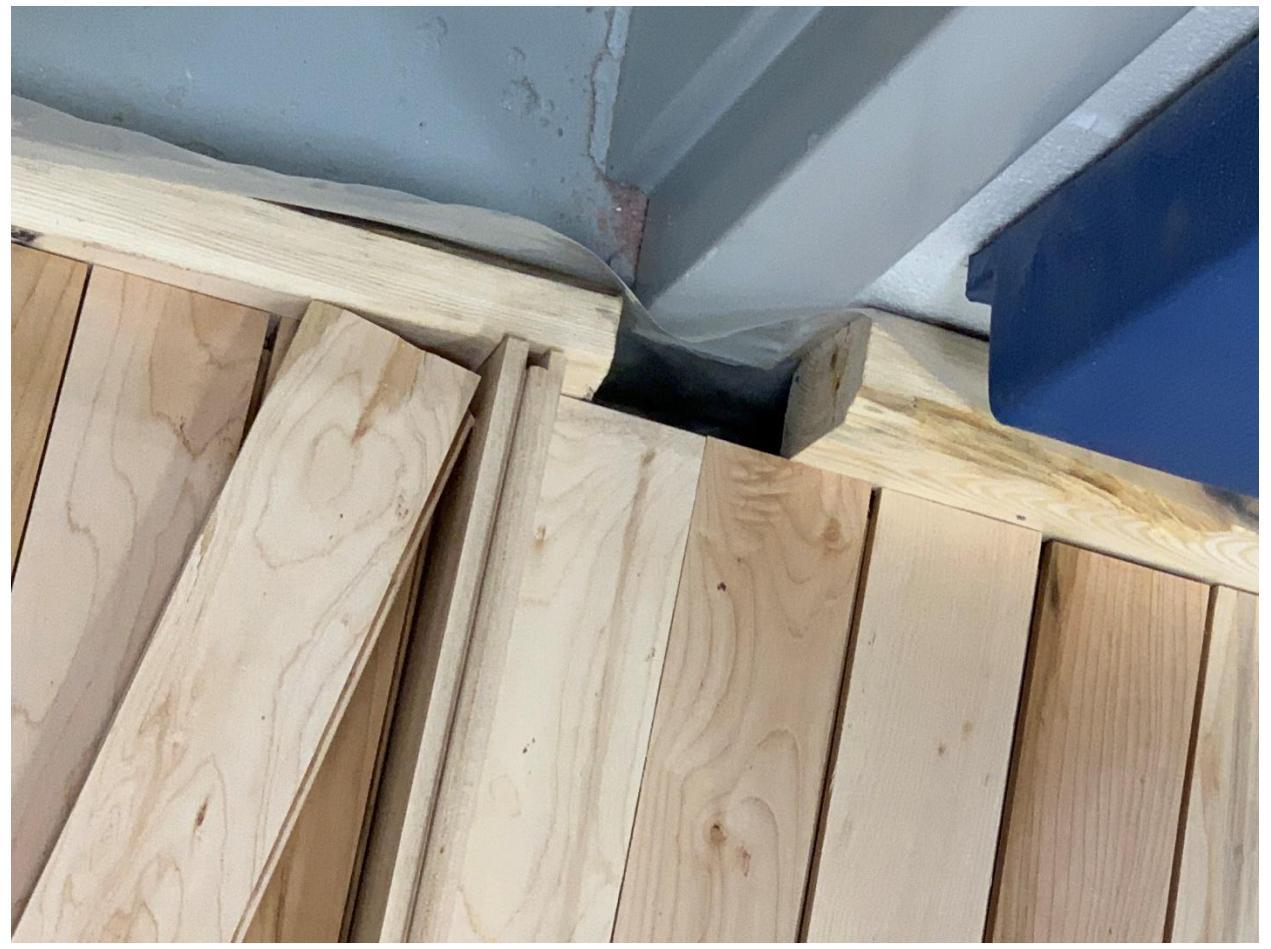
One and one-half inch spacers are placed around the floor for the installation process. The spacers are removed after the floor is nailed to the subfloor. The space is for the floor to expand and contract due to temperature and humidity

## variations.

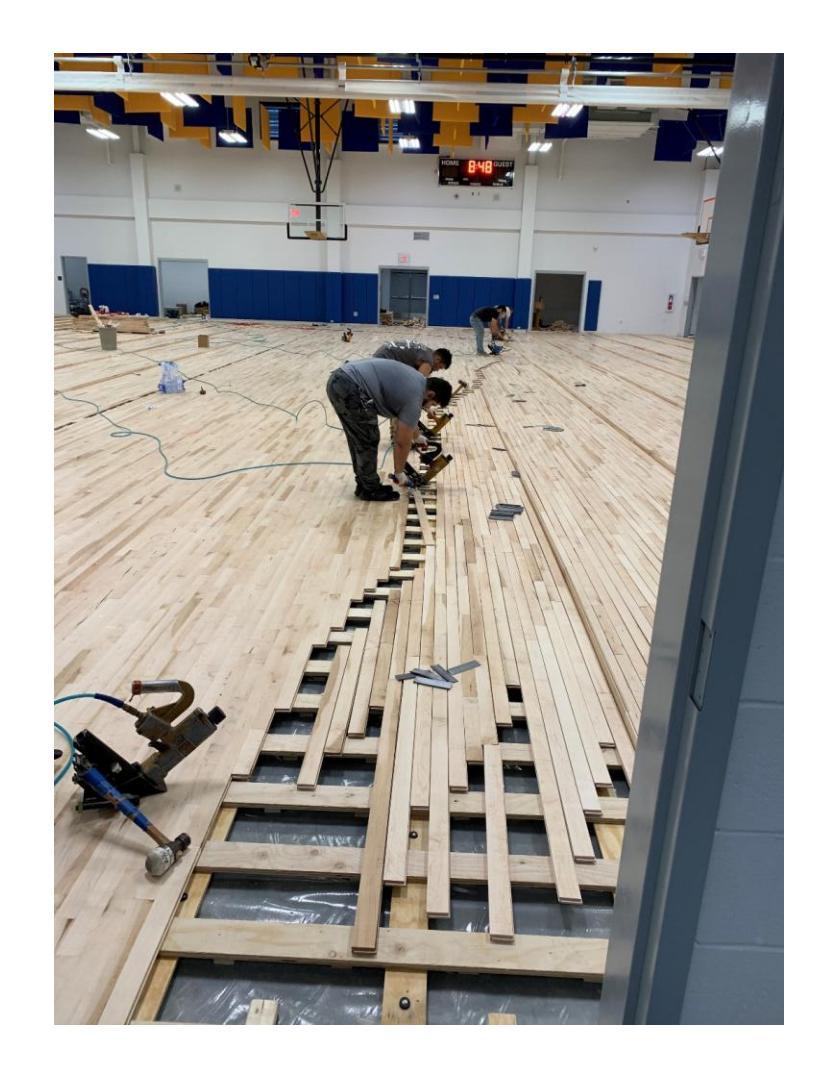
Workers nail the floor with air nailers. Most of the boards are moved with the soft hammer such as the one in the foreground of this picture. The run of boards starts at the spacer at the far end (south) of the gym with the end of the floor board touching the spacer block. When the run gets to the north end of the gym each board has to be cut to fit to the end spacer. The workers tap the board into place with the soft hammer then place the nail gun at the edge of the tongue side of the board centered over a subfloor member and hit the top of the air nailer causing it to drive a nail through the edge of the tongue and into the subfloor. It is truly amazing to see how quickly and accurately these workers go down a board driving nails.

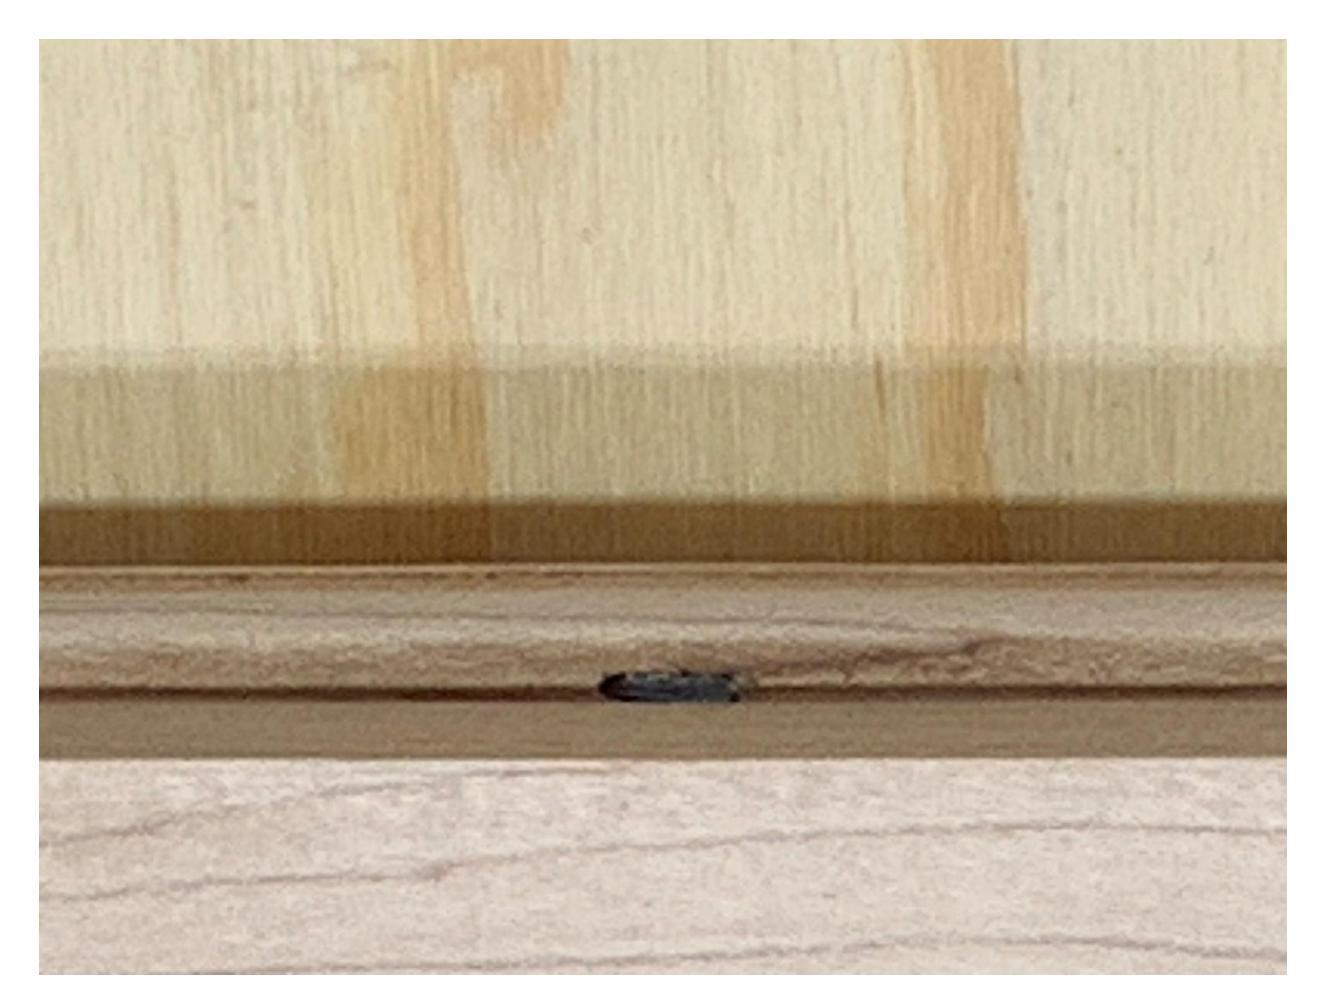
I took a picture of a nail in the edge of the tongue. The floor board is at the bottom of the picture with the grain running left and right while the subfloor is at the top with the grain running up and down. The nail is in the center of the picture. You would not notice it if you weren't looking for it.

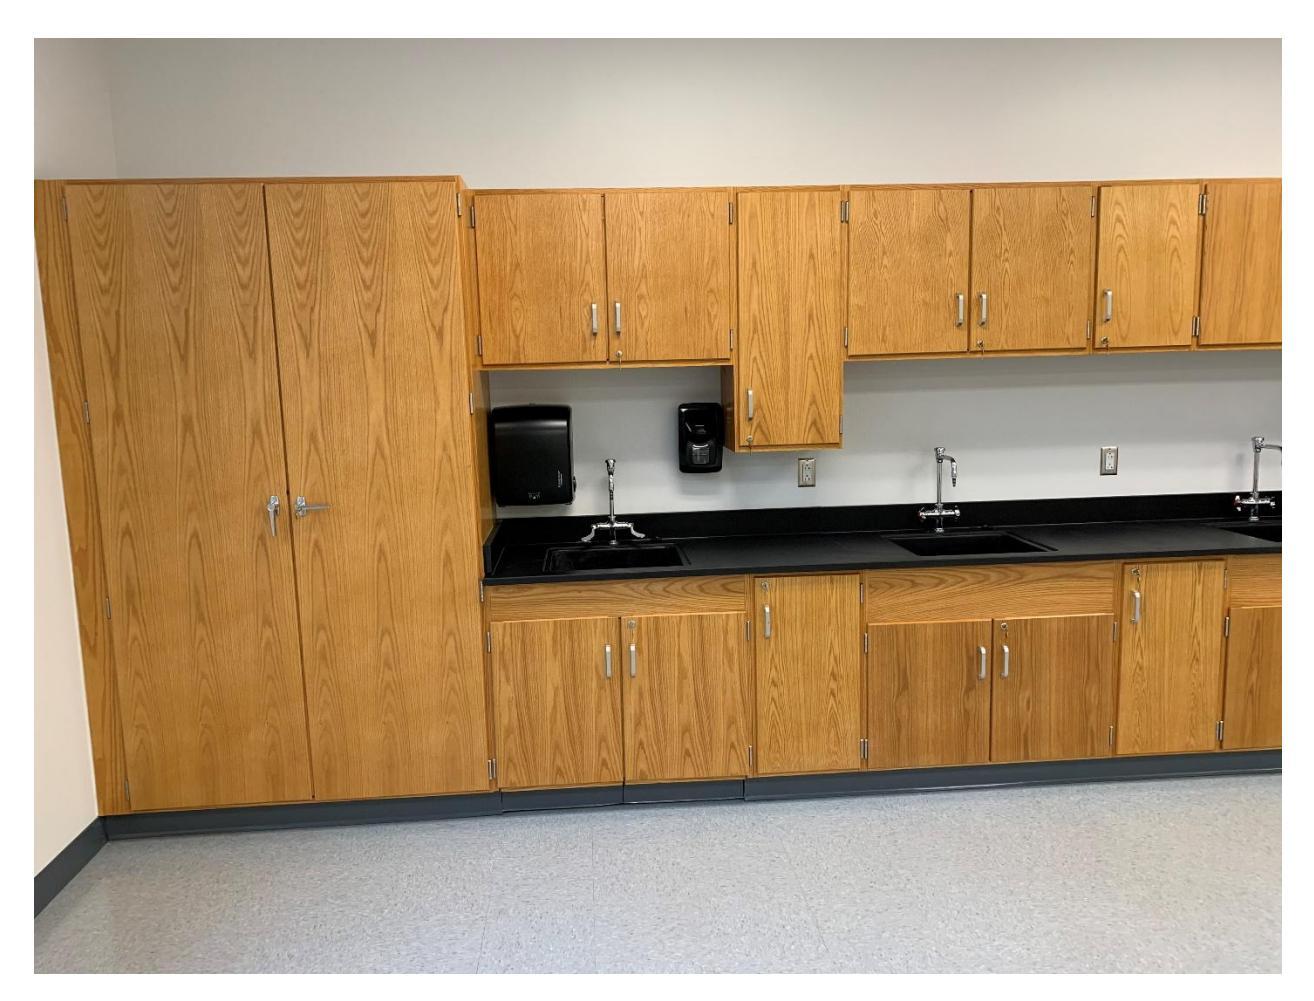
Most of the classrooms have overhead cabinets. The overhead cabinets usually have at least one section that drops down lower than the rest. The lower cabinet is for wheelchair accessibility. That was another of many items I learned by asking.

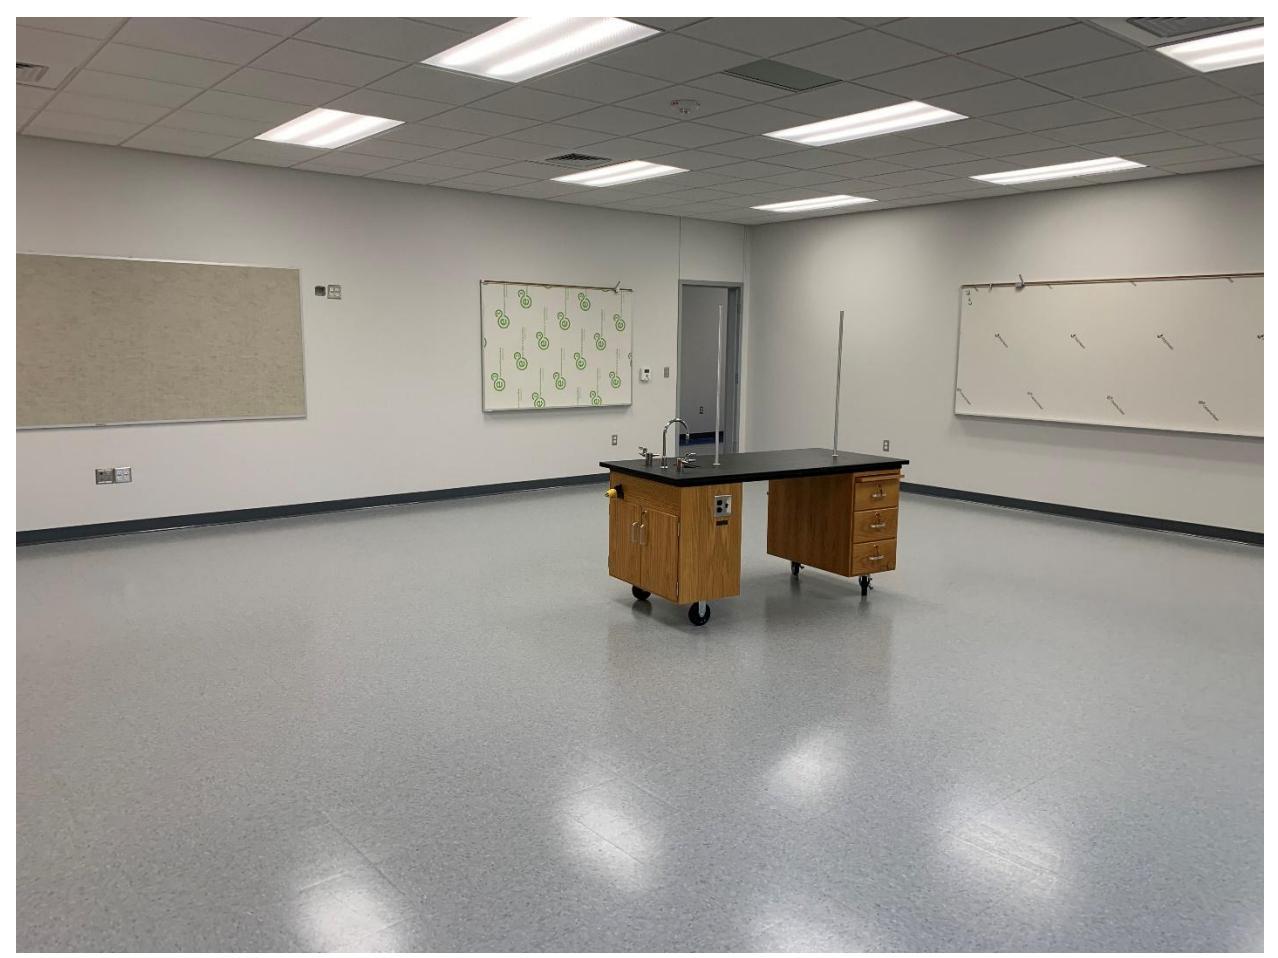
The science labs have portable teacher desks with running water provided by containers under the cabinet top. The sink is almost large enough to wash your hands

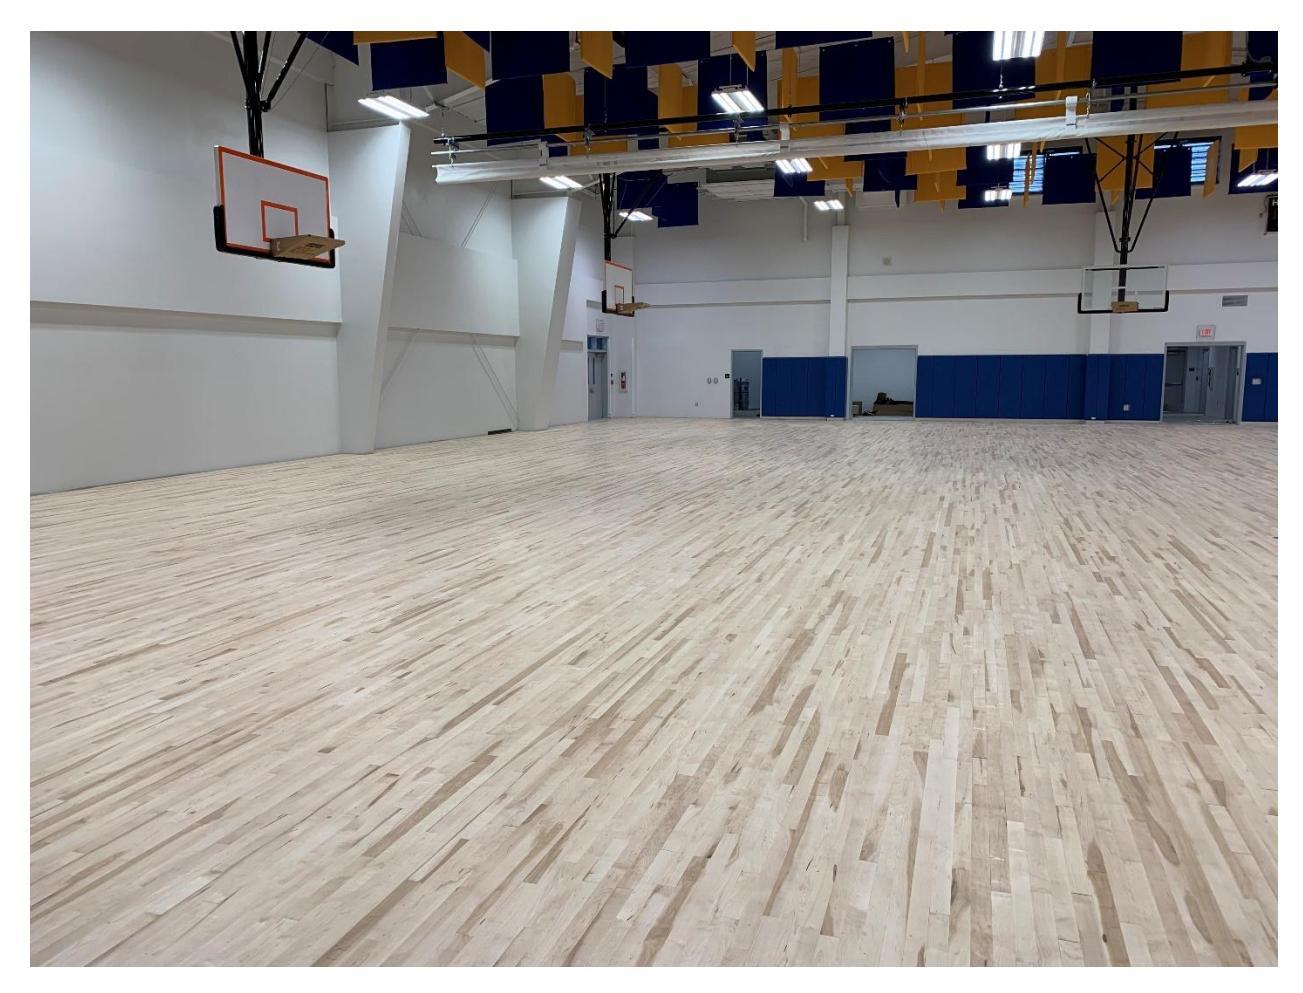
I walked back through the gym before I left for the day on Thursday and asked one of the workers when they thought they would have the floor down. He replied they hoped to finish Friday. It looked to me it would take all day Friday to get all that work done. I made plans to return Friday afternoon to see the finishing touches applied to the floor. I arrived at 1:57 and the floor was complete, the area cleaned of all trash and the workers nowhere to be seen. I am still amazed at the speed and quality of the work on the gym floor.

Sanders will move in Monday to sand the floor for the first step of the finishing process. The whole process will take about two weeks.

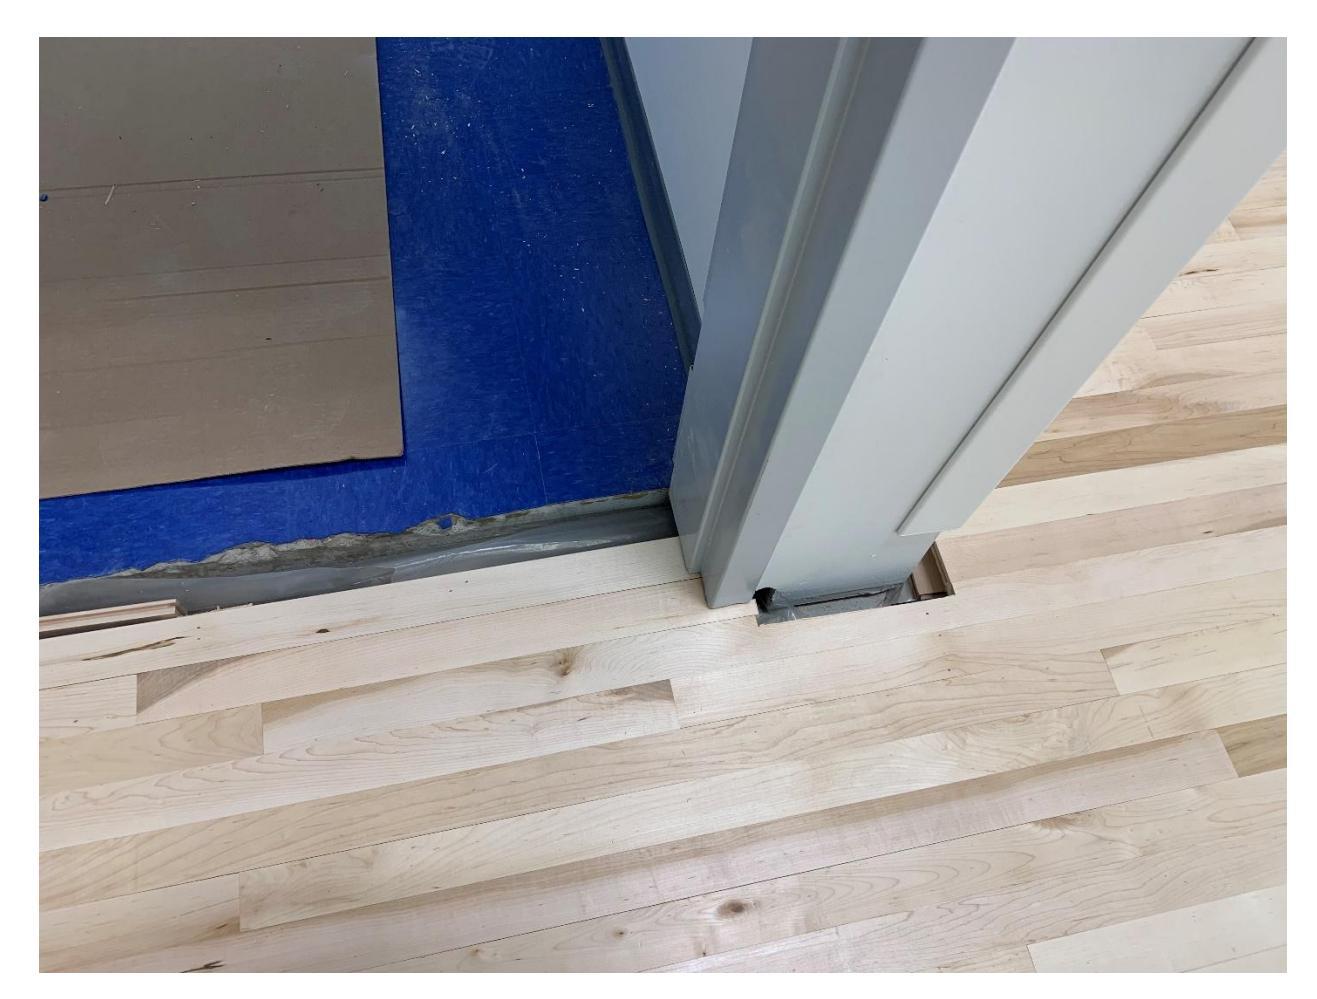
The floor now has a one and one-half inch space around it for expansion and contraction including around corners.

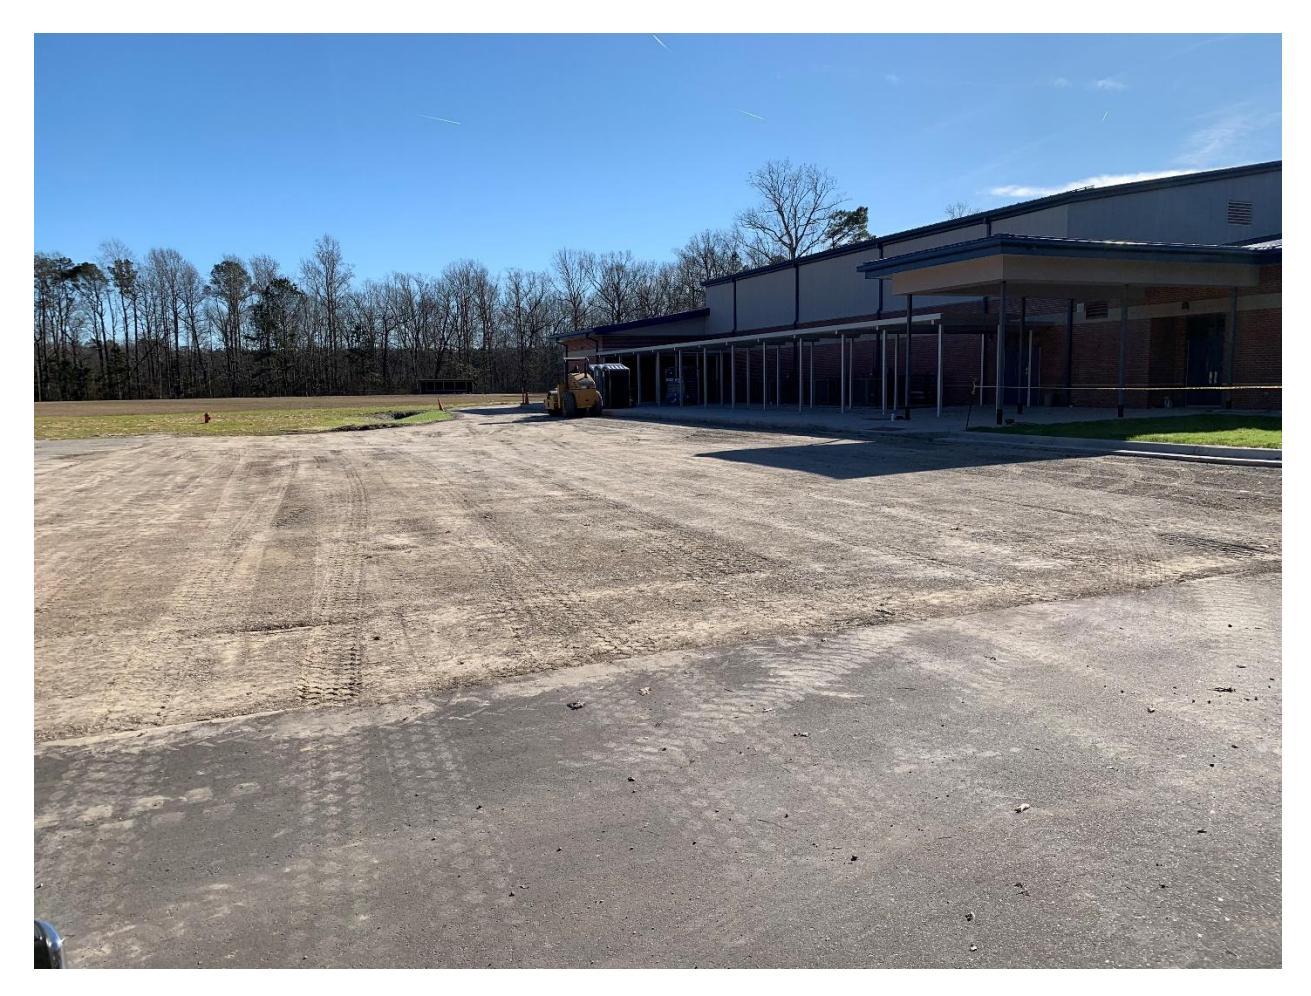
The final packing of the parking lot at the east end of the gym is complete and waiting for suitable weather to pour the asphalt. Notice the fence removed. This place is really looking like a school now!
