# Central Middle School

## Progress Week of June 21, 2019

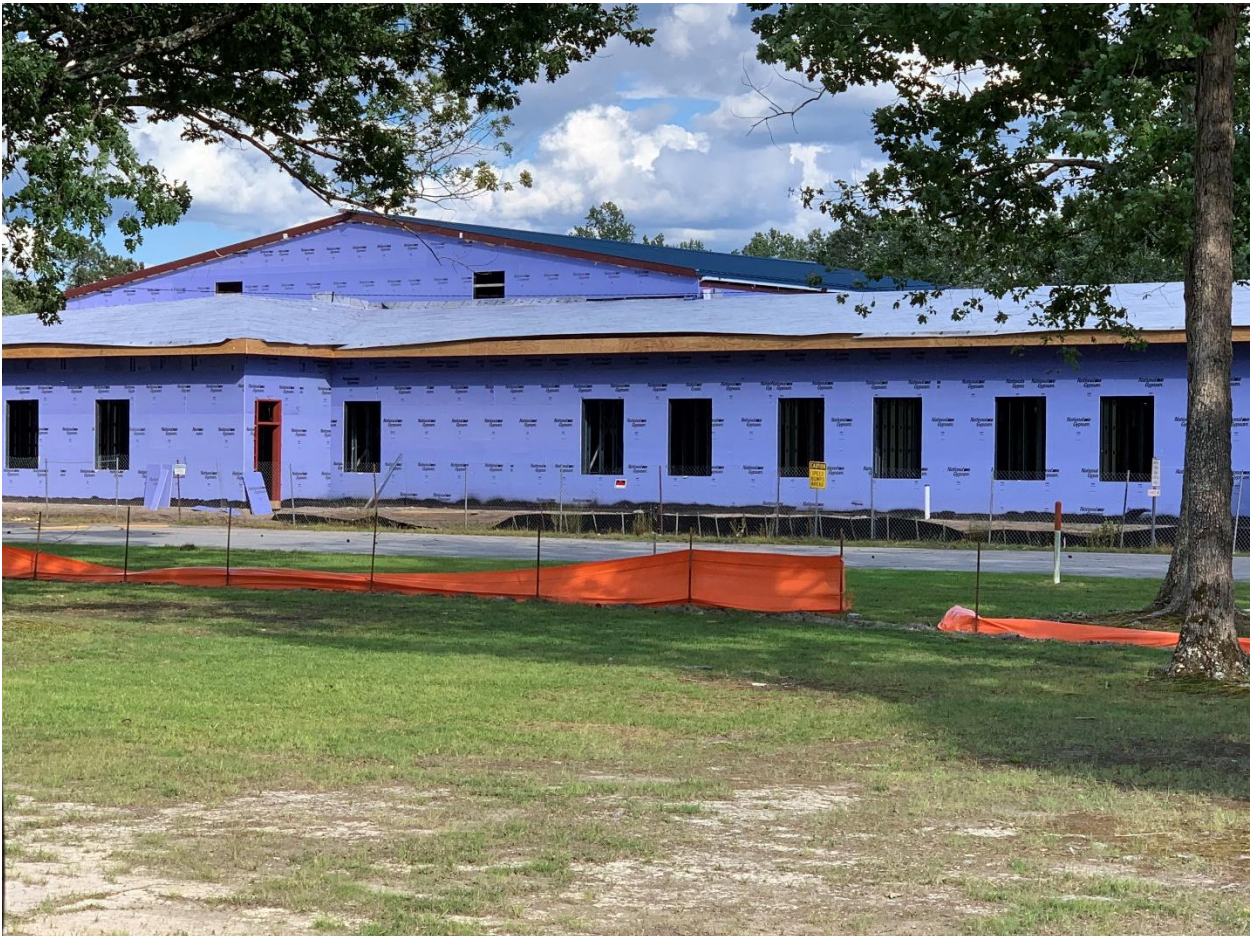
You notice the roof is waiting for roof sheets to be installed. The gypsum board is up to the bottom of the trusses and ready for brick work to start. Look closely at the bottom of the gypsum board and you will notice an irregular line of black at the bottom of the board. This is a waterproofing material to keep water that works its' way through the brick from going through the block. This waterproofing has been

applied most, if not all the way around the building. This is one of many things I learned about construction this week.

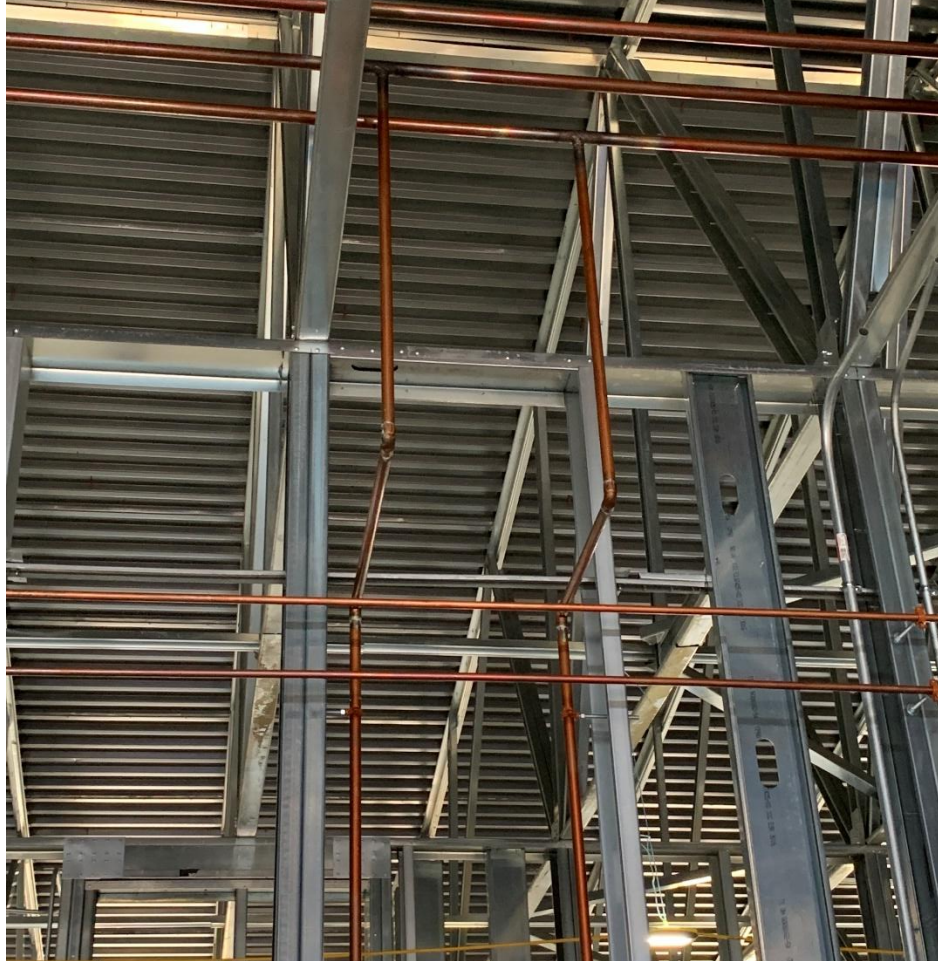
Work continues moving right along by all the trades with the easiest to notice being the copper pipe in the classrooms. The next picture is one of the classrooms on the east side of the eighth grade wing.

The above picture was taken looking west. The next picture is of the same room looking south.

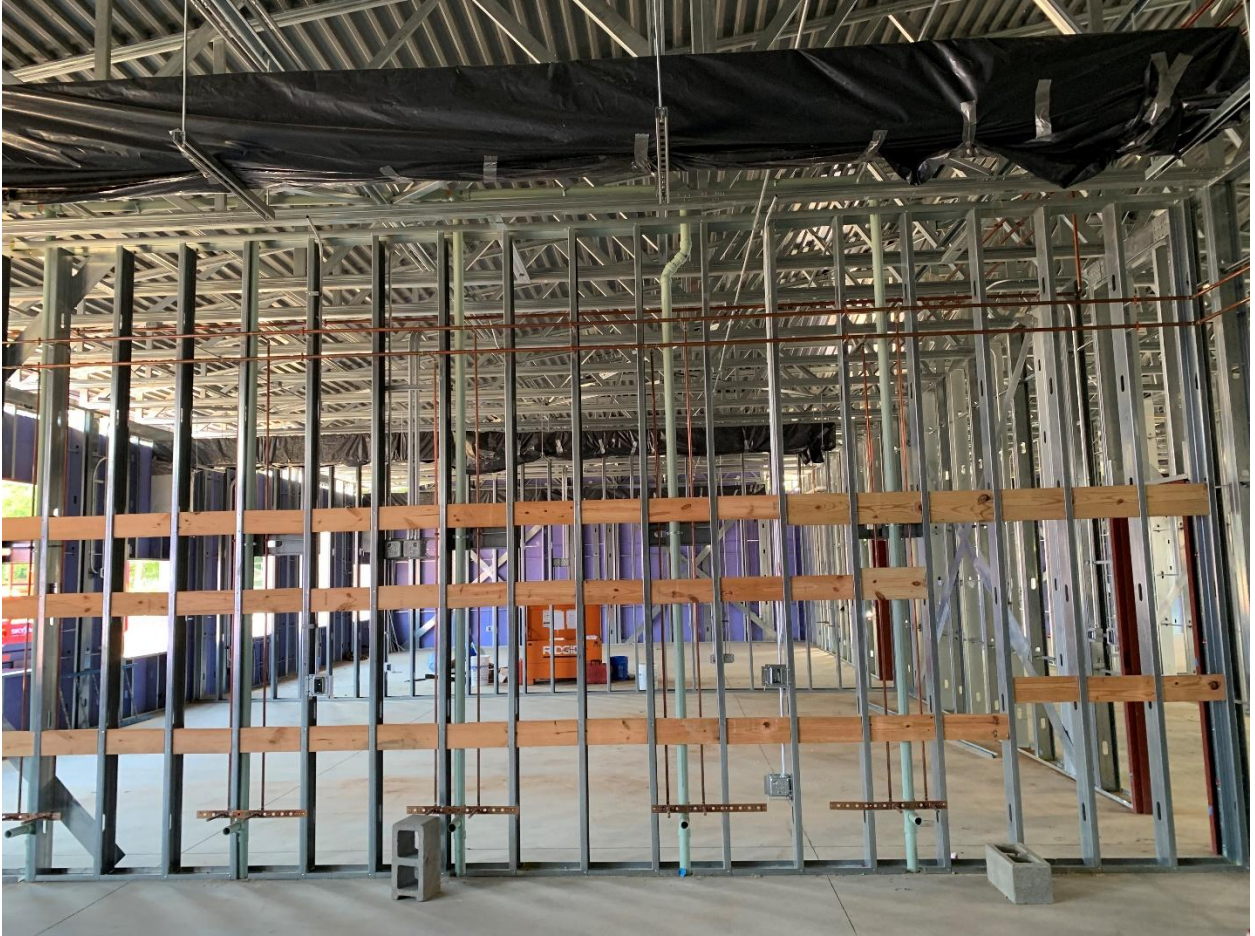
Just as a reminder, the boards in the wall are for attaching cabinets to the wall.

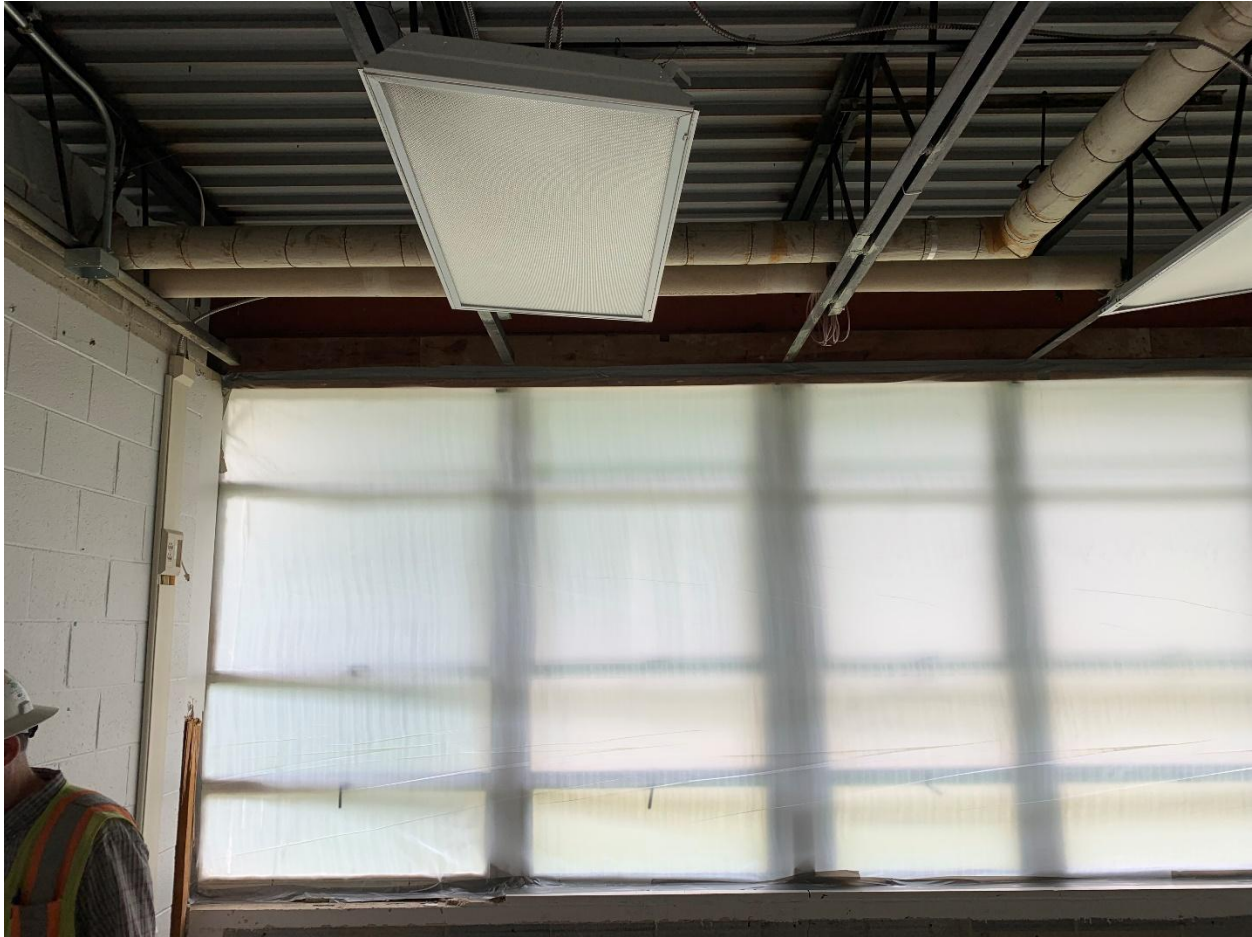
Moving over to the renovation area we see the middle classroom on the south end of the eighth grade wing. There are two pipes in the ceiling. The first line is a 2 ½" galvanized water line that turns down into the wall and runs down through the floor and then turns to the outside of the building tying

in with a line installed by Rountree Engineering a couple of years ago.

The picture is not out of focus. The windows have plastic inside them as containment for asbestos removal to start next week in this area. The elbows, hangers and insulation joints have mud sealant on them that contained asbestos fibers. Those areas will be abated, then the rest of the insulation will be removed. The school board will consider approval of replacing the old line with copper moving the vertical run to the end of the wall in a corner to get rid of the possibility of the old line failing overhead, inside the wall or under the slab. Now seems to be the appropriate time to address these issues.

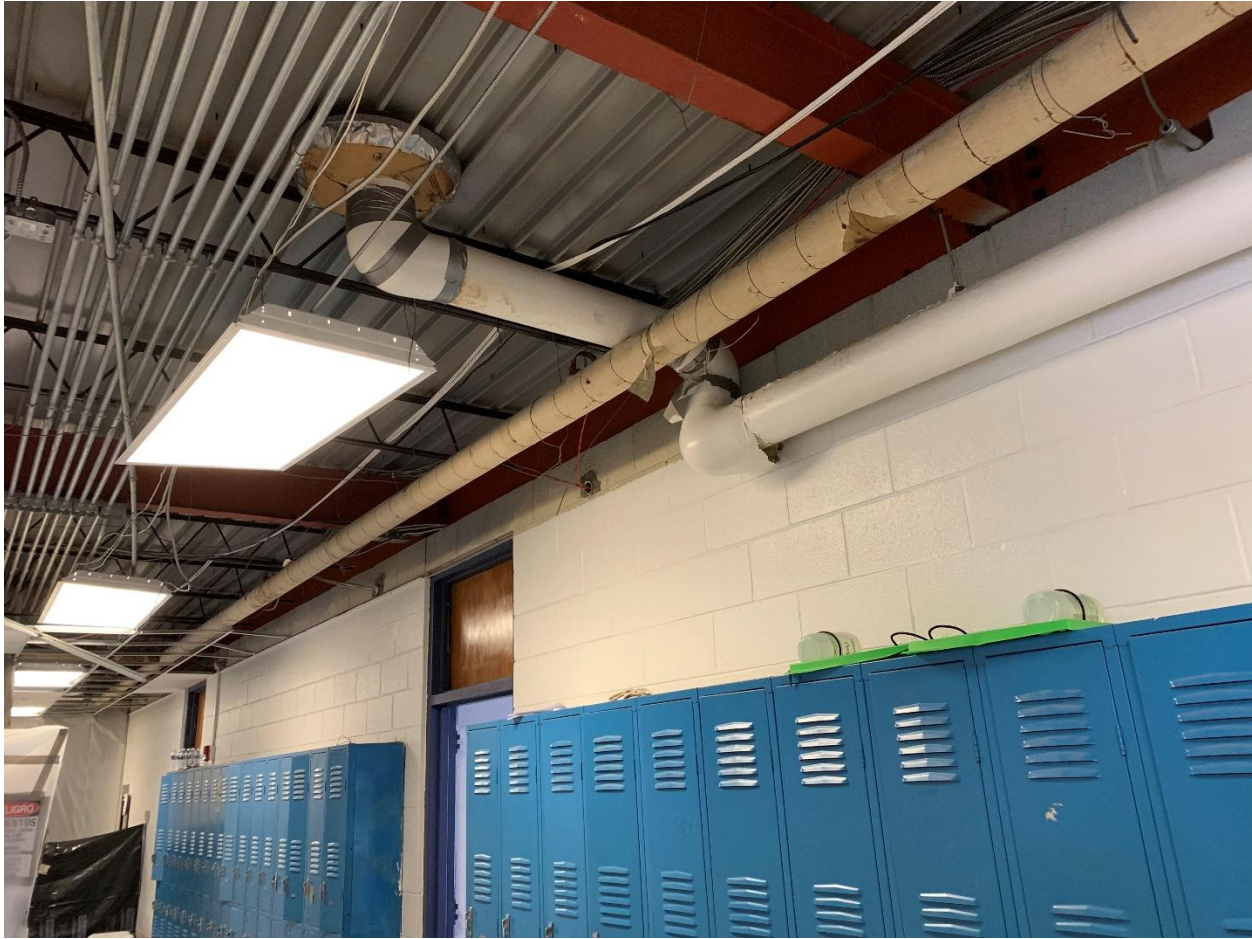
This picture is taken about the middle of the eighth grade hallway. The brown line is the 2 ½" galvanized water line we propose to replace with copper. The white line is a roof drain that will go away

with the installation of the new built up roof. Work on replacing that roof is to start next week.

You notice the lockers in this picture. From this angle, they look to be in pretty good shape. The lockers show their age with paint worn off especially at the corners, at the door latches and on the ends. We have not come up with a solution to improve their appearance. Mr. Plyler says we are probably talking \$75,000.00 to replace them. We are open for suggestions. Effective painting would require removal of all hardware and doors. Otherwise it will be very apparent we tried to make a silk purse out of a sow's ear.

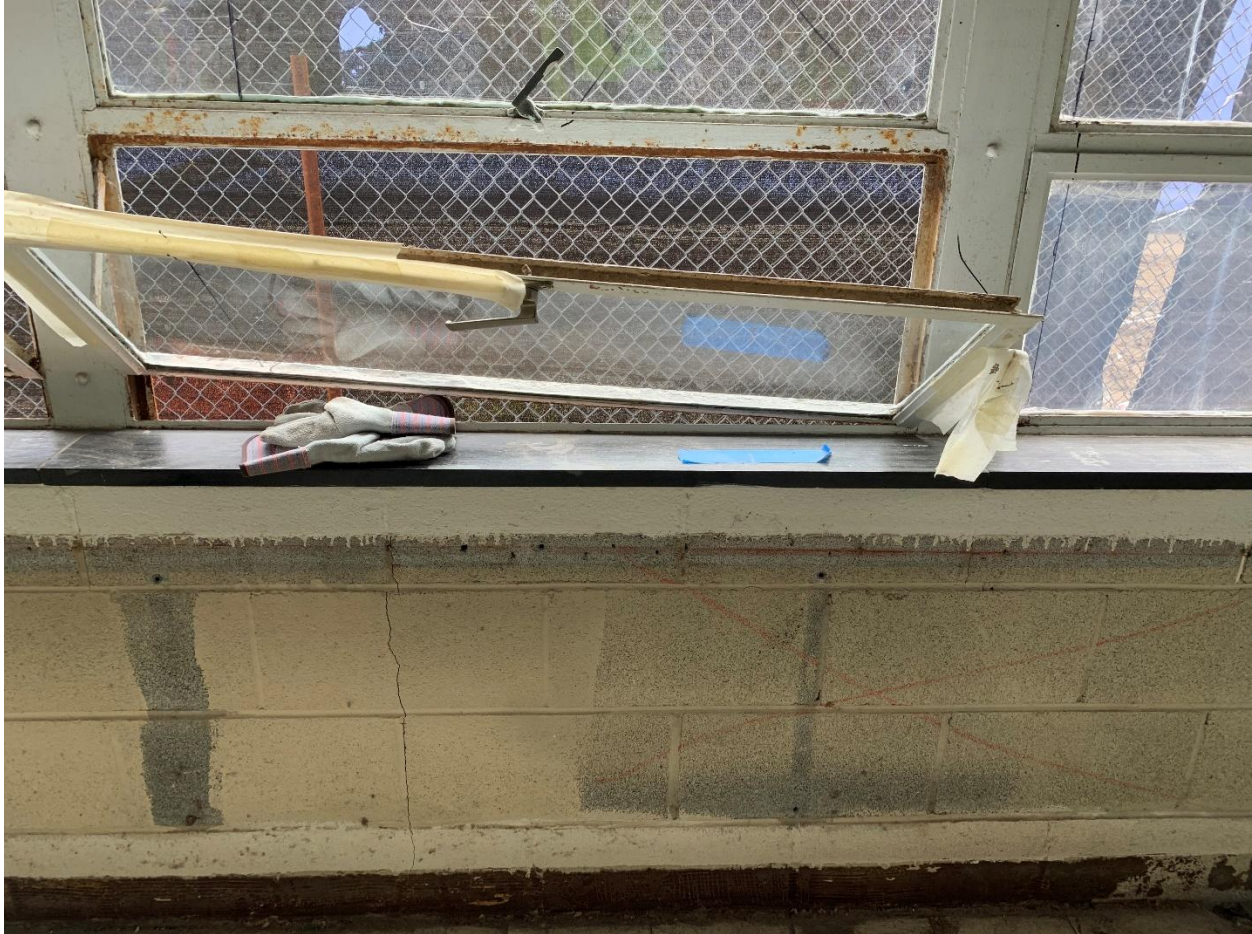
I like for us to see just how bad things were in the seventh grade wing. This is a window in one of the east side classrooms. The teacher had applied masking tape to slow winter's cold from blowing through. Those old windows are single pane in a steel frame.

They have little, if any, insulation value nor did they when they were installed before anyone thought about insulation value.

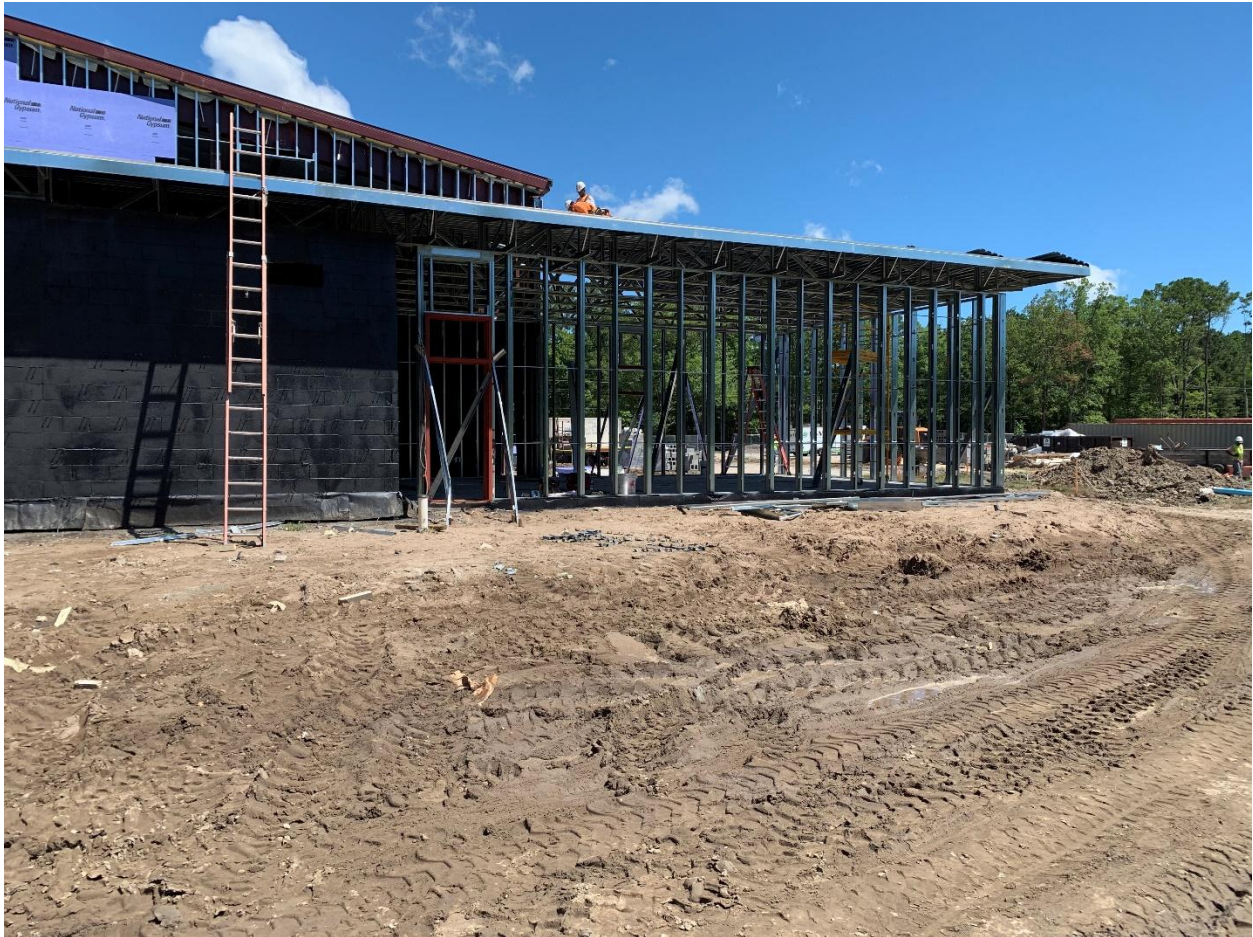
Finally, we go back to the new construction to enjoy a picture of the weight room all studded up and wearing a roof. It is truly amazing how much can happen in a week. Only the slab was there a week ago!
